**URGENT REMINDER: ProMaster Transmission Bracket Service**

May 29, 2019

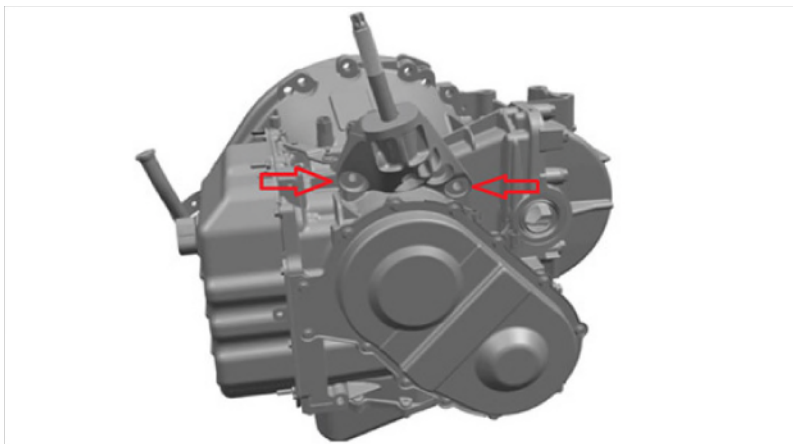
When servicing a Ram ProMaster equipped with a 3.6L engine, this notice is to emphasize the importance of **replacing** the **one-time use** bolts that fasten the left transmission mount to the transmission.

**WARNING: DO NOT reuse these transmission mount bolts, as it may lead to future catastrophic damages.**

Be sure to check all mounting bracket torque specifications -- some fasteners have a torque value higher than most bolts
