NUMBER: 08-045-19

Flash Over The Air (FOTA) Software Update UAV and UCV Radio

This bulletin provides information regarding the latest FOTA software update to 21.10.

2019 (DT) RAM 1500 Pickup

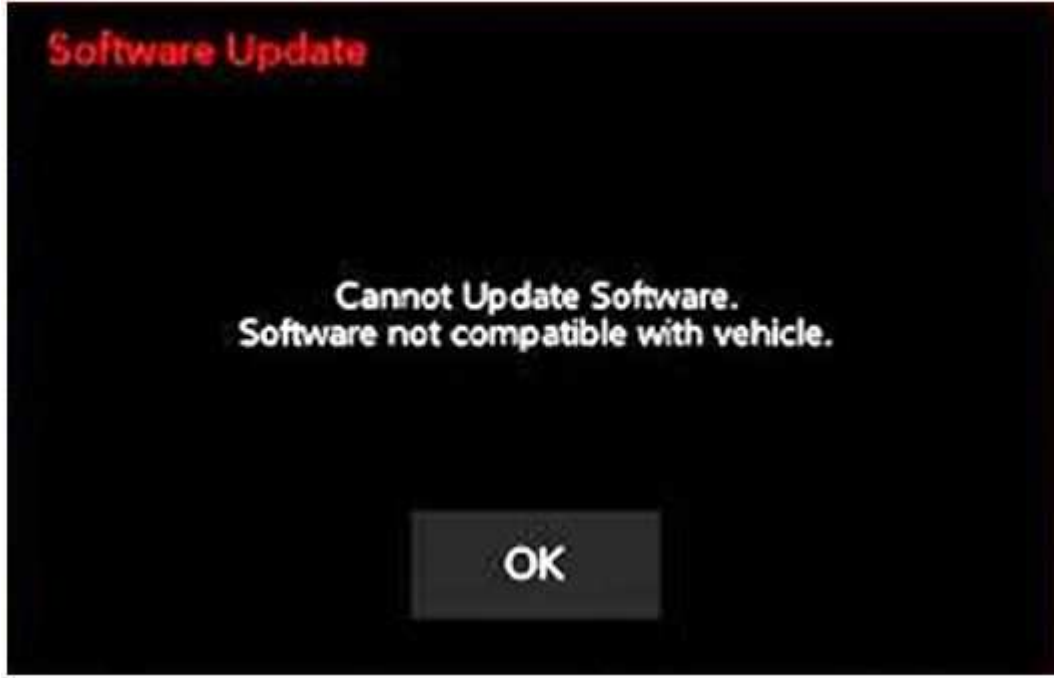
Fig. 8
Software Not Compatible

12. If the screen in (Fig. 8) is displayed, the USB flash drive was not set up correctly. Use a top name brand USB and create a new flash drive then start the update again.
