NUMBER: 02-002-19

Noise From Front Sway Bar Link

2019 (DT) RAM 1500 Pickup

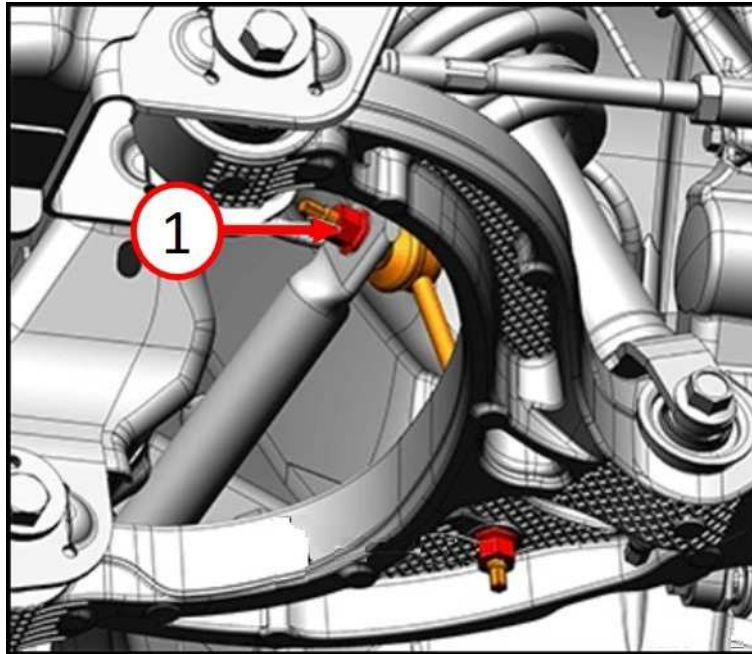
Fig. 1

Bar To Link Joint Nut Location (Left front side shown. Other side is similar)

1 - Bar To Link Joint Nut

- Torque the nut on the front left and right stabilizer bar link to 92 N·m (68 ft-lbs) at the bar to link joint (Fig. 1) .
