NUMBER: 23-016-19

Battery Acid Leaking on Transmission Pan

2015 - 2019

RAM ProMaster City

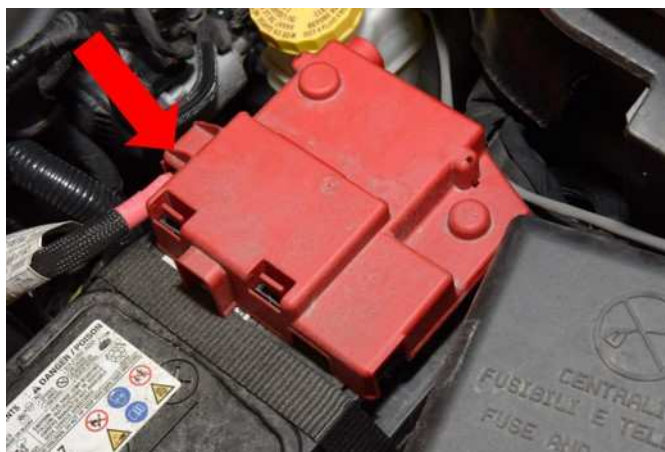
Fig. 1

Battery Fuse and Junction Box Cover

1. Open the hood.
2. Remove the positive battery fuse and junction box cover (Fig. 1) by pressing both tabs and then lifting up on the cover.

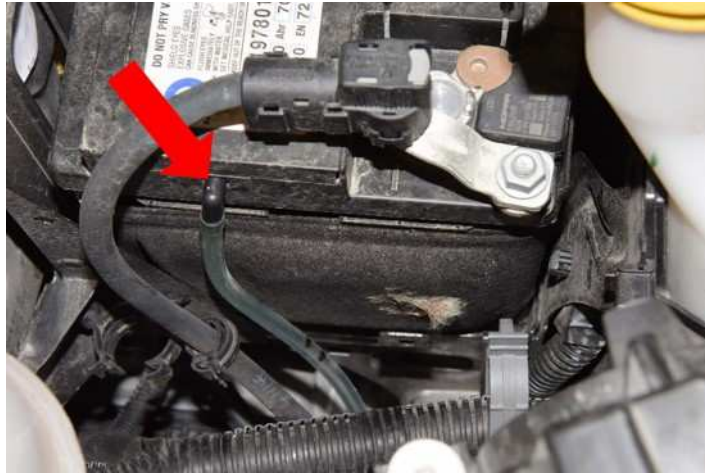
Fig. 2
Negative Side Vent Pipe

6. Install new battery vent pipe **P/N 68476284AA** on the negative side of the battery (Fig. 2) .

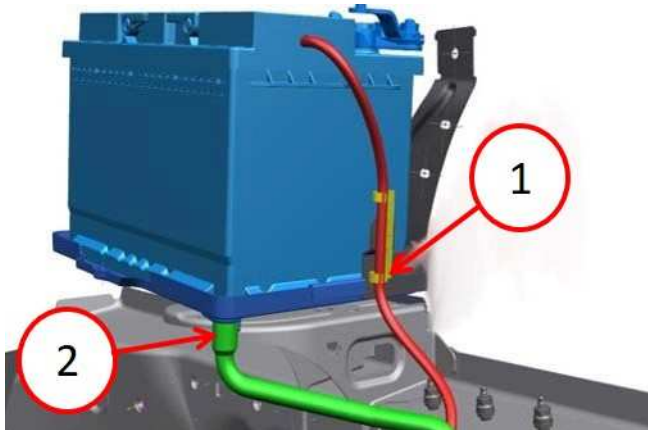
Fig. 3
Clip and New Battery Tray Vent Pipe

- 1 - P/N 68476190AA Clip
 - 2 - P/N 68417800AA Battery Tray Drain Pipe
-

7. Install new battery tray drain pipe **P/N 68417800AA** on the battery tray (Fig. 3) .

9. Fasten the battery vent pipe **P/N 68476284AA** on clip **P/N 68476190AA** (Fig. 3) .
10. Install the battery strap and fuse junction box. Refer to the detailed service procedures available in DealerCONNECT/Service Library under: Service Info>08 - Electrical/8F - Engine Systems/Battery System/Battery/Installation.

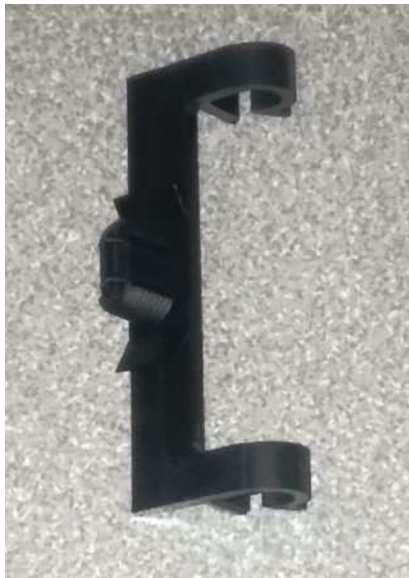
Fig. 4
P/N 68476190AA Clip

8. Install clip **P/N 68476190AA** (Fig. 4) on the battery tray bracket (Fig. 3) .

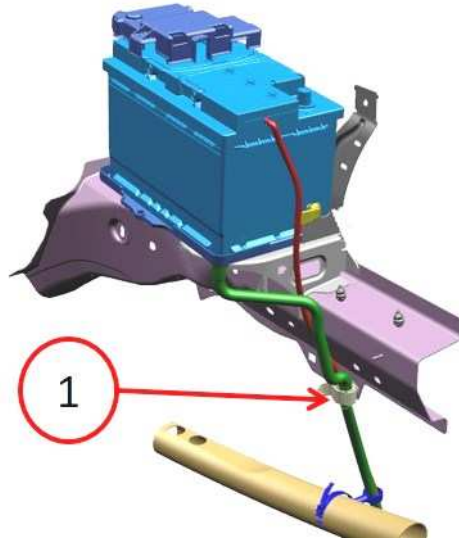
Fig. 5
Clamp on Body Hole

1 - P/N 68163243AA Clamp Installed on Body Hole

13. Install clamp **P/N 68163243AA** into the body hole (Fig. 5) near the transmission.

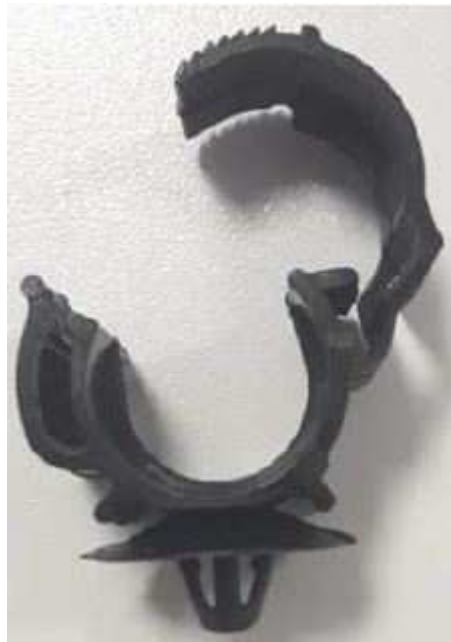
Fig. 6
P/N 68163243AA Clamp

14. Install both the battery tray drain and battery vent pipes on clamp **P/N 68163243AA** (Fig. 6) .

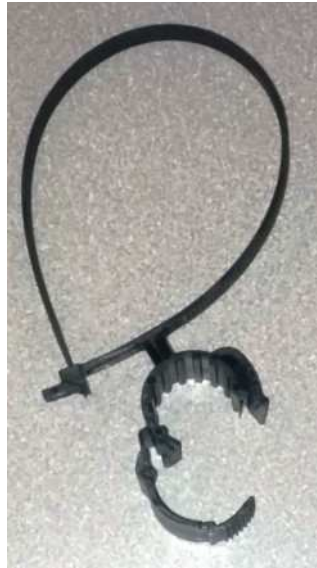
Fig. 7
P/N 68461928AA Clamp

15. Install banded clamp **P/N 68461928AA** on the battery tray drain pipe (Fig. 7) .

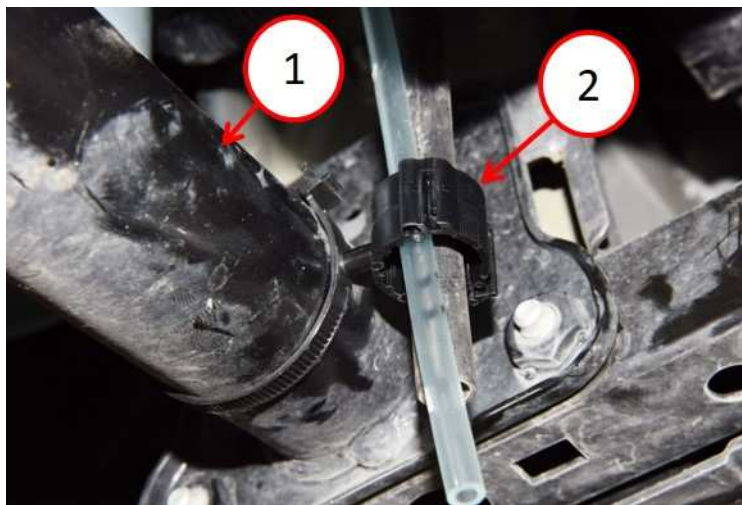
Fig. 8
Clamp on Radiator Support Beam

- 1 - P/N 68461928AA Banded Clamp On Pipe
2 - Support Beam
-

16. Secure the band from clamp **P/N 68461928AA** to the round cradle and radiator support beam (Fig. 8) .

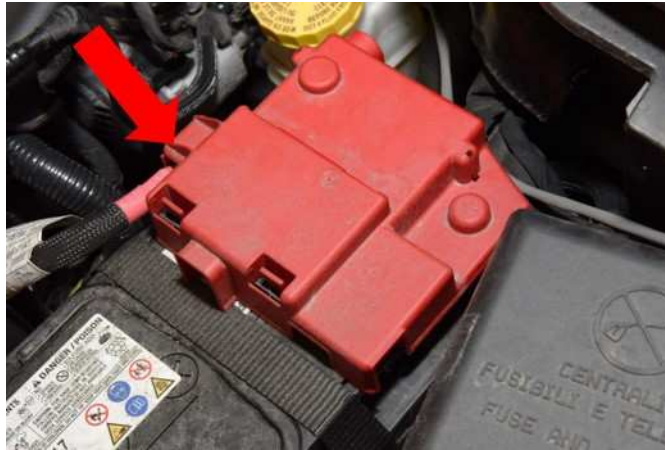
Fig. 9
Battery Fuse and Junction Box Cover

1. Open the hood.
2. Remove the positive battery fuse and junction box cover (Fig. 9) by pressing both tabs and then lifting up on the cover.

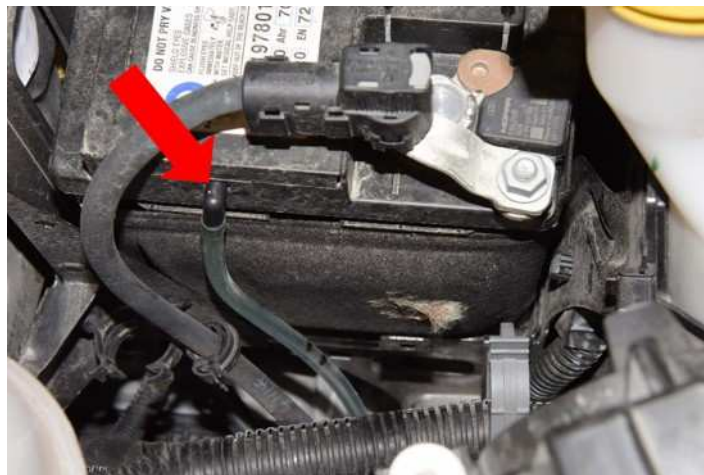
Fig. 10
Negative Side Vent Pipe

3. Install new battery vent cap (plug) P/N 68476390AA on the positive side of the battery.
4. Install positive battery fuse and junction box cover on the battery.
5. Install new battery vent pipe P/N 68476284AA on the negative side of the battery (Fig. 10) .

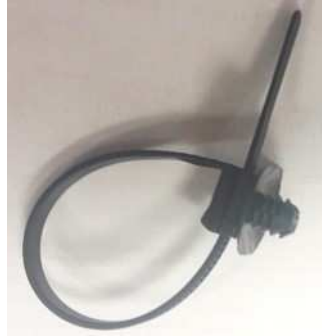
Fig. 11
Zip Tie Clamp

CAUTION! Do not overtighten zip tie clamp to the vent pipes. Failure to do so may result in the pipes not venting properly.

6. Install zip tie clamp (Fig. 11) on the battery vent pipe and attach to battery tray bracket (Fig. 12) .

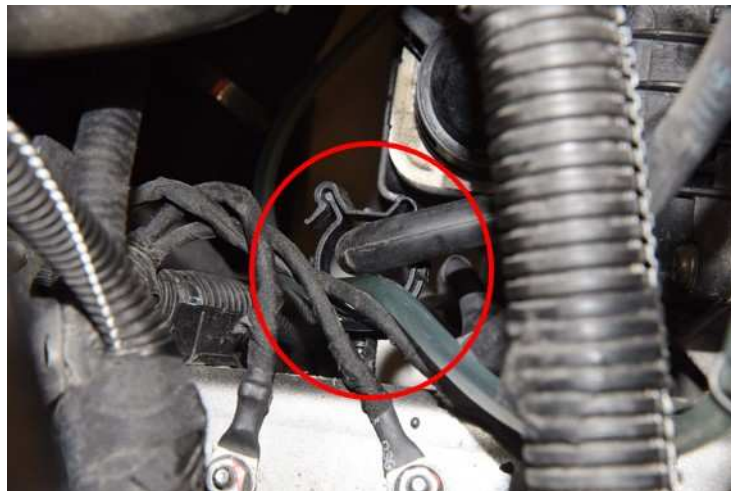
Fig. 14
Clamp Installed On Support

7. Remove and discard the existing pipe clamp and install clamp **P/N 68470618AA** (Fig. 13) on both of the pipes and attach to the sub frame support (Fig. 14) .

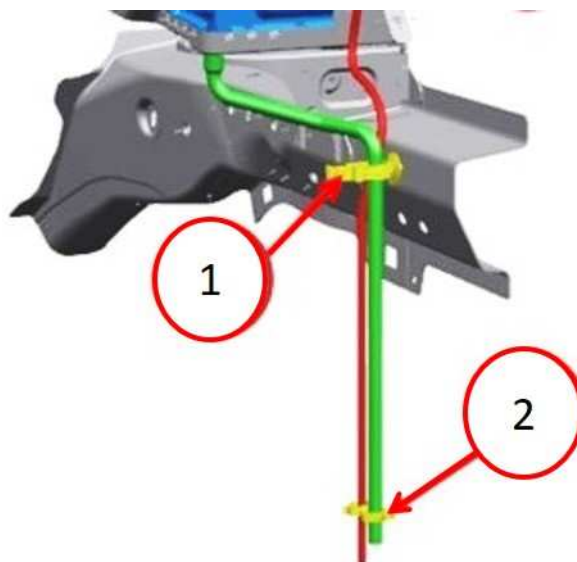
Fig. 15
New Battery Vent Pipe Routing and Clamps

- 1 - P/N 68470618AA Clamp
- 2 - P/N 68112893AA Clamp

8. Position both pipes downward pointing to the ground (Fig. 15) .

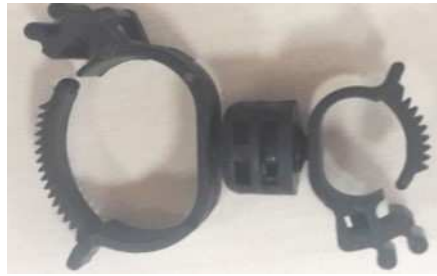
Fig. 16
P/N 68112893AA Clamp

11. Install **P/N 68112893AA** clamp (Fig. 16) on both pipes between 20 - 30 mm (.78 - 1.18 in.) on the tray drain pipe and between 45 - 55 mm (1.77 - 2.16 in.) from the end of the battery drain pipe (Fig. 17) and (Fig. 18) .

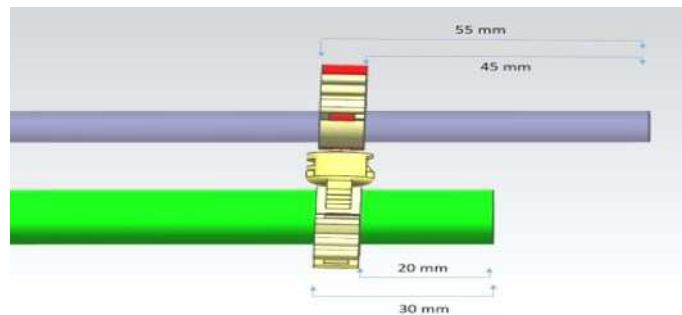
Fig. 17
P/N 68112893AA Clamp Measurement Locations

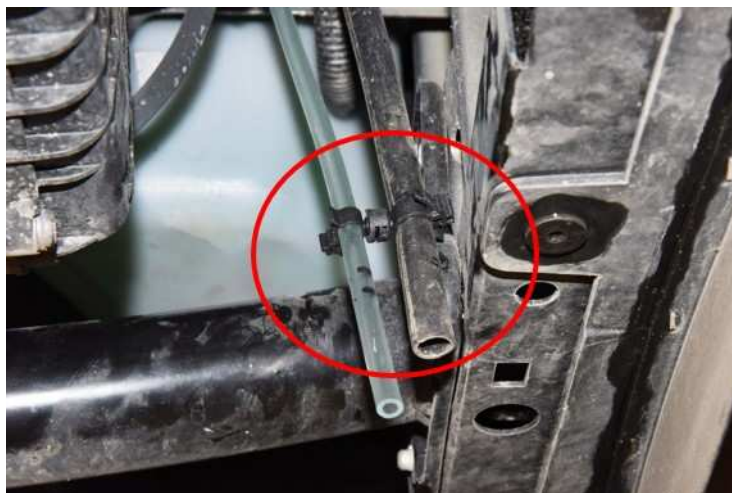
Fig. 18
Clamp Installed On Hoses
