**NUMBER:** 08-050-19

**GROUP:** 08 - Electrical

UGQ Radio Enhancements

2018 (BU) Jeep Renegade

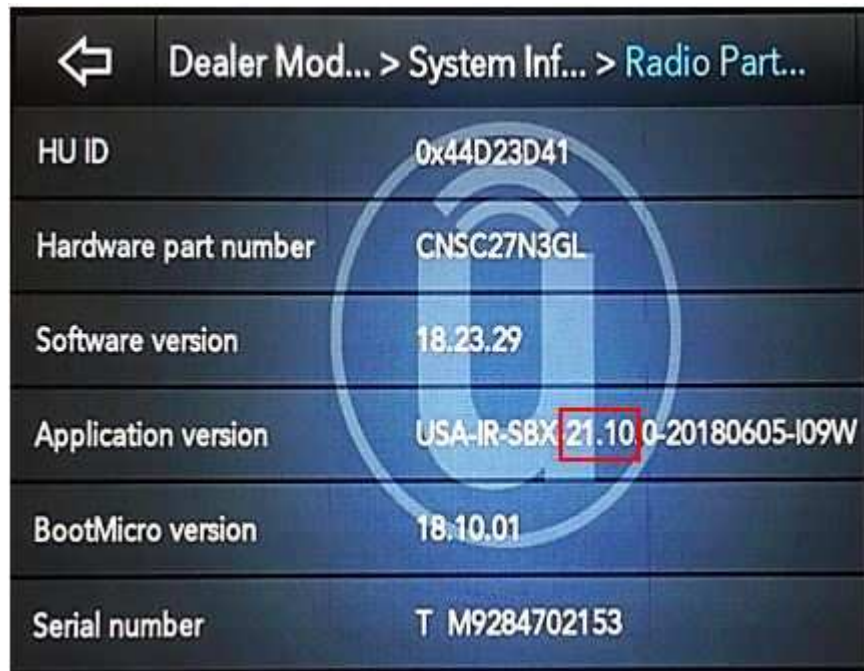
Fig. 1  
Radio Software Level Screen

1. Verify the radio software version. Radio must be in Dealer Mode to verify. To put the radio in Dealer Mode, follow these steps:
  - a. Press and hold both lower corners of the display screen, until the Dealer Mode screen appears (approximately seven seconds). Release buttons.
  - b. Select "Radio Part Information". The software level will be listed next to "Application Version".
2. Is the radio currently at software level **\*\*21.9\*\*** or higher (Fig. 1) ?
  - YES >>> This service bulletin has been completed. Use inspection LOP (18-60-02-QU) to close the active RRT.
  - NO >>> The radio software needs to be updated. Back out of Dealer Mode and proceed to [Step 1](#) of the Repair Procedure.

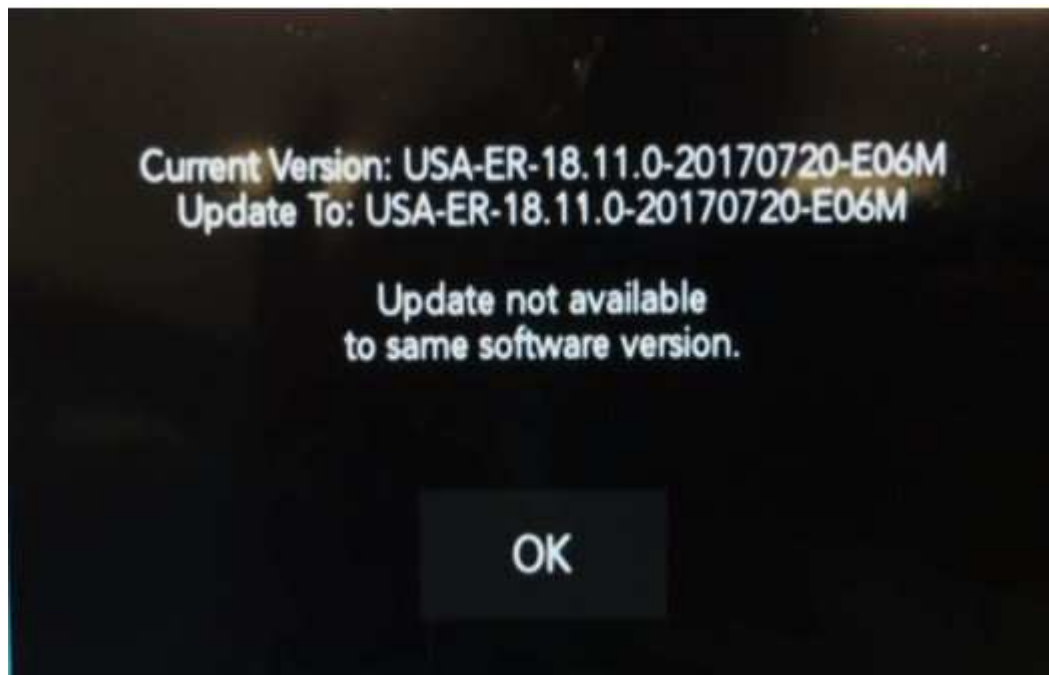
Fig. 12  
Software Levels (The figure is for reference only, actual software levels will be \*\*21.9\*\*)

16. After the update has completed, the radio will shut down. With the USB flash drive still inserted in the USB port, turn the ignition back to the run position. If the radio has been updated correctly, the screen in (Fig. 12) will be displayed. Press "OK" and remove the USB flash drive.
