NUMBER: 08-051-19

UJQ with RS9 Radio Enhancements

This bulletin involves inspecting and if required, updating the radio software level to ****21.9.****

2018 - **2019**	(LA)	Dodge Challenger
2018 - **2019**	(LD)	Dodge Charger
2018 - **2019**	(LX)	Chrysler 300

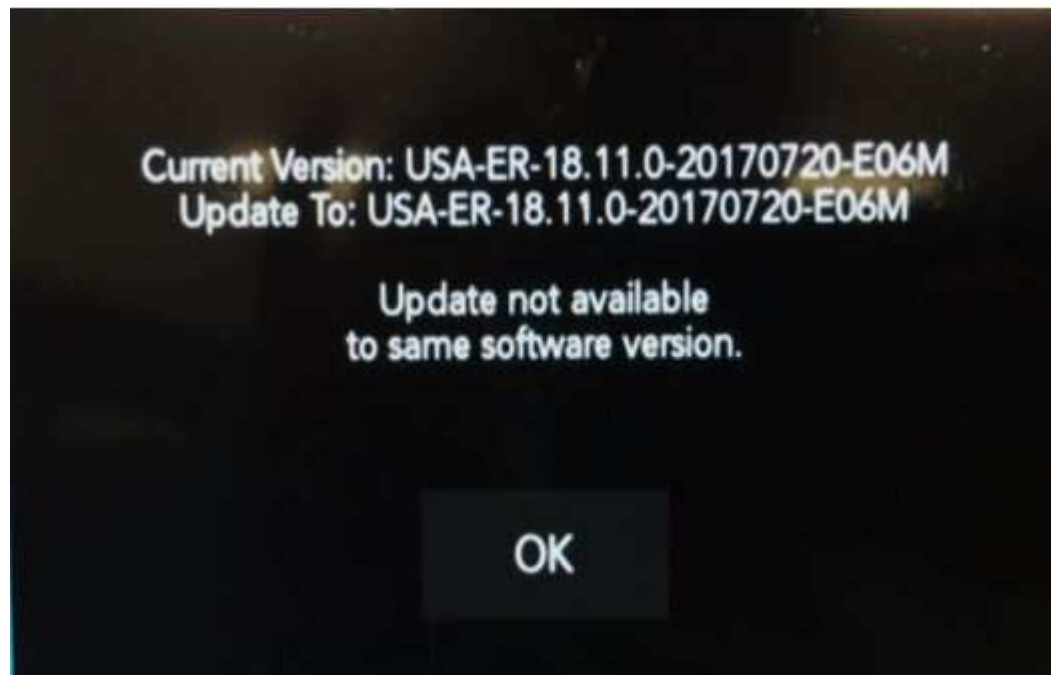
Fig. 12

Software Levels (The figure is for reference only, actual software levels will be **21.9**)

16. After the update has completed, the radio will shut down. With the USB flash drive still inserted in the USB port, turn the ignition back to the run position. If the radio has been updated correctly, the screen in (Fig. 12) will be displayed. Press "OK" and remove the USB flash drive.
