Technical Service Bulletin Notification TSB #19-032

Emergency Brake Breakaway Switch Wiring

| Incident: | Incorrect wiring of the Emergency Brake- breakaway switch will prevent trailer brakes from engaging. |

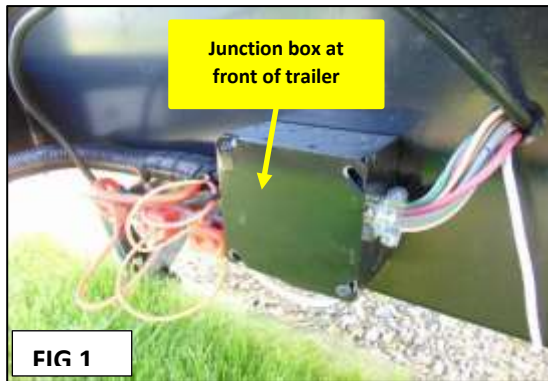
FIG 1:

- Locate the junction box located at the front of the trailer, mounted on the front cross member inside the A-frame hitch area.
- Remove the 2 screws holding the cover on.

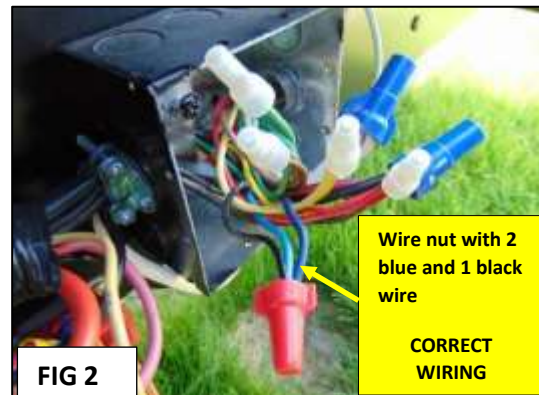
FIG 2:

- Pull out the wiring and inspect the wiring.

Correct is a wire nut with 2 blue wires and 1 black wire. There will only be one wire nut with this wire color combination. If the switch wiring is correct, no repair is required. Replace the cover and the 2 screws.

Incorrect is the absence of a wire nut with 2 blue wires and 1 black wire. Continue with the following repair instructions.

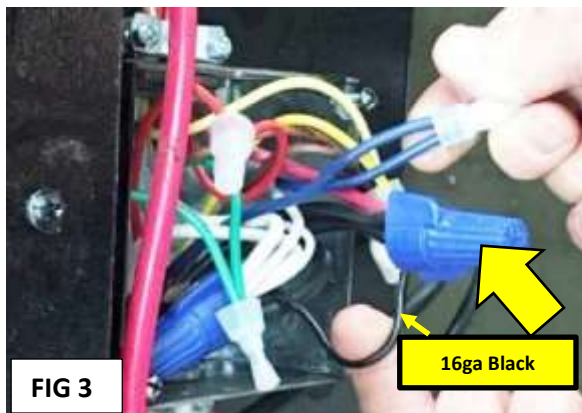
FIG 3:

- Locate the large blue wire nut with 4 black wires, and 1 red wire (large arrow). **(INCORRECT WIRING)**
- One of the 4 black wires will be a 16ga and smaller than the others.
