Title Mack Chassis - Equipped With An Automated Manual Transmission **Model D or F** (mDrive, AMT-D, AMT-F) - Transmission Oil Leakage From Transmission Input Shaft Seal Or Output Shaft Seal - **US10 And Newer Emissions, Common Model Years 2010 And Newer**

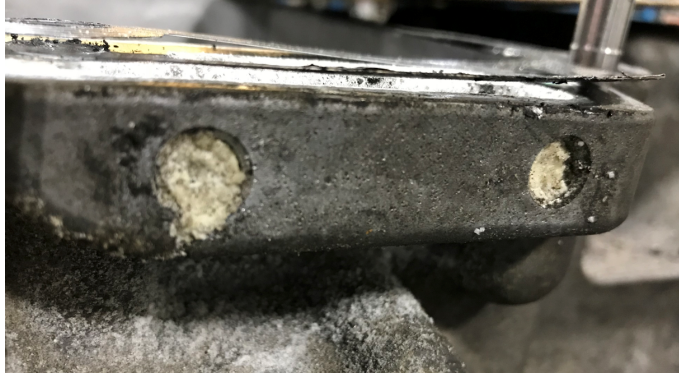
Cause Accumulation of debris in the left side vent ports of the transmission main case (corrosion, road salt, dirt, etc) may result in oil leaks present at the transmission input and output shaft seals.

Blockage of these ports allows pressure to build to a point that it forces oil past the input and output shaft seals. In extreme cases, the pressure buildup can be high enough that operation can be affected. Excessive internal pressure caused by blocked vents may result in slow or sluggish gear shifts.

Clogged vent ports

1. Check the vent ports on the upper left side of the the main gearbox housing for any sort of blockage or obstruction.

2. Clean out any debris that is observed during the inspection.
3. Check the transmission oil level in the gearbox.
 - **If the lube level is excessively low:** Proceed to the next section.
 - **If the lube level is at an acceptable level:** Fill the transmission oil to the correct level and check operation.
