# TECHNICAL INFORMATION

#Bulletin	Date	Page
MAS001912	17/06/2019	1/6

**MODEL:** Maserati Levante

**SUBJECT:** Installation of new type of windscreen side trim moulding on chassis lower then 332748

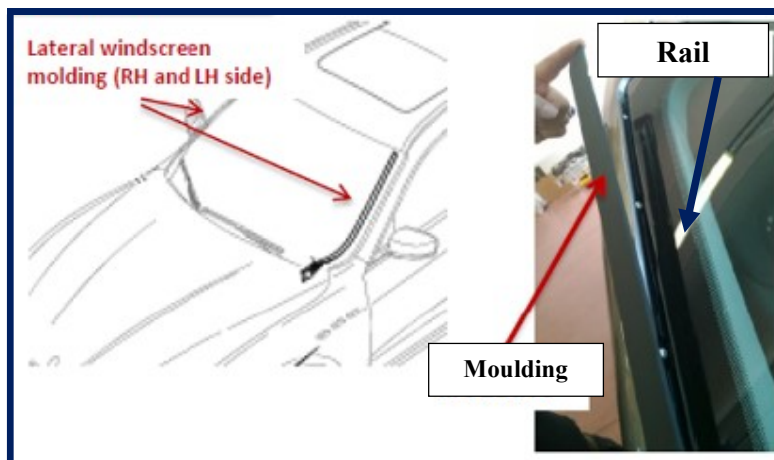
We inform you that from chassis **332748** onwards a new type of windscreen side trim moulding is fitted. The new moulding has an improved fixing.

With this improvement shall prevent the loosening of the windscreen side trims.
