## MBUX multimedia system: High-frequency interference noise from speakers

| Topic number | LI82.85-P-069851 |
| Validity | Model series167 with code 547/548/549+810 |

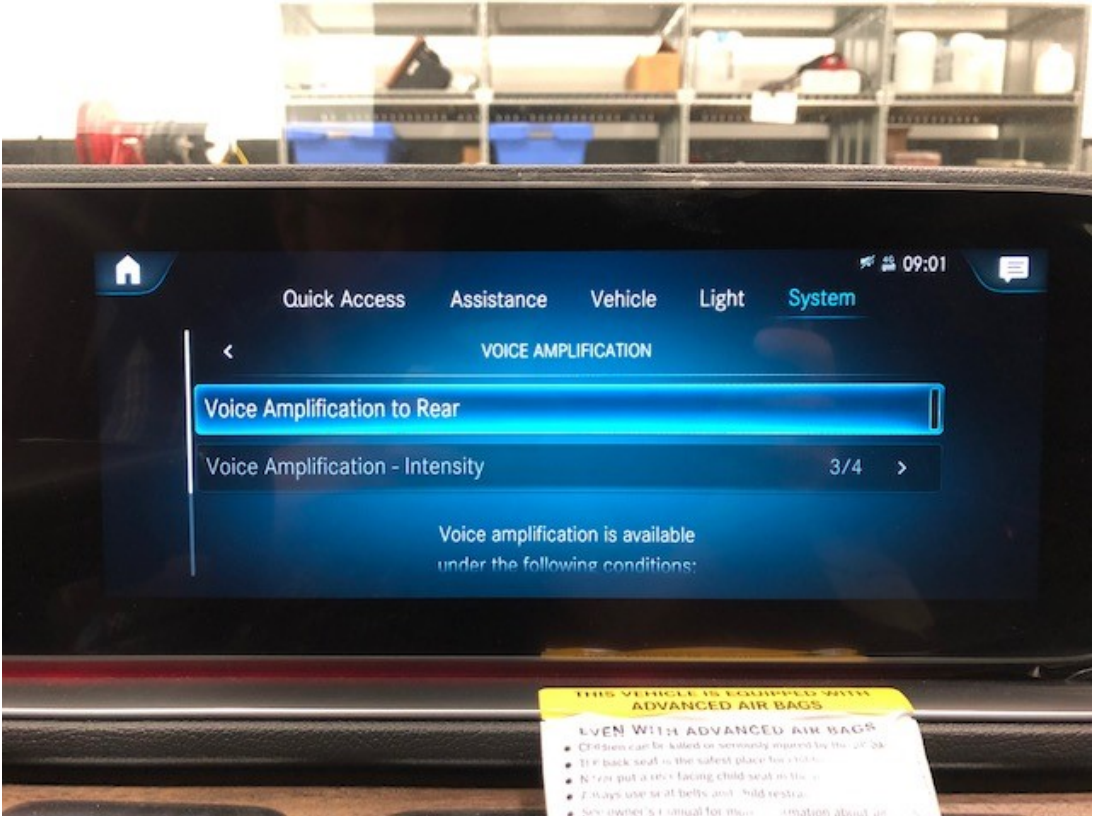
voice amplification to rear.jpg:

| Attachments | |
|---|---|
| voice amplification to rear.jpg | Voice amplification menu |

The interference noise can be remedied by deactivating voice amplification: "Home" -> "Settings" -> "System" -> "Audio" and de-select "Voice amplification to rear" to switch off the function (see attachment).
