## Latest Vehicle Concern Fixes

### Coolant Leaks in AJ20P6 equipped vehicles

### 2019 RR Sport with AJ20P6

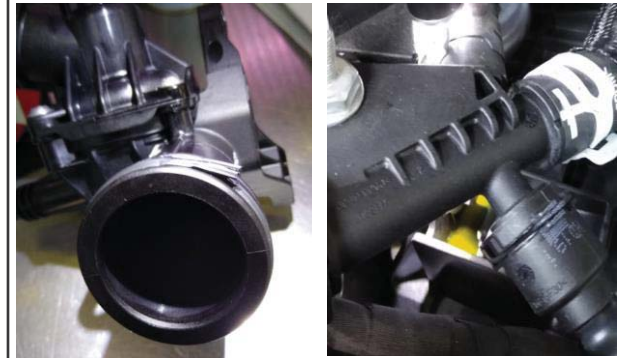
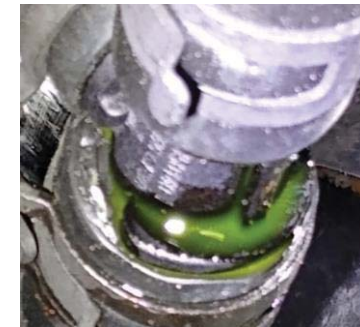
- A leak is identified from the engine cooling system.

- There have been reports of leaks from multiple locations in the engine cooling system at PDI or low TIS.
- It is essential that an EPQR is raised including clear pictures and/or videos of the leak and an image from TOPIx or EPC, if necessary, to identify location.
- Also include contact information for someone in the retailer who can support PRR in the EPQR.
