Campaign Code:
L73X-A.01.19

Campaign Name:
Rerooting of ION ECU harness

Model:
Aventador S and SV J

To: Official After-Sales Network
Subject: Rerooting of ION ECU harness
Date: Friday, January 25, 2019.
Pages: 4

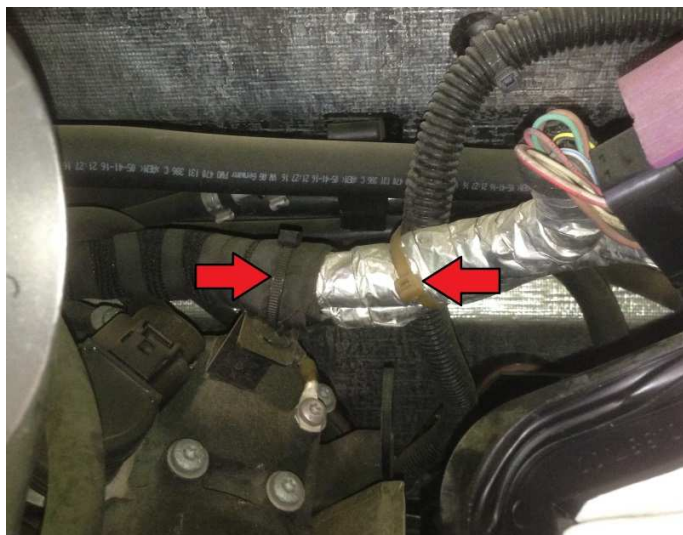
2. If present, eliminate the twist of the wiring by disconnecting the black connector.
3. Identify retainer bracket 470854121 of the ECU ION wiring.

Open the 2 clamps and free the ION ECU wiring.
