**Campaign code:**L636-B.09.19**Campaign Name:**Gateway Update**Model:**Urus**Model year:**From 2019**Special or limited editions:**All versions**Markets:**Only NAR market**VIN identification:**From KLA02065 to KLA04068

As a result of the continuous monitoring of the product, Automobili Lamborghini S.p.A. has released a new update for the Gateway ECU of Urus. This update contains improvements for vehicle ignition management.

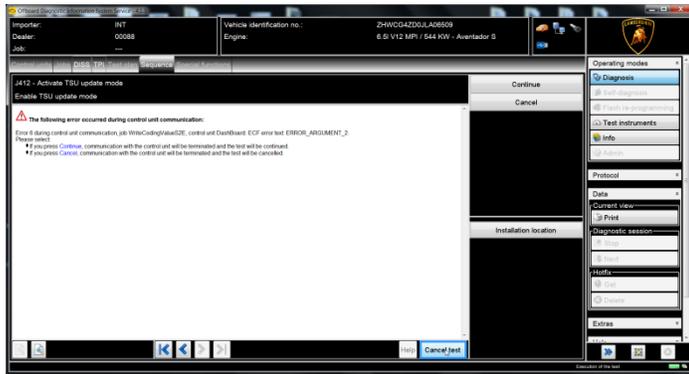
- i. If the following error screen is displayed, abort the guided function by clicking on “Cancel Test” and contact Technical Support.

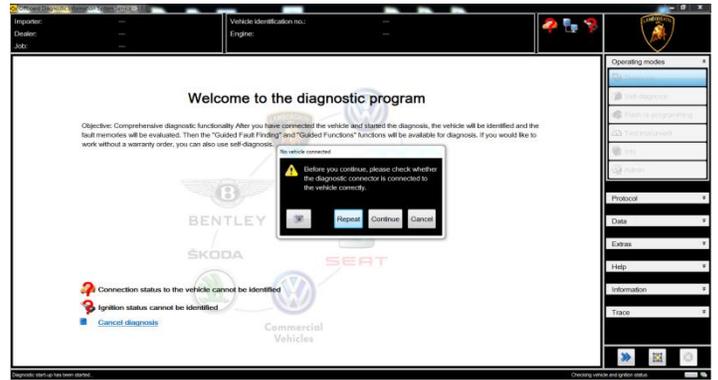
- ii. If an error is displayed that regards the hardware interface, and the "connection to vehicle" and "key state" icons appear as shown in the figure below:

- Click “Cancel”
- Repeat installation of the interface VAS5054 per the instructions in procedure (*) “VCI Manager v2.0”, selecting the right-hand “Extras” menu in ODIS and clicking on the “Diagnostic interface” button.

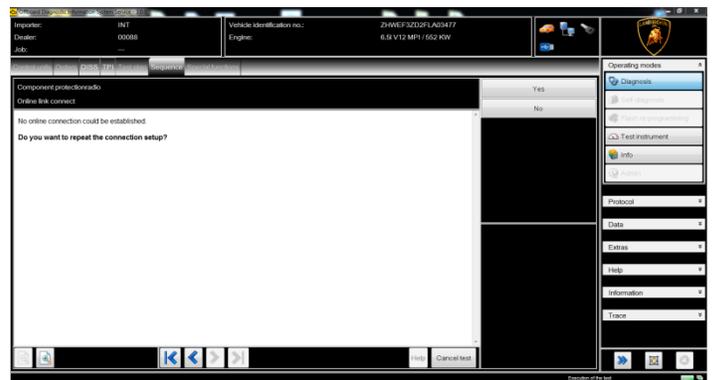
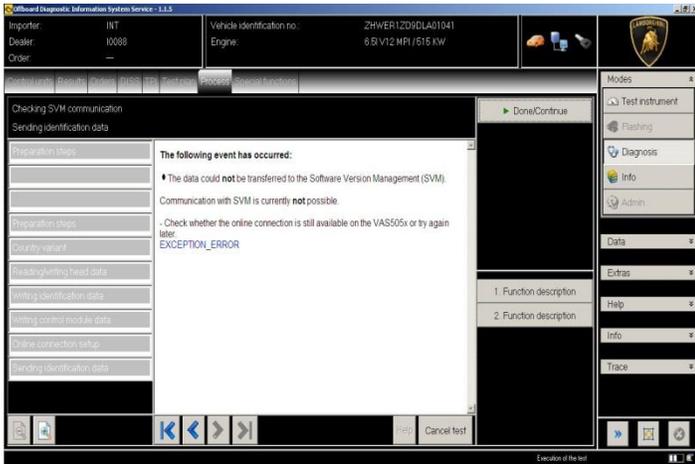
- iii. If one of the following connection errors is displayed like in the following example screenshots:

- It is not possible to connect to the central server; check that your laptop is correctly connected to the Internet and retry by clicking on “Yes” or “Done/Continue”, as appropriate.

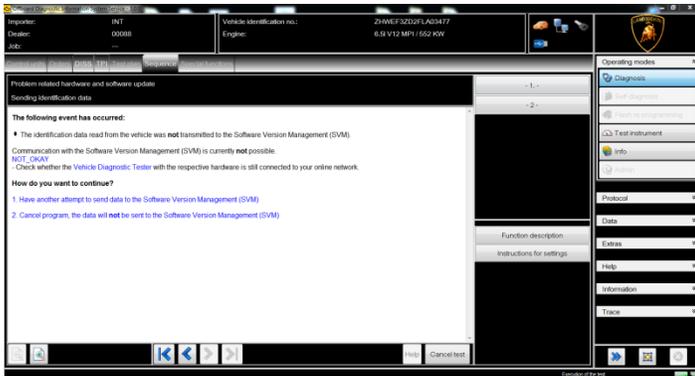
iv. If the connection is dropped during the course of the target/actual comparison during the SVM procedure:

- It is not possible to connect to the central server; check that your laptop is correctly connected to the Internet and retry by clicking on “1”.

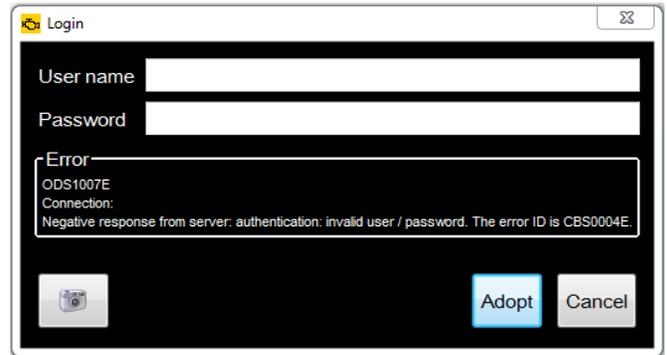
v. If the authentication error as shown in the following screenshot is displayed (error code: ODS1007E):

- Ensure you have a valid GeKO user account
- Ensure that the “GeKo” label is printed on the token you are using
- Ensure you have entered the correct password

- Click on “Cancel” and run the application test (see document “ODIS_ControlloConnessione_Server_SVM_2.0” (*)).

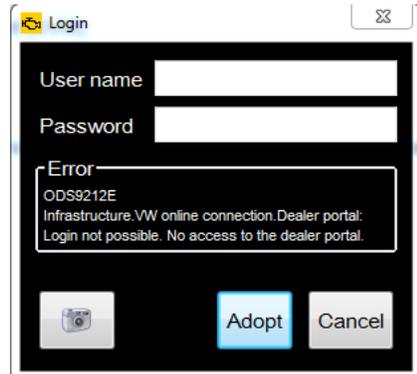
vi. If the infrastructure error as shown in the following screenshot is displayed (error code: ODS9212E):

- Ensure you have a valid GeKO user account
- Ensure that the “GeKo” label is printed on the token you are using
- Check that the Internet is set in ODIS settings and not CPN (see document “Set-up_Iniziale_ODIS_2.0” (*))
- Click on “Cancel” and run the application test (see document “ODIS_ControlloConnessione_Server_SVM_2.0” (*)).
