L73X-A.03.19.

Pydos ECU flash and instrument cluster update.

Aventador.

To: Official After Sales Network
Subject: Pydos ECU flash and instrument cluster update
Date: 21 June 2019
Pages: 25

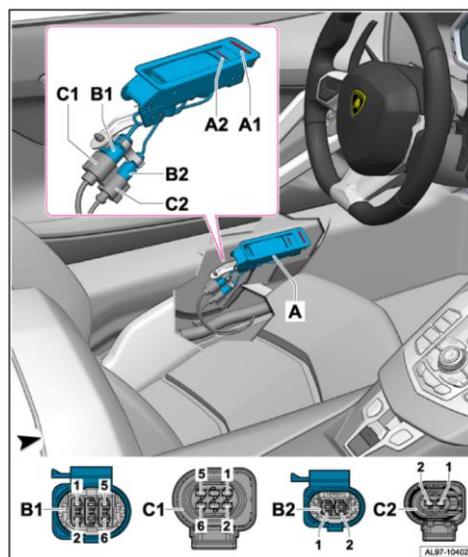
4. The first check to perform is to verify the status of the Pydos warning light (component A1 in the following image). If the warning light A1 is blinking it is necessary to replace the Pydos control unit, therefore order the correct control unit before to proceed in performing this service campaign.

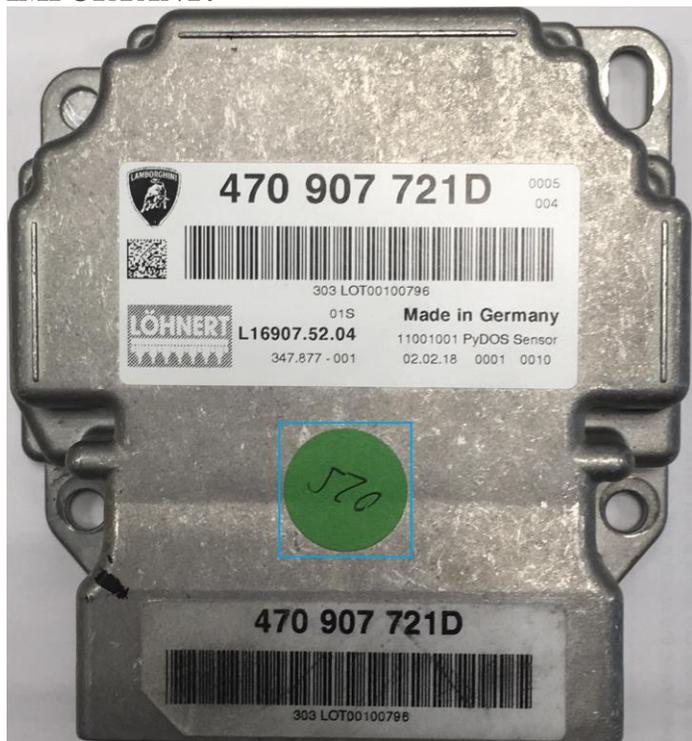
The green label "02S" indicates that the control unit is already updated, therefore if the Pydos control unit fitted in your car has the same label the flash procedure with the service tool 61653001466 is not needed.

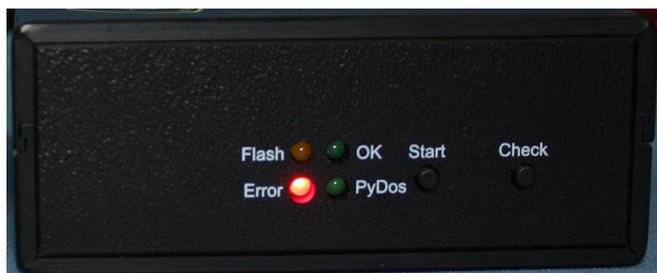
If the red “Error” LED is permanently ON or blinkin, the updating procedure was failed, refer to the following table for the failure cause.

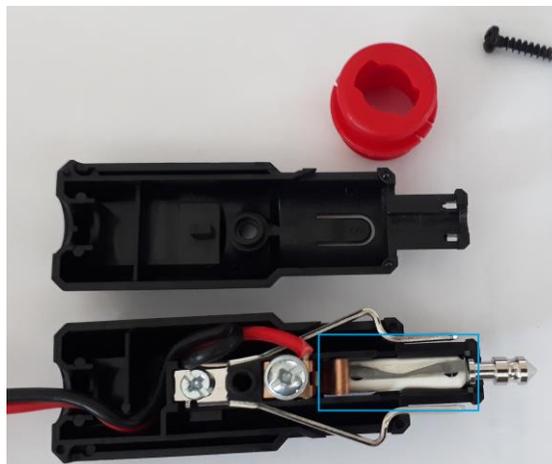
Check if the safety fuse (8A) inside the connector of the power cable to the cigarette lighter is defect and must be replaced.

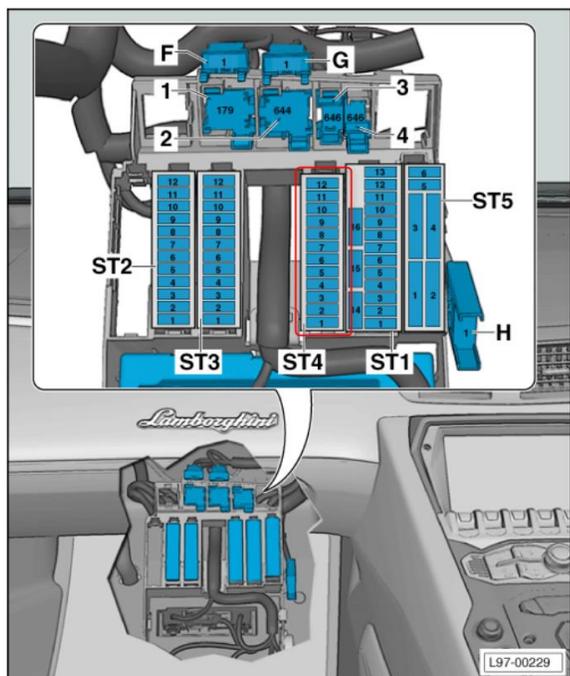
6.3 *Safety fuse for the 12V socket*

If you are using the 12V socket of the car and the service tool doesn’t work, check if the safety fuse inside the cigarette lighter of the car is defect and must be replaced.

Check the fuse of your specific model year on the fuse carrier ST4.
