TO: Mercedes-Benz Dealer Principals, General Managers, Sales Managers, Service Managers, Parts Managers	FROM: Anthony Washington, Department Manager, Regulations & Certifications
RE: Customer ONE Action Campaign C1A-201901 Model 907 Year 2019 Check sliding door carrier adjustment and bolt torque.	DATE: June 6, 2019

Date: June 2019
Action No.: C1A - 201901
Group: 72

SUBJECT: **Model 907**
Model Year 2019
Sliding Doors

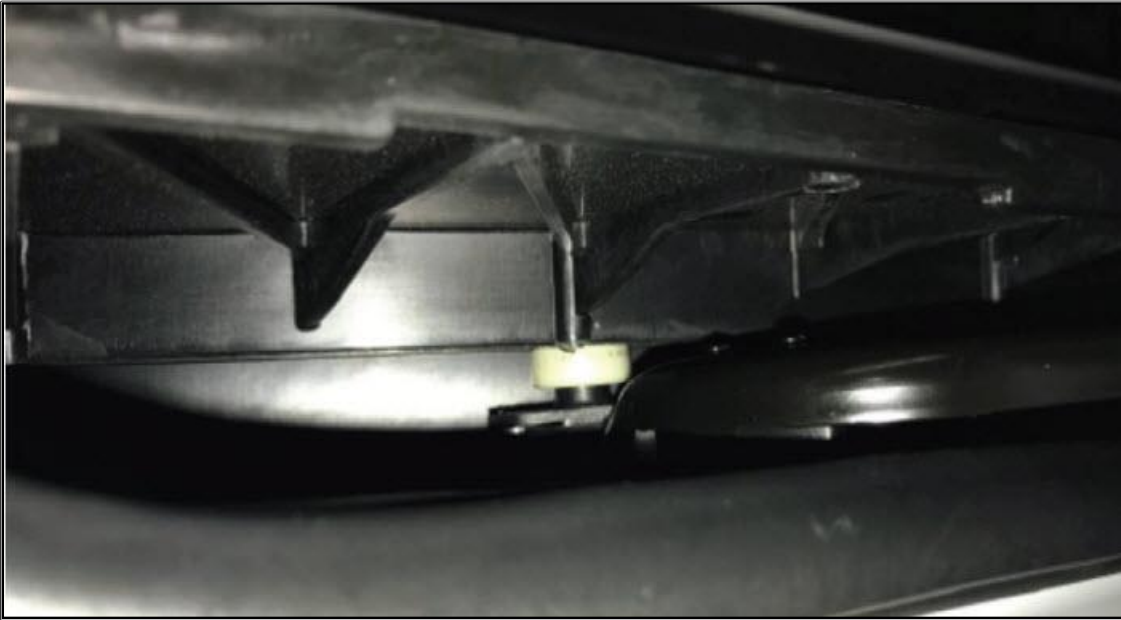
Figure 1

The guide roller of the lower carrier must not protrude by more than 2mm along the entire range of travel.

- If the guide roller protrudes by more than 2mm on any part of the entire travel (see figure 1) proceed to **step 3**
- If the guide roller does not protrude by more than 2mm along the entire range of travel (see figure 2) proceed to **step 4**

3. Perform **LI72.16-N-069628**
