**NOTE: THIS LSC EXPIRES ON May 31, 2019**

**TECHNICAL INSTRUCTIONS**  
**FOR**  
**LIMITED SERVICE CAMPAIGN G0T**  
**SOFTWARE UPDATE FOR COMBINATION METER**  
**CERTAIN 2016 MODEL YEAR PRIUS**

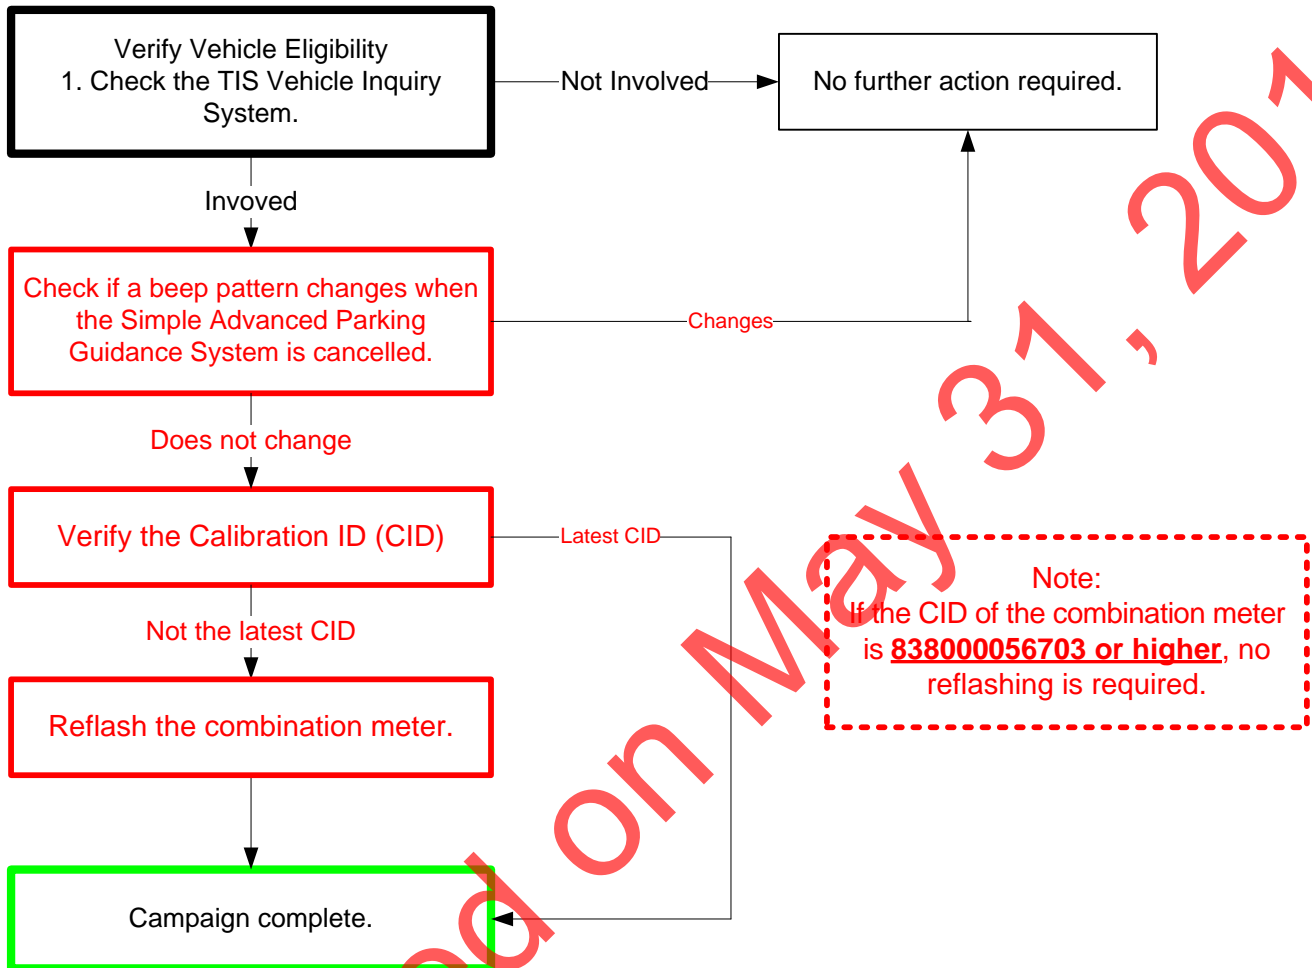
## I. OPERATION FLOW CHART

In the involved vehicles, the S-APGS (Simple Advanced Parking Guidance System) buzzer may not sound as designed to alert the driver to stop the vehicle during back-in assist parking mode and parallel parking mode. However, the stop indicator displays correctly on the multi-information display to alert the driver to stop the vehicle.

**Note: This campaign only covers reflashing. Any additional repairs are not covered under this campaign and must be done under regular warranty.**
