Multimedia System Enhancements Phase 3 (Panasonic)

Service Category Audio/Visual/Telematics

Section Navigation/Multi Info Display

YEAR(S)	MODEL(S)	ADDITIONAL INFORMATION
2018	LC500, LC500H, LS500, LS500H, NX300, NX300H, RC F, RC300, RC350	
2019	NX300, NX300H, RC F

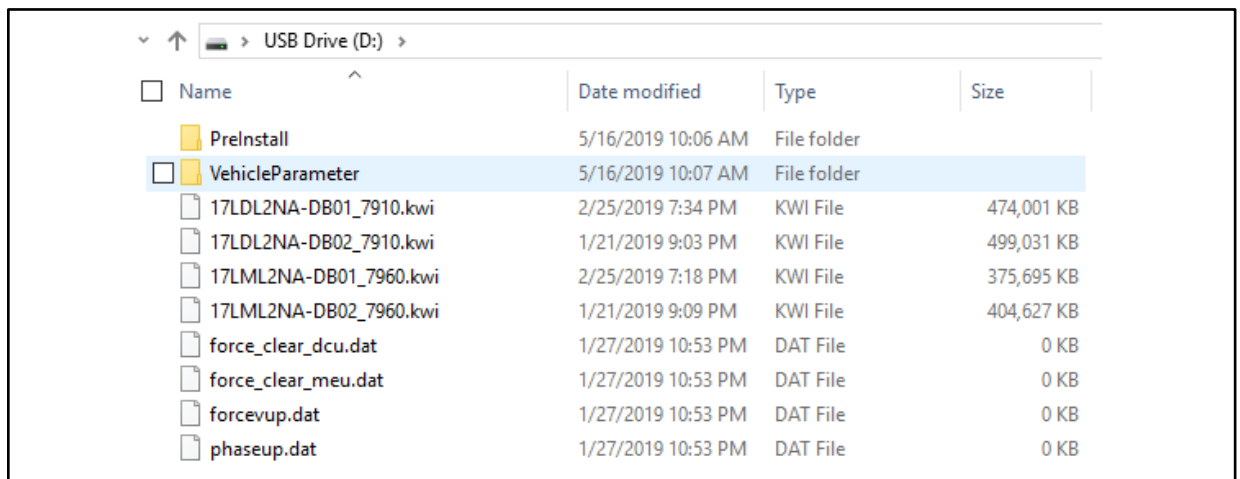
Figure 1.

The USB flash drive (root directory) must NOT contain an additional folder name above the content folders and files. The audio head unit will NOT be able to search past an unrecognized folder name to view the internal folders and files. See the NX, RC, LS Enform example below.

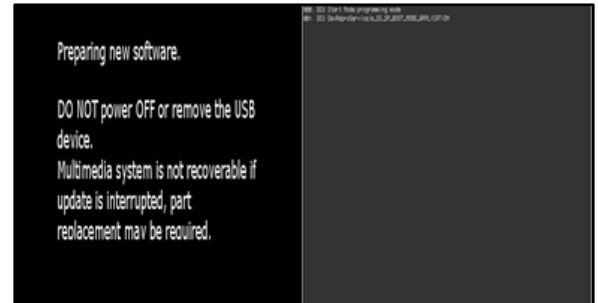
Figure 2.

9. Insert the prepared USB flash drive into the vehicle's USB port.
The software update will begin automatically and take approximately 60 minutes.

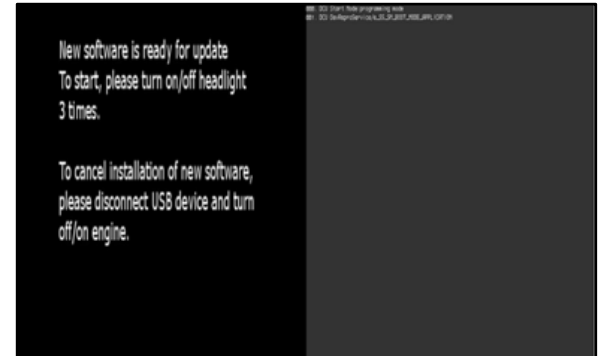
Figure 3.

- When the “New software is ready for update” screen appears, cycle the headlights ON/OFF three times within 3 seconds.

- This user interaction occurs approximately 13 minutes after beginning the software update.
- If a red screen appears, remove the USB flash drive, verify ALL downloaded files are present on the USB flash drive, cycle the vehicle OFF/ON, and begin the procedure again.

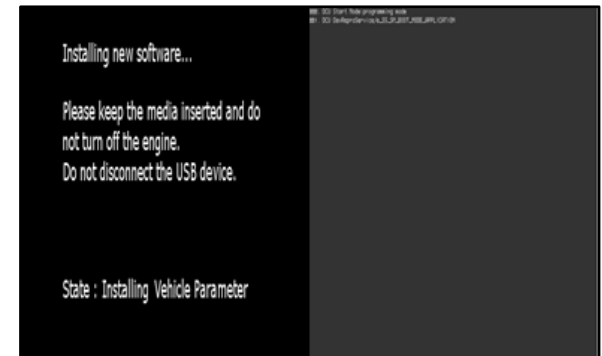
Figure 4.

- Once the “Installing new software...” screen appears, do NOT turn the vehicle off or remove the USB flash drive. This will cause damage to the head unit.

If a red or green screen appears, cycle “IG-OFF” and “IG-ON.” If the head unit does NOT boot up after “IG-OFF” and “IG-ON,” replace the head unit.

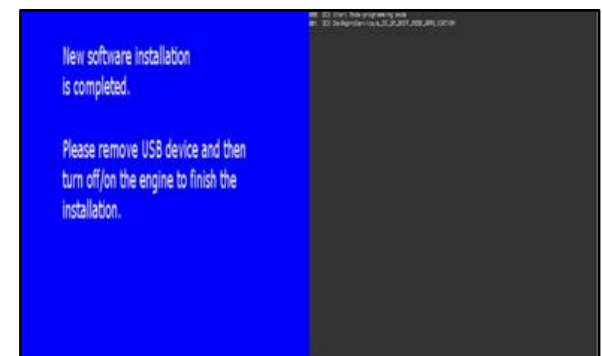
Figure 5.

- Once the blue “New software installation is completed” screen appears, remove the USB flash drive.

Leaving the USB flash drive inserted while cycling the ignition will start the update process again.

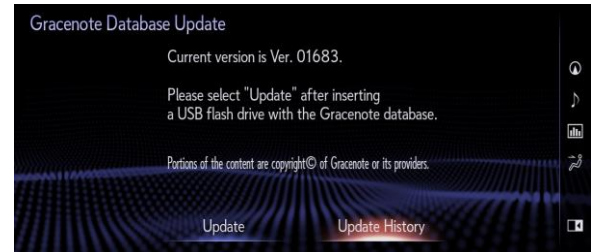
Figure 6.

Verify the Gracenote Database version is 01683.

If the Gracenote version does NOT match, the Phase 3 reformat installation failed to complete. If the head lights were cycled properly in step 10 to start the installation process, it may be necessary to replace both the head unit and MEU.

Even if Apple CarPlay® and Amazon Alexa™ function at this time, the wrong Gracenote file confirms the reformat was NOT completed properly and will require unit replacement.

- **YES** — Continue to step 17.
- **NO** — Was step 10 performed?
 - **YES** — Replace the head unit and MEU.
 - **NO** — Begin the procedure again and perform step 10 to continue with this Service Bulletin.
