# Various Drivability Concerns, and/or DTCs, Corrosion Present in A43 or A9 Connector

**Service Category** Engine/Hybrid System

**Section** Engine Control

YEAR(S)	MODEL(S)	ADDITIONAL INFORMATION
2014 - 2018	Highlander, Highlander HV

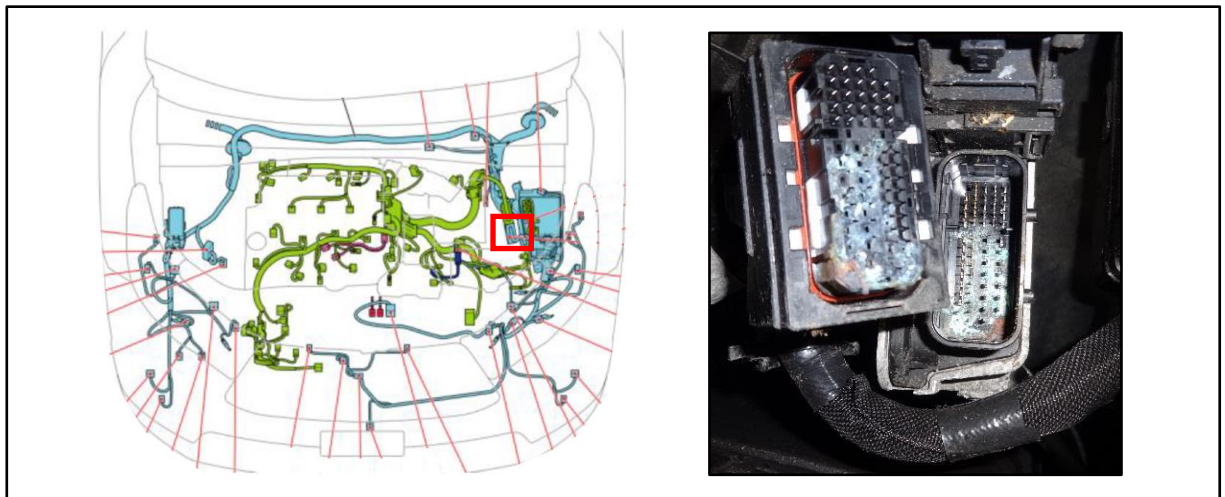
**Figure 1. A43 Connector Location and Corrosion**

These conditions may be caused by corrosion/water in the A43 ECM connector (Highlander) or the A9 inverter water pump connector (Highlander HV). The corrosion in the A43 and A9 connectors is due to poorly sealed or damaged aftermarket windshield deicer harnesses. Follow the Repair Procedure in this bulletin to address these conditions.

3. Check for corrosion in the A43 ECM connector.  
Remove the A43 ECM connector.

Is corrosion or water present?

- Replace the components listed in the table below.

NON-HYBRID VEHICLE	HYBRID VEHICLE
COMPONENT	ECM	Inverter Water Pump
	Engine Room Main Wire Harness	Engine Room Main Wire Harness
	Windshield	Windshield

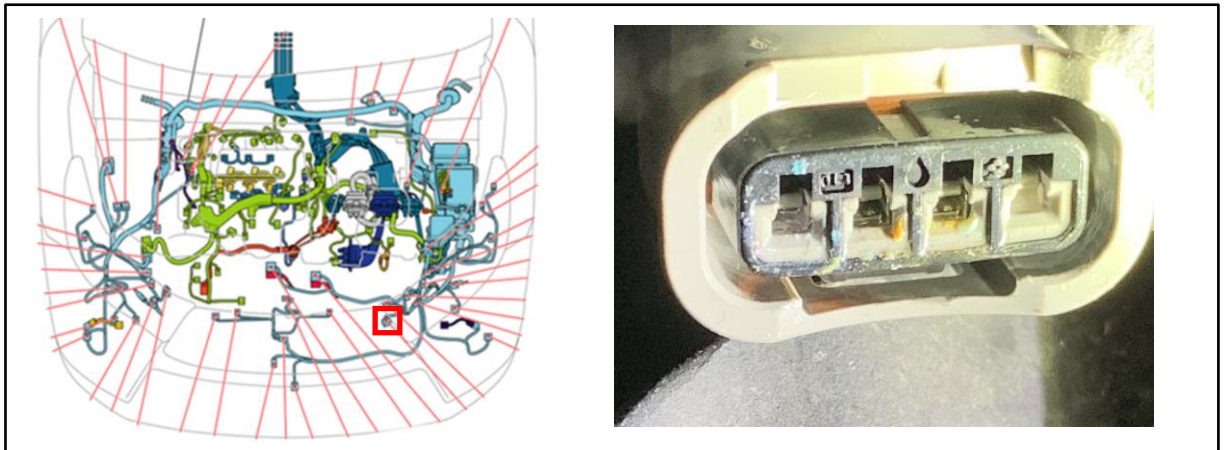
**Figure 2. A9 Connector Location and Corrosion**

- Remove the A9 inverter water pump with motor assembly connector.

Is corrosion or water present?

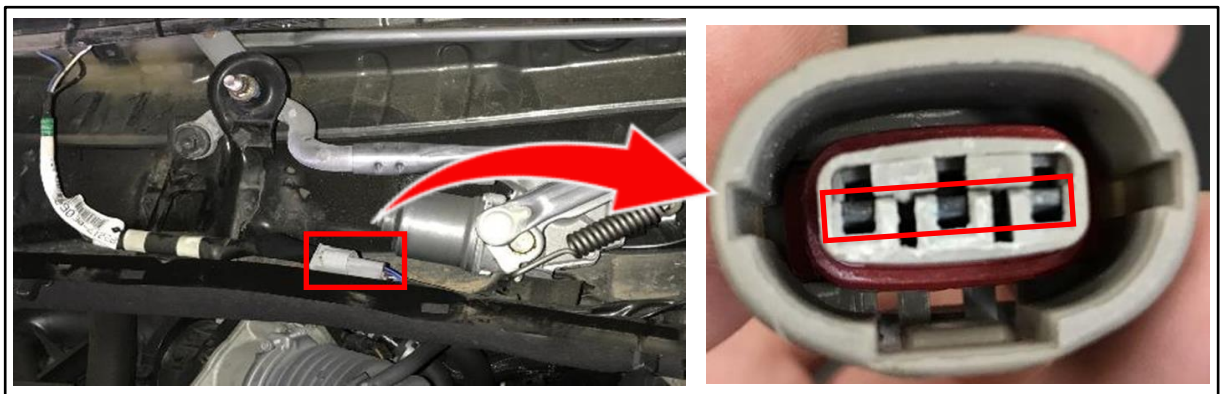
**Figure 3. A33 Connector Location and Corrosion**

- Check for corrosion in the A33 front wiper deicer (windshield glass) connector (Highlander and Highlander HV).

Remove the A33 front wiper deicer (windshield glass) connector.

Is corrosion or water present?

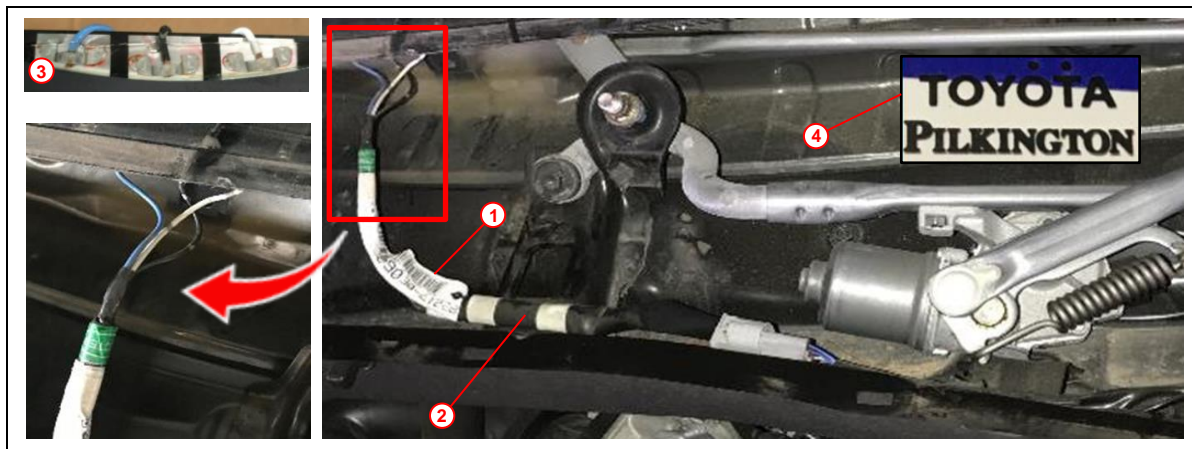
**Figure 4.**

It is strongly recommended to replace the windshield with a Toyota genuine windshield. Toyota windshields utilize special seals to prevent water/moisture from entering the engine room main wire harness. Some aftermarket windshields do NOT have these seals.

1	Toyota Part Number and Markings
2	Toyota Genuine Deicer Harness
3	Underside of Deicer Harness Connection (Underside of Windshield)
4	Toyota and Pilkington Markings (Lower Corner of Driver Side Windshield)

Reference the figure below to identify Toyota genuine parts.
