# Driveline Vibration Under Deceleration Around 10 - 30 mph

The information contained in this bulletin supersedes Service Bulletin No. T-SB-0171-16.

Some 2016 – 2019 model year Tacoma vehicles equipped with an automatic transmission may exhibit a vibration felt in the seat, floorboard, and/or steering wheel between 10 – 30 mph, caused by a driveline vibration under deceleration. Follow the Repair Procedure in this bulletin to address this condition.

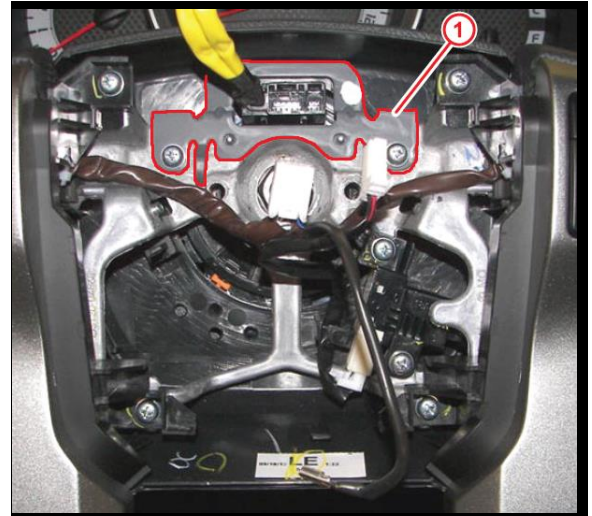
**Figure 1.**

<b>1</b>	<b>Steering Wheel Switch Wire Harness Retainer Bracket</b>
----------	--

- Remove the steering wheel switch wire harness retainer bracket (ONLY for vehicles with steering wheel mounted switches).

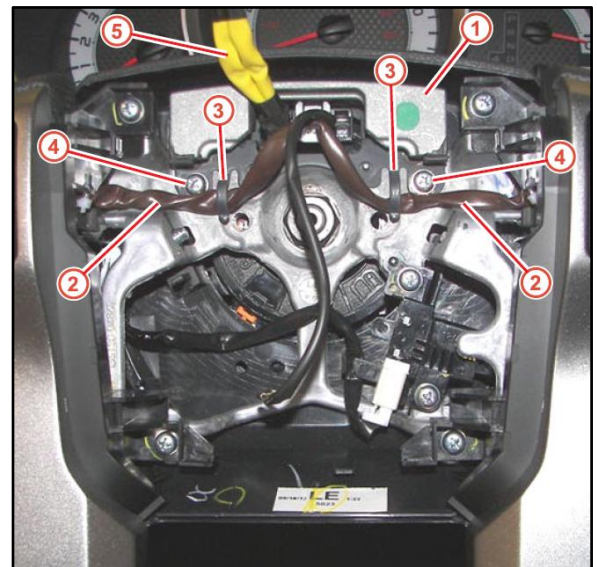
**Figure 2.**

**NOTE**  
Secure the steering wheel switch wires to the steering wheel damper bracket hooks as shown.

<b>1</b>	<b>Damper</b>
<b>2</b>	<b>Steering Wheel Switch Wire Harness</b>
<b>3</b>	<b>Damper Bracket Wire Retainer Hook</b>
<b>4</b>	<b>Screw</b>
<b>5</b>	<b>Driver Side Airbag Wire Harness</b>

- Install the steering wheel damper with two NEW screws in the locations shown. Torque: 2.35 N\*m (24 kgf\*cm, 20.8 in\*lbf)

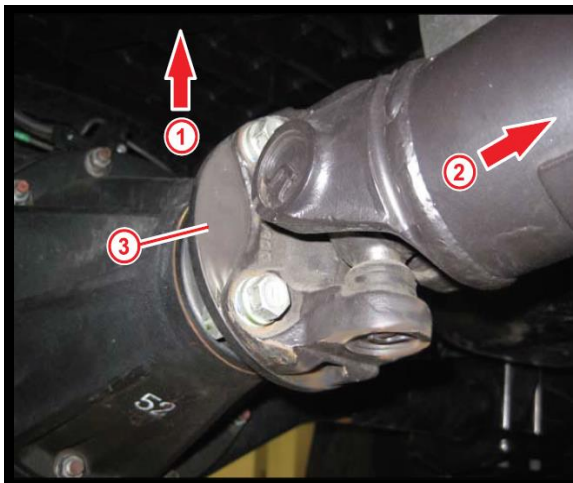
**Figure 3.**

- Large flange (Figure 3) — Continue to step 8.
- Small flange (Figure 4) — Go to step 9.

<b>1</b>	Up
<b>2</b>	Front
<b>3</b>	Pinion Flange

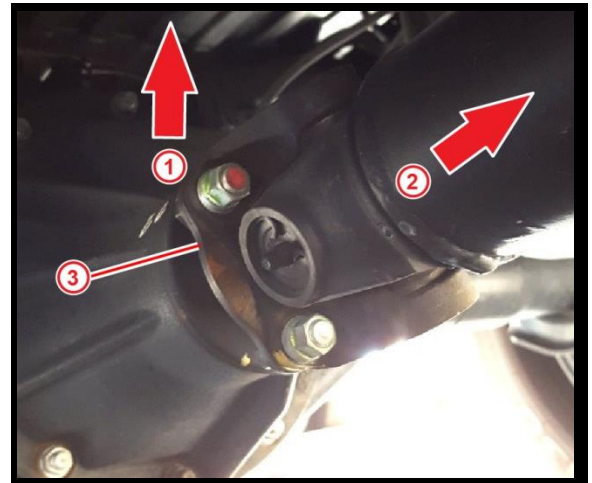
**Figure 4.**

<b>1</b>	Up
<b>2</b>	Front
<b>3</b>	Pinion Flange

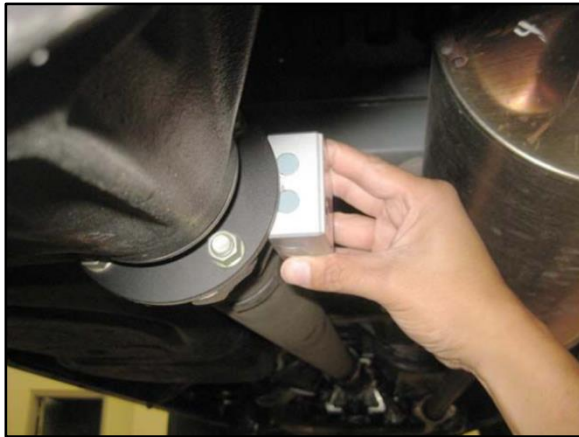
**Figure 5.**

- (1) Ensure the digital angle gauge is firmly against the flange to obtain an accurate pinion flange angle as shown in Figure 5.

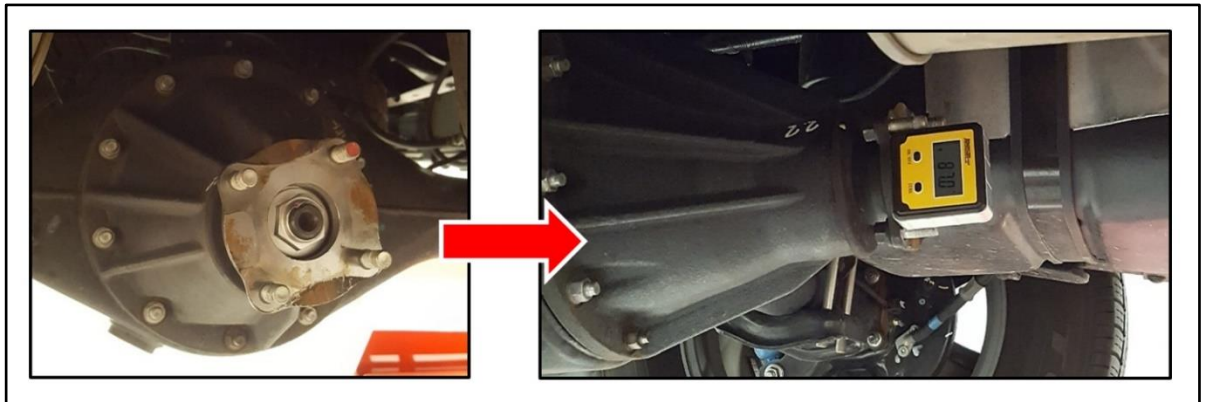
**Figure 8.**

Ensure the digital angle gauge is firmly against the flange to obtain an accurate pinion flange angle as shown.

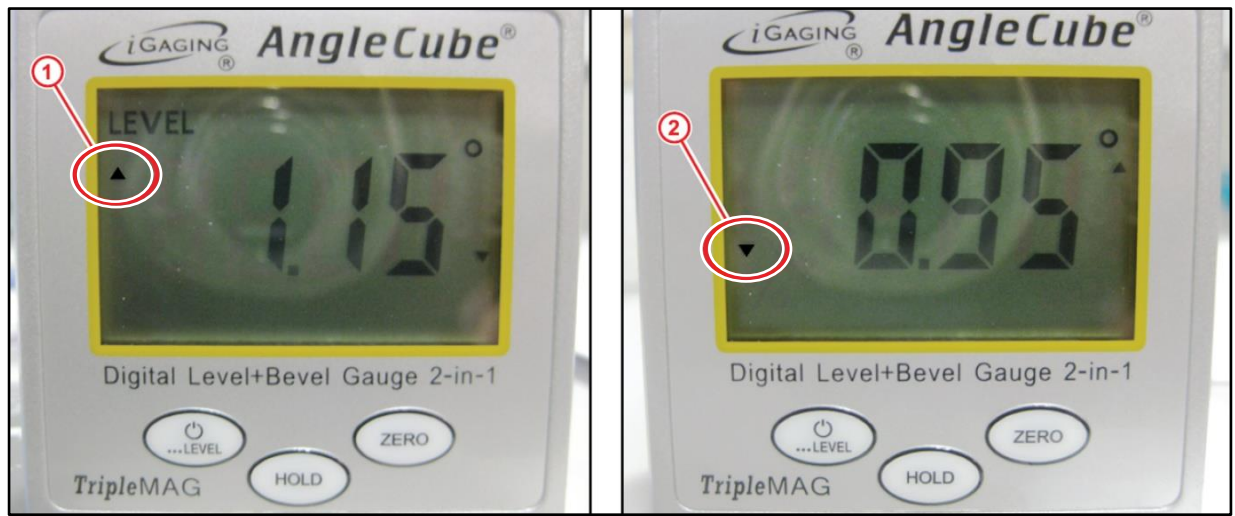
**Figure 9.**

ALL measurements MUST be taken from the passenger side of vehicle facing the driver side. Refer to Figure 9 to ensure that the angles measured have the correct positive (+) or negative (-) values assigned.

- An arrow pointing up indicates a positive (+) angle. In the example on the left, the angle measured is a positive 1.15 (+1.15).
- An arrow pointing down indicates a negative (-) angle. In the example on the right, the angle measured is a negative 0.95 (-0.95).

<b>1</b>	<b>Up Arrow (Positive)</b>
----------	----------------------------

<b>2</b>	<b>Down Arrow (Negative)</b>
----------	------------------------------

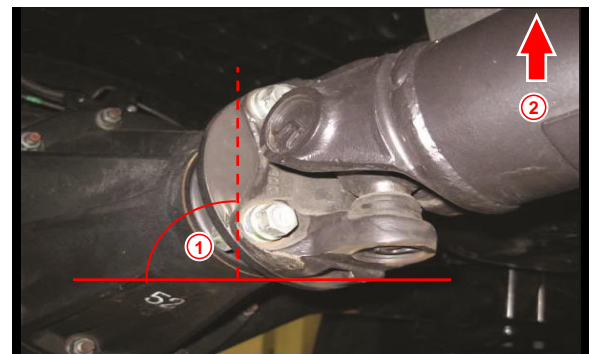
**Figure 10.**

- A. Rotate the pinion flange (as shown in Figure 10) to the correct position (as shown in Figure 11).

<b>1</b>	<b>90°</b>
<b>2</b>	<b>Up</b>

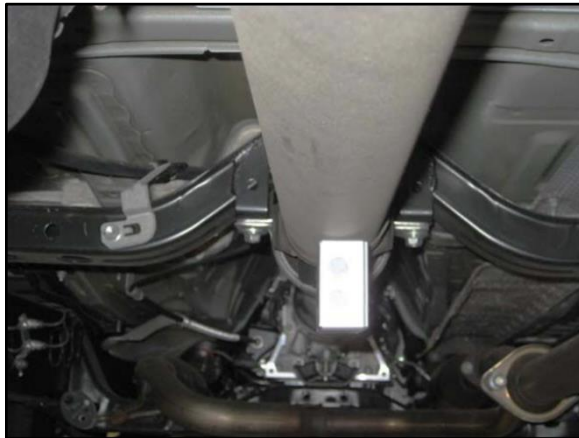
**Figure 11. CORRECT Placement of Digital Angle Gauge**

- B. Use the digital angle gauge and measure the angle of the rear section of the two-piece propeller shaft. Ensure the digital angle gauge is placed along the centerline of the propeller shaft as shown in Figure 11.

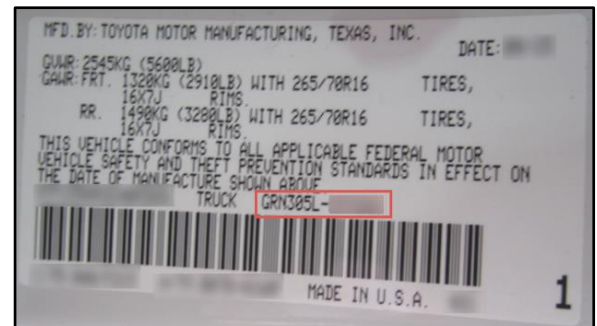
**Figure 14.**

13. Verify the vehicle's model code (**Katashiki**).  
 The model code can be found on the Vehicle Identification Label in the driver doorjamb as shown.
