Re: TECHNICAL SERVICE BULLETIN – V1422CLOD / V1422BROD / V1422WHOD

Alpha Systems, LLC is alerting you to a potential issue involving the Alpha Systems polycarbonate outer dome skylights (Clear/Bronze/White), installed on units manufactured between 12/1/2018 and 4/19/19.

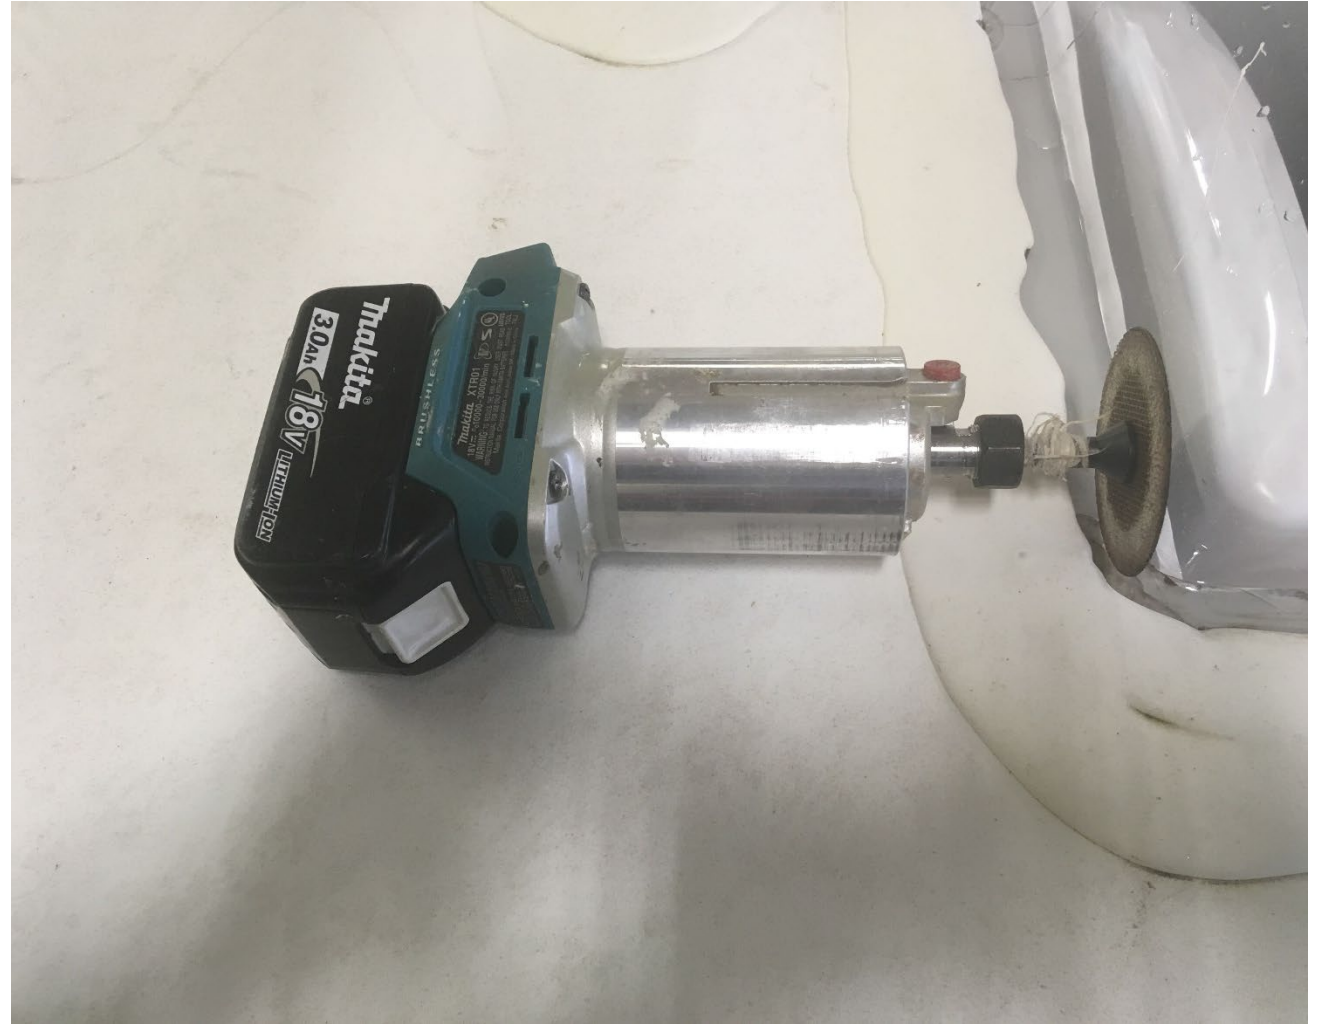
# Step 1

A limited number of outer dome skylights (V1422CLOD/V1422BROD/V1422WHOD) have displayed cracks soon after installation. Cracks may originate at the flange of the skylight and extend outward. This issue has been known to occur within 2 weeks of installation.

From the roof side of the unit, using a cut off wheel, cut away as much of the clear polycarbonate skylight bubble as possible.
