**PRODUCT CAMPAIGN BULLETIN**

**APPLICABILITY:** 2019MY Ascent

**NUMBER:** WUI-94

**SUBJECT:** STOP SALE: Propeller Shaft

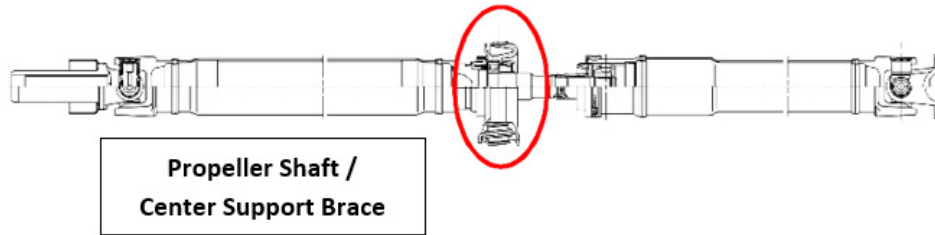
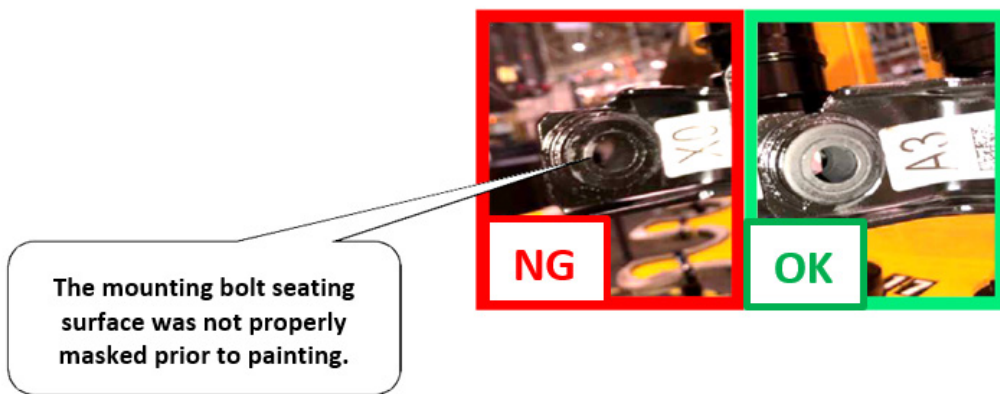
**INTRODUCTION:**

This recall involves replacement of the propeller shaft assembly.

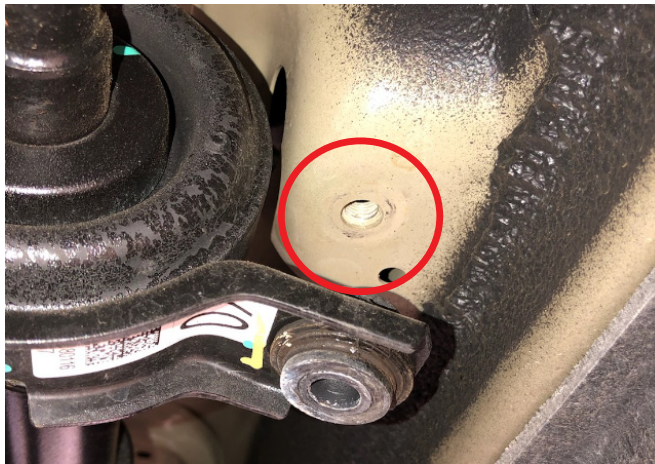
**VERY IMPORTANT:** After removing the original propeller shaft, confirm there is no residual **BLACK** paint remaining from the center support brace on both mounting surfaces of the body. The mounting surfaces **must be clean** as shown below. Use a mild solvent on a clean shop cloth to clean the area if necessary. **NEVER** use an abrasive disc or otherwise remove the tan-colored protective underbody finish coat. Doing so will expose bare metal making it susceptible to corrosion / rust.
