PRODUCT CAMPAIGN BULLETIN

APPLICABILITY: 2019MY Legacy and Outback
SUBJECT: Front Duct Panel Spot Weld

NUMBER: WUH-93R
DATE: 06/26/19
NHTSA: 19V493
REVISED: 07/17/19

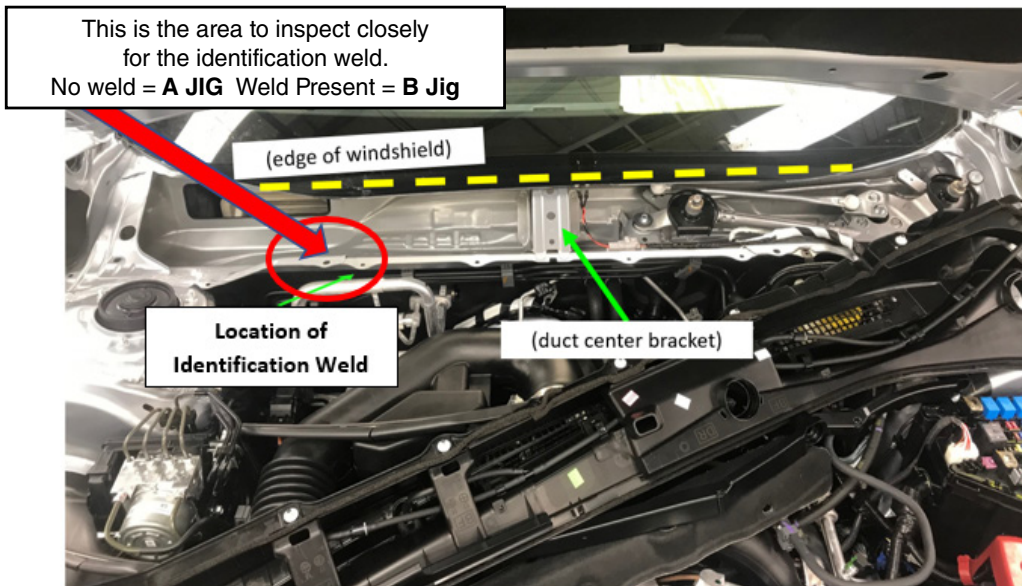
6. With the cowl trim panel removed, use the photos below to determine if the vehicle is equipped with an **A Jig** or **B Jig** part. The **B Jig** part has an identification weld to distinguish it from the **A Jig** part.

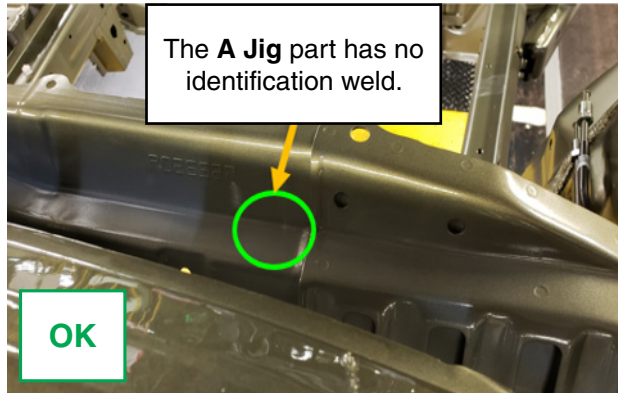
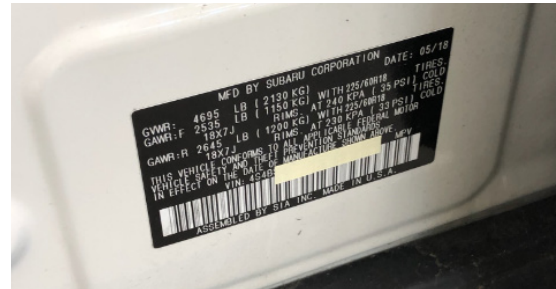
HOW TO DETERMINE IF THE INSTALLED PART IS "A JIG" OR "B JIG"

- If the cowl area inspection reveals an **A JIG** part, the vehicle is **OK**. **STOP**, take a clear photo of this area and the VIN plate at the base of the "B" pillar. Reinstall all the removed parts in reverse order to prepare the vehicle for sale. Proceed to **Step 8**.

CRITICAL: If the cowl area inspection reveals a **B JIG** part, THE VEHICLE IS **NG** AND **MUST BE HELD** WHILE DETERMINING THE NEXT COURSE OF ACTION. Do not reassemble the vehicle. Proceed to **8**. below.

A completed QMR **MUST** be submitted immediately with one photo clearly showing the **Part A**, Jig A/B inspection point AND a photo of the VIN plate located at the bottom of the "B" pillar for **ALL** affected vehicles (pass or fail). Use the photos above as examples for the inspection point photos.
