# Keystone RV Company

## SERVICE ADVISORY # 19-356

### Cougar 32RDB Ceiling Vents

**Models Included:** 2018 - 2020 Cougar 32RDB

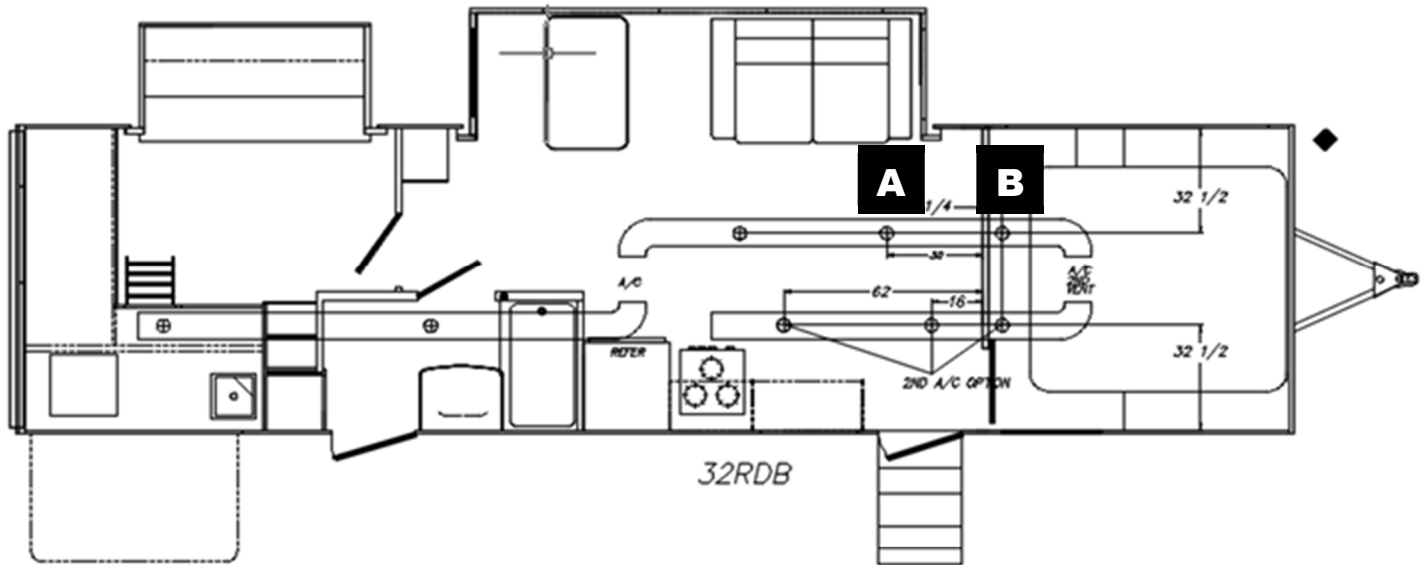
Fig. 1

It has been determined that the Cougar 32RDB units may not have the adequate amount of A/C ceiling vents installed. The following procedure describes the locations and how to install the required A/C ceiling vents.

Inspect the existing ceiling vents and compare to Figure 1. There should be a minimum of 5 A/C vents: one in the bunk room, one in the bathroom, two in the main living area, and one in the bedroom. The forward living room vent (A) and bedroom vent (B) may or may not be installed, inspection is necessary. The second A/C option is also included on Figure 1 and indicates where the holes can be drilled. The 2<sup>nd</sup> A/C option is not standard on every unit, to verify this option use the “**Search Unit Info**” function on Key Express.

Locate (measure) for the missing A/C ceiling vents, Figure 1. The vents in the above figure may or may not be installed, inspection is necessary.

Using measurements from Figure 1 and a 5" hole saw, add vents as needed, drilling into ceiling panel and A/C duct, being careful that you do not drill into the top side of the A/C duct.

Install KRV#101886 Grill – 5" – Ducted Ceiling – AC in the locations indicated on Figure 1 using HVAC tape to seal the vents to the ducting.

The A/C vent holes A and B should be located 32 ½" from the off-door-side inside panel, of the sidewall, to the center of the vent hole. The kitchen/living area A/C vent hole (A) is 30" from the bedroom divider wall. The bedroom A/C vent hole (B) is 5 ¾" from the bedroom divider wall. Drill hole through the ceiling panel and first side of the A/C ductwork in the ceiling.

If the unit has a second A/C, vent holes are located 32 ½" from door-side inside panel, of the sidewall, to the center of vent hole. Bedroom A/C vent hole is 5 ¾" from the bedroom divider wall, kitchen/living area A/C vent holes are 16" and 62" from the bedroom divider wall. Drill hole through the ceiling panel and first side of the A/C ductwork in the ceiling.
