July 11, 2019

Warranty Extension: Steering Feels Heavy, EPS Indicator Blinks with No DTCs or Comes On Steady with DTC 32-09, 32-08, or 61-04

Year	Model	Trim	VIN Range
2013-14	Crosstour	V6	Check the iN VIN status for eligibility.

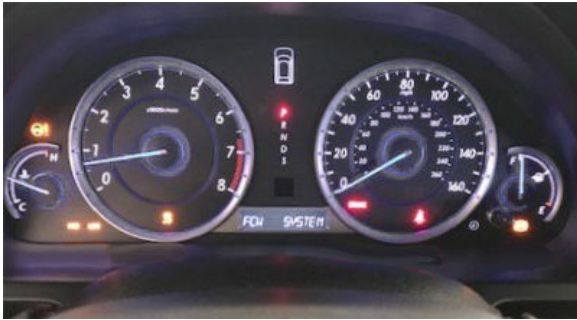
1. Connect the i-HDS, and check for the following DTCs:
 - 32-09 (motor current correlation)
 - 32-08 (EPS control unit internal circuit [current sensor])
 - 61-04 (motor harness malfunction)
 - If any of the listed DTCs are set, write down the DTC on the RO, and go to the REPAIR PROCEDURE.
 - If none of the listed DTCs are set, go to step 2.
2. Check if there are any other DTCs set.
 - If there are other EPS DTCs set, this bulletin does not apply. Continue with normal system troubleshooting.
 - If there are no other EPS DTCs set, go to step 3.
3. Check if the EPS indicator is blinking.

- If the EPS indicator is blinking, go to the REPAIR PROCEDURE.
- If the EPS indicator is not blinking, this bulletin does not apply. Continue with normal system troubleshooting.
