Technical Service Bulletin

23 MIL on, DTCs P0087, P0088, and/or P0191 stored in the ECM - TDI only

23 19 51 2036668/5 July 1, 2019. Supersedes Technical Service Bulletin Group 23 number 17-40 dated March 29, 2017 for reasons listed below.

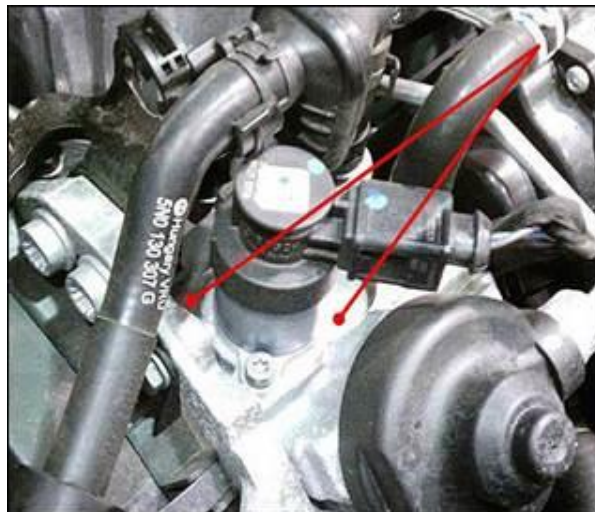
Figure 1. The area surrounding the valve.

Before the N290 fuel metering valve is removed, the area surrounding the valve (Figure 1) must be sprayed with a cleaner and dried with compressed air to ensure that all debris is removed from the area.

Fuel system components may be damaged if any debris enters the fuel system.

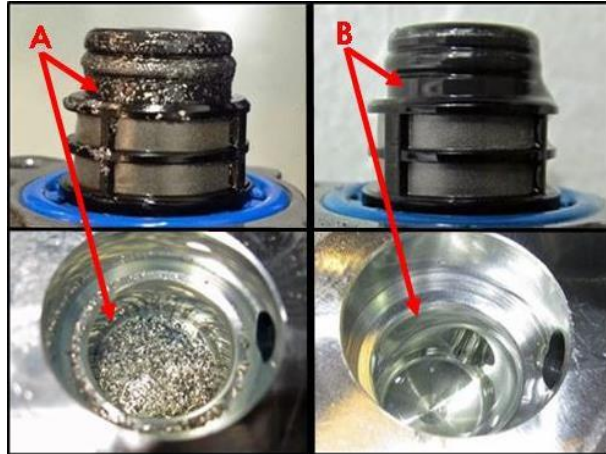
Figure 2. Fuel metering valve and valve bore with metallic particles (A), and without metallic particles (B).

1. Remove the N290 fuel metering valve and inspect the valve and valve bore for the presence of metallic particles (Figure 2). Proceed with the appropriate section below.

If metallic particles are found on the N290 fuel metering valve or in the valve bore:

1. Contact the Audi Technical Assistance Center (TAC) and open a TAC ticket before continuing with the repair. Before contacting TAC, attach the following to the TAC ticket:
 - GFF diagnostic log
 - Clear pictures showing the metallic particles in the N290 fuel metering valve and bore (Figure 3 and Figure 4).

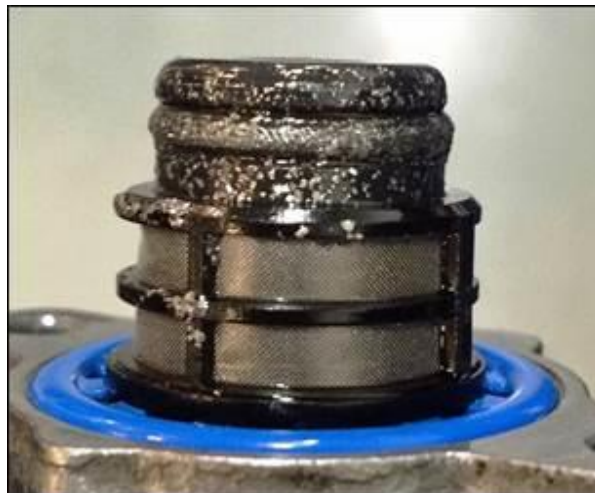
Figure 3. Example of a clear picture showing the metallic particles in the N290 fuel metering valve.

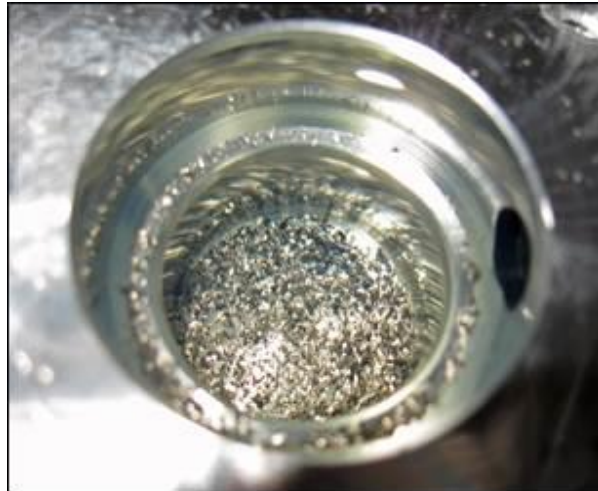
Figure 4. Example of a clear picture showing the metallic particles in the valve bore.

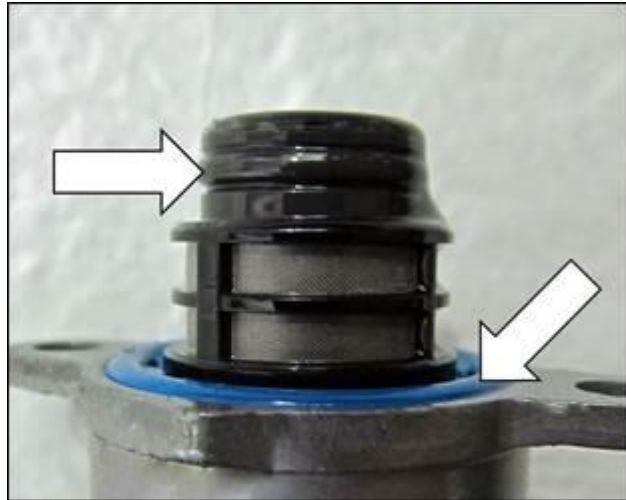
Figure 5. N290 fuel metering valve O-rings.

Additionally, ensure that neither O-ring (Figure 5) is damaged. If either O-ring is damaged, replace the high fuel pressure pump.

To prevent damaging the O-rings when reinstalling the N290 fuel metering valve, lubricate them with diesel fuel.

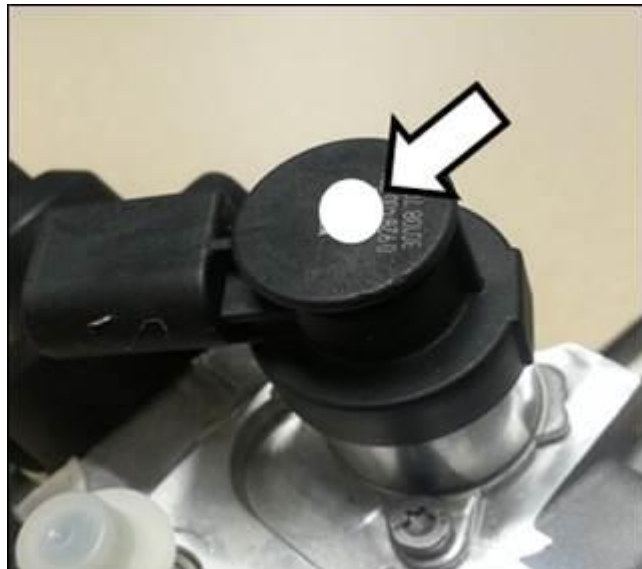
Figure 6. The white dot on N290 fuel metering valve.

2. Use light pressure to reinstall the N290 fuel metering valve into the valve bore.
3. Install and hand tighten both M5 fasteners, ensuring that the threads are clean and dry. Pre-tighten to 2 Nm, then to 6.5 – 7 Nm.
4. Use a paint marker or equivalent to mark the top of the N290 fuel metering valve with a white dot (Figure 6).
