## SERVICE BULLETIN

<b>Reference number:</b>	<b>SB-10-0409V2</b>	<b>Issued: 06 June 2019</b>
<b>Subject:</b>	<b>Fuel Filling Problem</b>	
<b>Model(s):</b>	<b>DB9, DBS, Virage and Vanquish Volante</b>	
<b>VIN Range:</b>	<b>All</b>	
<b>Applicable to:</b>	<b>All Dealers</b>	
<b>Distribute to:</b>	<b>After Sales Manager</b> <b>Executive Manager</b> <b>Service Manager</b> <b>Sales Manager</b>	<b>Warranty</b> <b>Technician(s)</b> <b>Parts</b>

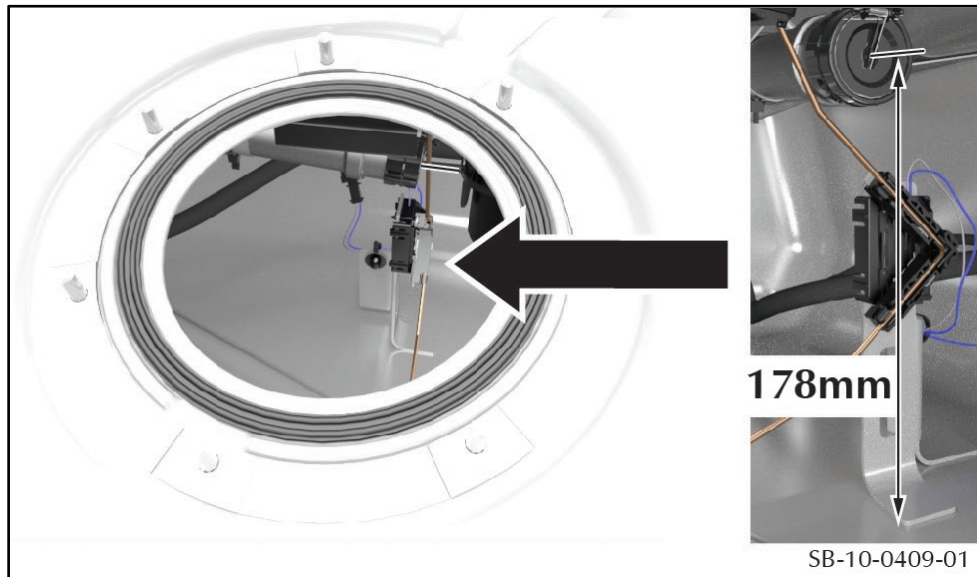
Figure 1

- The fuel tank manufacturing tolerances can make the internal pipe too high.
- Combination of the tolerances that prevents the downward gradient between the filler neck and the tank. This is usually in the rubber section of the filler neck.
- The fuel filler neck has a reduction in diameter that prevents gas escape when you fill the fuel tank.

1. Drain the fuel tank (refer to Workshop Manual procedure 10.01.EA).
2. Measure the distance from the centre of the filling pipe inside the fuel tank to the bottom of the tank. Make sure that this distance is 178 mm (refer to Figure 1).

3. If the distance is not 178 mm, carefully bend the filling pipe inside the fuel tank and do step 2 again.
4. Make sure that the external tank filler neck (1) has a constant downward gradient. To do this, make sure that the damper casting (2) is in the highest position. Also make sure that the fuel filler neck to damper casting (3) is in the highest position (refer to Figure 2).
