# SERVICE BULLETIN

Classification: EL15-006s	Reference: NTB15-049s	Date: June 21, 2019
------------------------------	--------------------------	------------------------

## TELEMATICS SERVICE INFORMATION

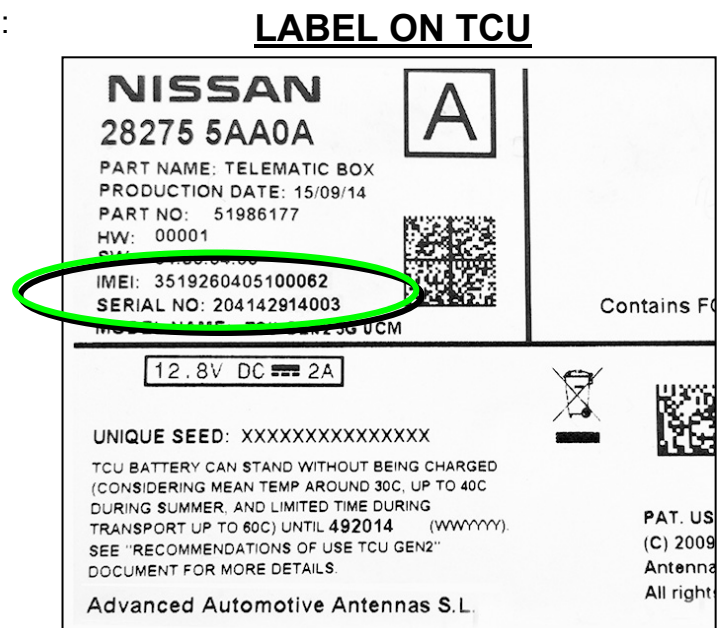
Figure 7

13. Write down the following information:

- VIN.
- International Mobile Equipment Identity Number (IMEI) of the **original TCU**. This number is located on the TCU.
- IMEI Number of the **replacement TCU**. This number is located on the TCU.

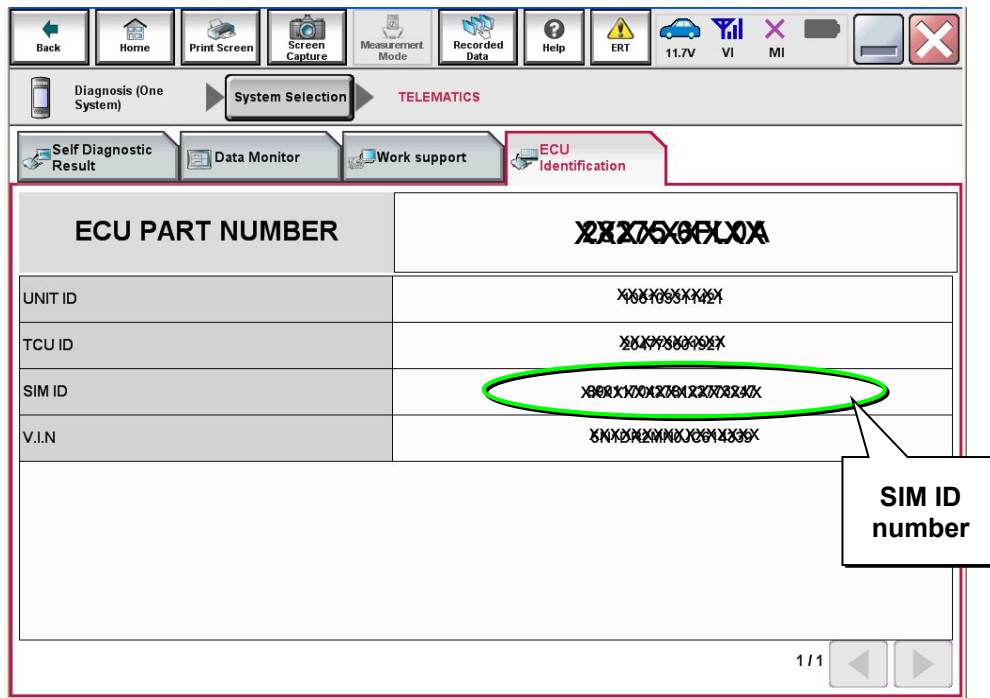
Figure 17

a. Navigate C-III plus to the screen shown in Figure 17.

**Diagnosis (One System) > TELEMATICS > ECU Identification**

b. Locate the SIM ID number and write it on the repair order as "New SIM ID".

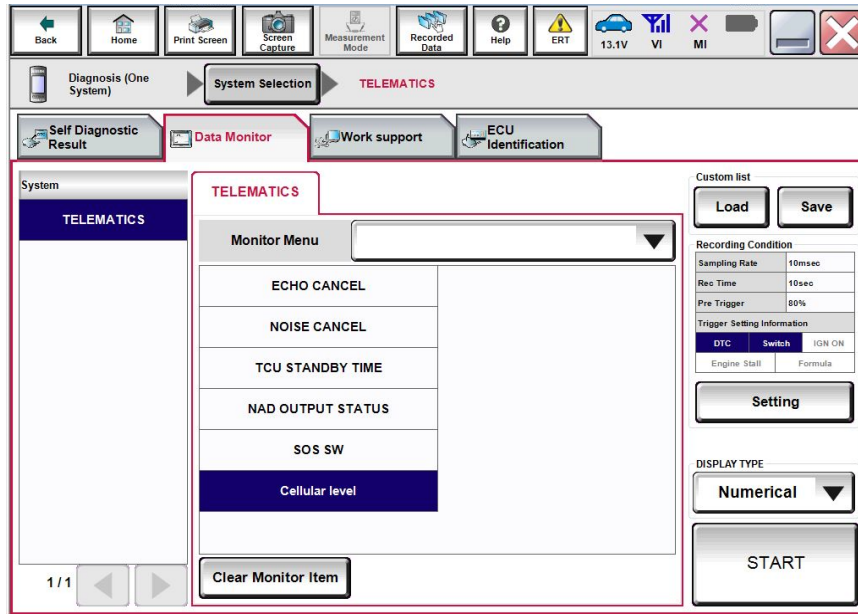
Figure 24

50. Check the **Cellular level** and confirm that it is "GOOD".
51. If the **Cellular level** is MARGINAL or LOW, move the vehicle to an area with good signal.

**NOTE:** The **Cellular level** constantly updates. Safely relocate the vehicle until a "GOOD" **Cellular level** is received.

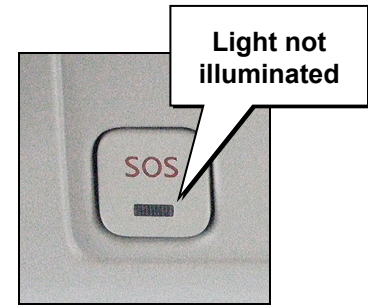
Figure 5a

1. With the vehicle in an area of known good reception, turn the ignition ON and check whether or not the green light on the SOS button is illuminated (see Figure 5a).

**NOTE:** It may be difficult to tell if the green light is illuminated if the vehicle is outside in bright sunlight.

- If the green light **is** illuminated, the process to turn ON the TCU is complete and no further action is needed.
- If the green light **is not illuminated**, go to **Turn ON TCU** on page 14.
