**SERVICE INFORMATION BULLETIN**

**APPLICABILITY:** 2019MY Forester **NUMBER:** 12-261-19R  
**SUBJECT:** EyeSight Camera Cover Removal and Installation **DATE:** 04/17/19  
 Cautions **REVISED:** 06/04/19

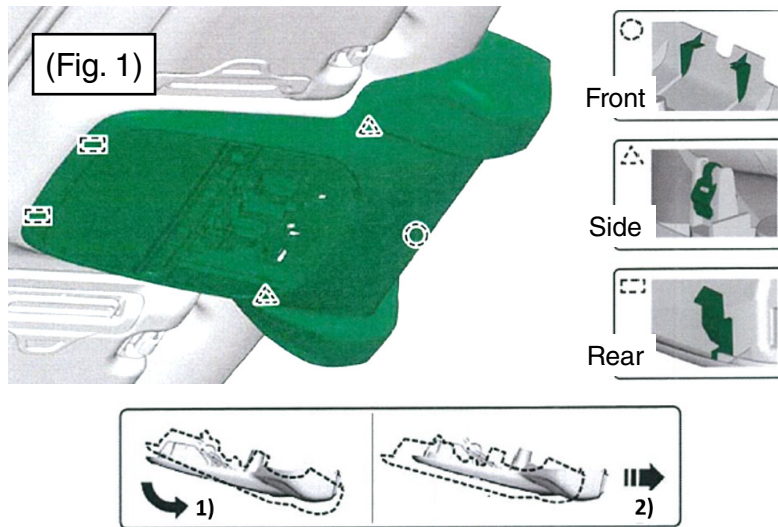
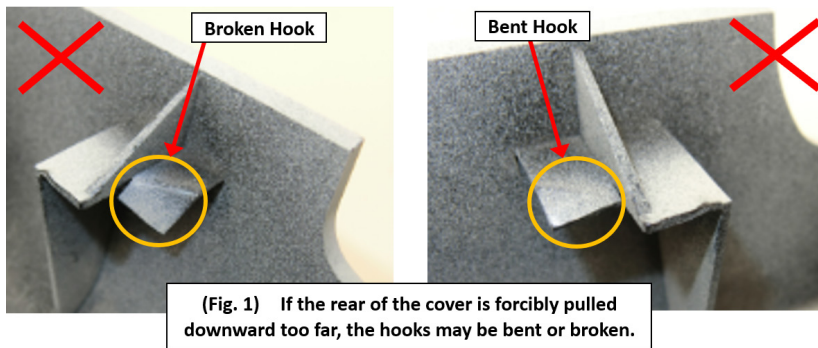
After removing the two bolts adjacent to each map light, **CAREFULLY** pull down on the back edge of the camera cover **ONLY AS FAR AS NECESSARY** to access and release the two clips at the rear with a plastic trim tool. Pulling the cover down any more than needed will likely damage the two front hooks necessitating cover replacement. See (Fig. 1) below. Use a twisting motion with a plastic trim tool to release the single clip on either side while being extremely careful to not damage the edges of the cover. Once all four clips are released, slide the cover forward to release the two front hooks from the camera assembly.

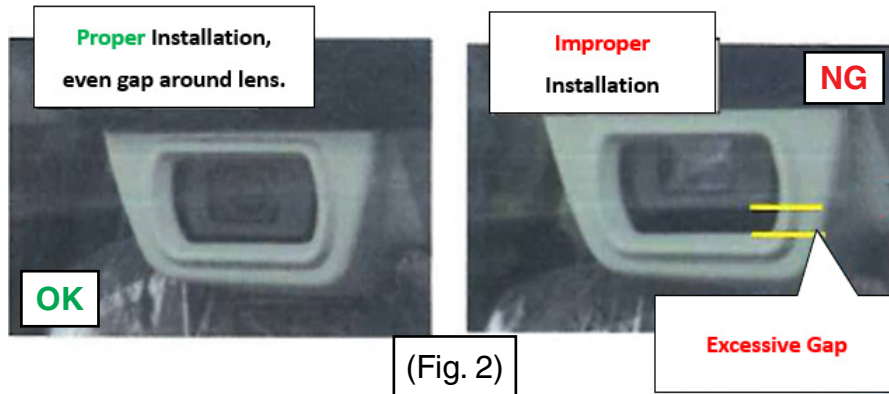
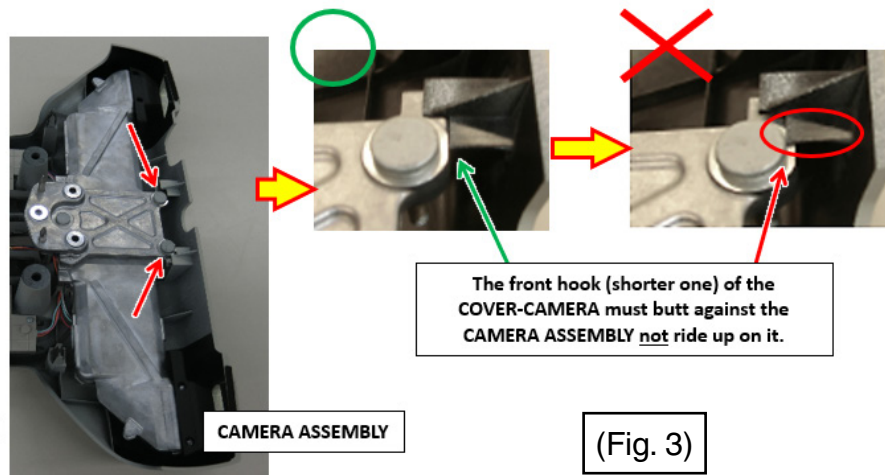
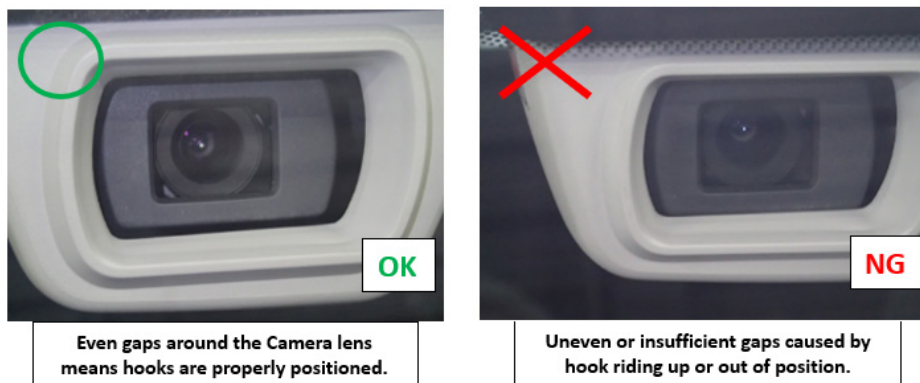
Once the cover is reinstalled, confirm a proper repair by looking closely through the windshield at the front of both EyeSight camera lenses. When the cover is installed properly, there should be an even gap (approximately 1mm) all the way around each lens as shown in the OK photo in (Fig. 2) and (Fig. 3) below. If there is an uneven gap, chances are the shorter portion of the front hook(s) has ridden up onto the camera housing instead of being butted up against it. OK and NG photos of this condition are also included in (Fig. 2) and (Fig. 3) below.

**IMPORTANT:** If the cover is not installed properly, there will be an uneven gap around the lens. This can cause a rattle sound when driving on rough roads and / or possible EyeSight operational concerns.

**VERY IMPORTANT:** Whenever the camera cover has been removed, always confirm proper EyeSight system operation as a final quality check before releasing the vehicle.
