# TECH TIPS GREATEST TIPS

## 01 UNDERSTANDING DTCs AND HOW TO PROCEED PROPERLY WITH REPAIRS

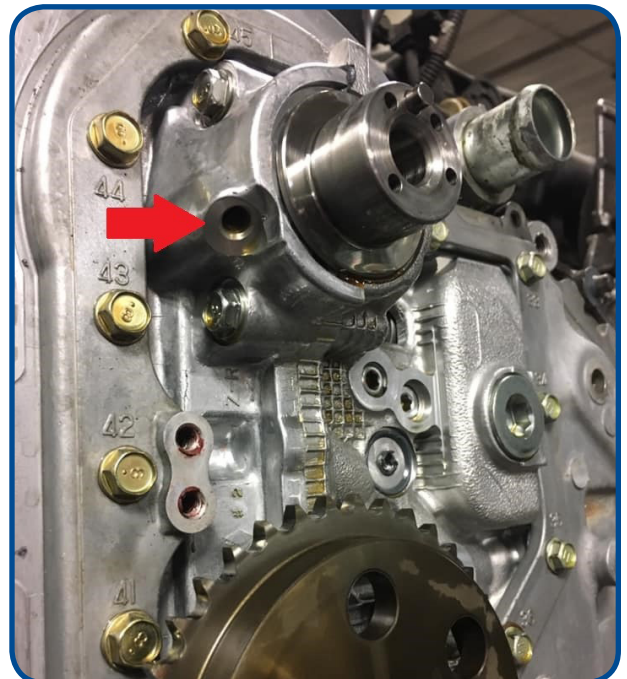
Techline has received reports from the field concerning AVCS related DTCs after H6 cylinder head replacement. When replacing H6 cylinder heads, thoroughly inspect both the new and old cylinder heads to ensure all parts not included with the new cylinder head have been transferred. The image to the right shows one of the oil galley plugs that must be transferred from the old cylinder head.

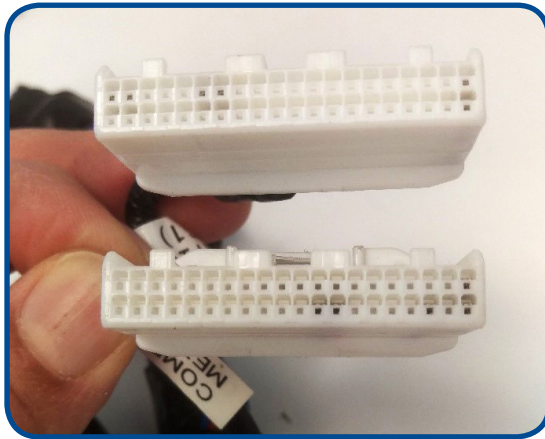
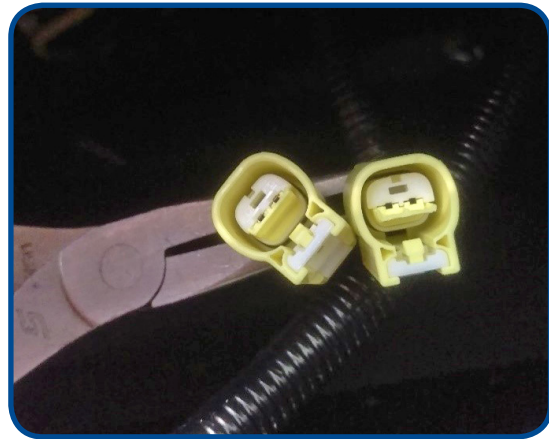
Most electrical connectors in Subaru vehicles have unique designs that allow them to be plugged in to only one component. However, this does not apply to all connectors. Some connectors have the same physical shape and will connect to multiple components. These connectors don't always have the same power, ground, or signal pins. If the component receives the incorrect circuit path, the component could be damaged. This is very common when installing Keyless Access Control Modules. Below are some examples of identical connectors for different components.

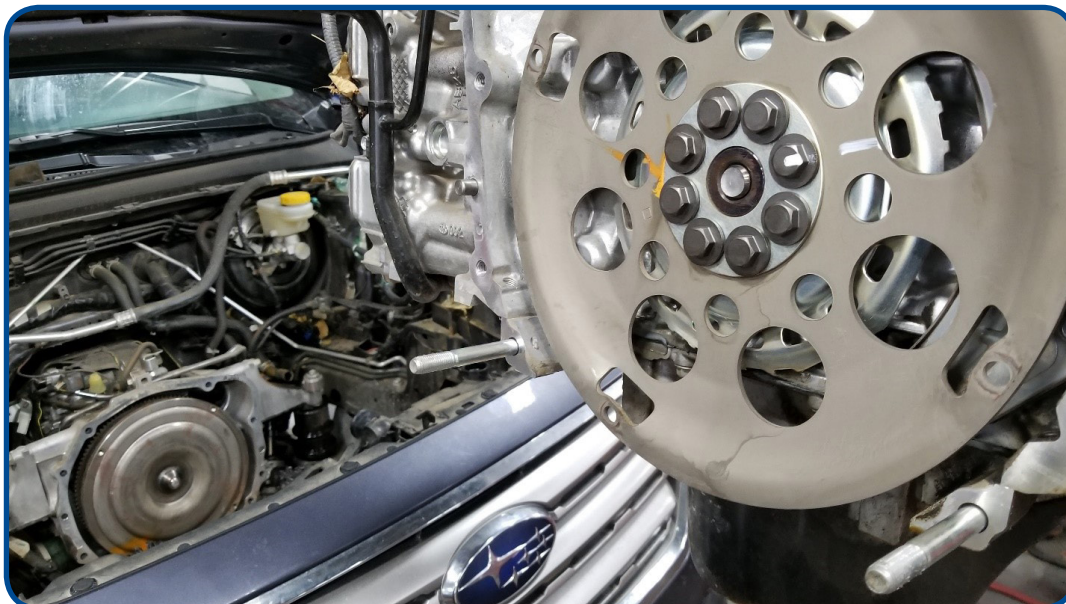
Techline has received increasing concerns of vibration after transmission or engine removal. Multiple cases have been identified where the vibration has been traced back to the snout of the torque converter being broken. This can happen if the torque converter holder tool is not used. When removing an engine or transmission the component needs to be released as straight as possible without any rocking or pitching.

The photo above shows the nose of the torque converter is broken off and remaining in the crankshaft. Also note, there is no torque converter holder tool installed to the transmission.

During component removal it is imperative to follow all steps of the procedure as outlined in the Service Manual. In addition, always confirm both dowel pins are installed in the engine block before engine re-installation to insure proper engine to transmission alignment.

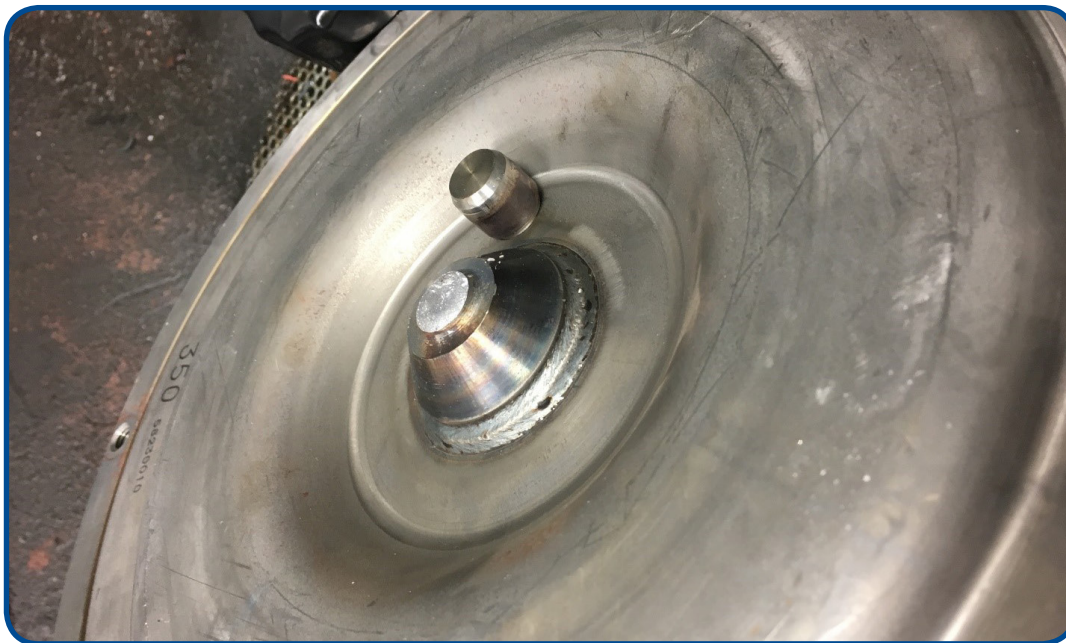
Torque converter with broken nose.
