ENGINE VIBRATIONS OR NOISE

This Service Information bulletin replaces SI B11 01 19 dated February 2019

**Partial or full detachment damage of the crankshaft vibration damper:
B4x, B5x engines**

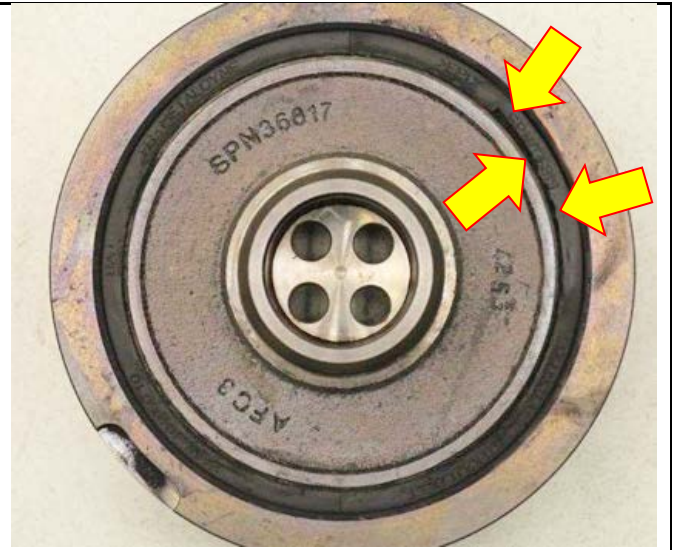
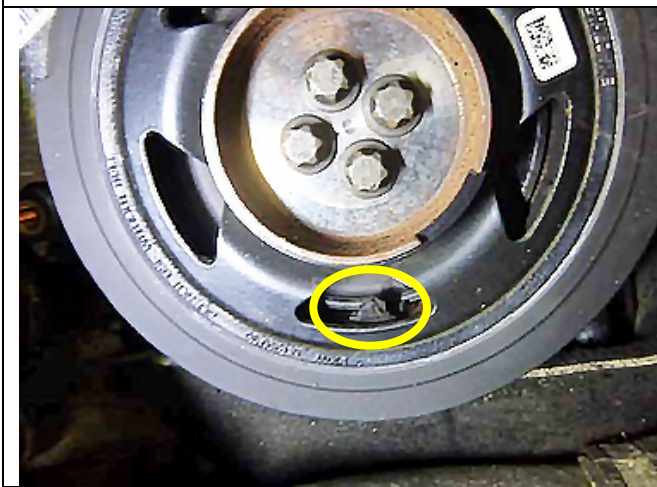
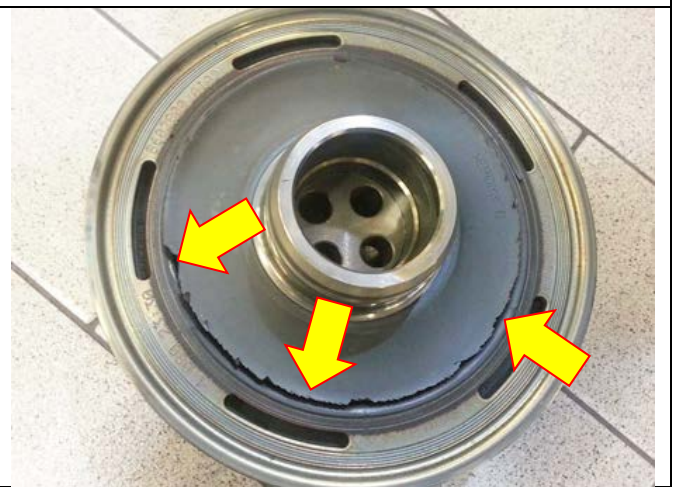
The vibration damper rubber insulator located between the drive belt pulley and its center hub has either partly or fully separated (torn). The separation will allow the two components to move independently from each other.

Partially damaged/detached bonded rubber insulator between damper center hub and the outer belt pulley.

1. Check the vibration damper, remove the drive belt and refer to Repair instruction 11 28 010 "Removing and installing/replacing alternator drive belt". Visually inspect the vibration damper for cracks in the rubber insulator. Refer to the attachment for descriptions.
2. If cracks or damage to the vibration damper are visible or if the hub and belt pulley are no longer connected then replace the vibration damper **and the drive belt.**

Refer to Repair instruction 11 23 010 "Removing and installing/replacing vibration damper".

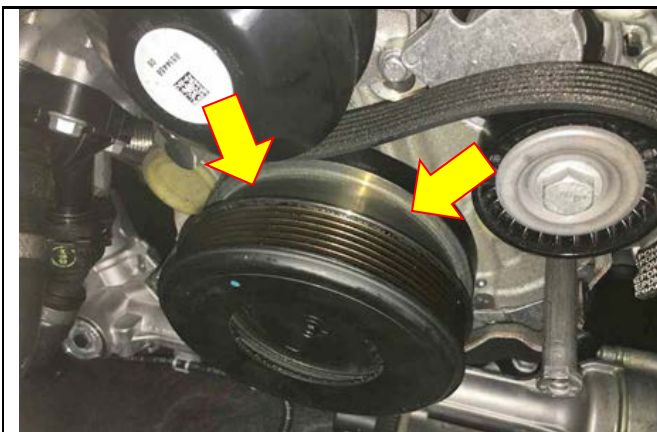
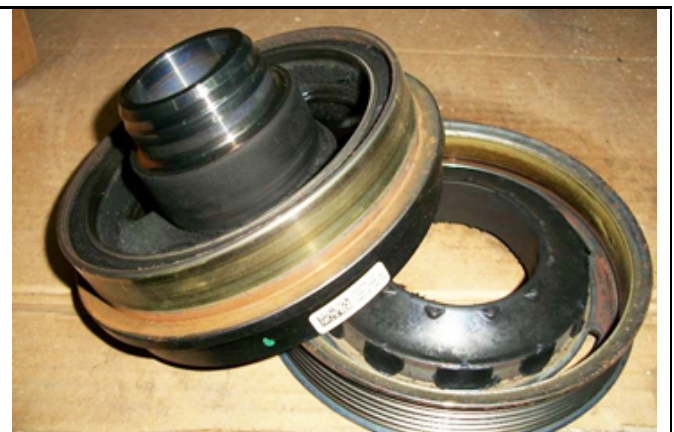
The separation will cause vibrations and or noises from the engine compartment. In some cases the belt could sustain damage.

Fully separated/detached rubber insulator.
