EME GROUND CONNECTION MONITORING FAULTS

F30 PHEV (330e iPerformance)	G12 PHEV (740e xDrive iPerformance)	G30 PHEV (530e iPerformance)
------------------------------	-------------------------------------	------------------------------

GRUSB1219-00

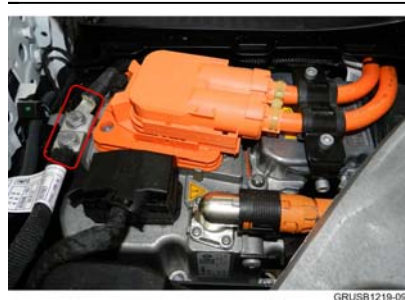
1. Remove both grounding cables at the EME
G30 shown; ground location for other models are similar.

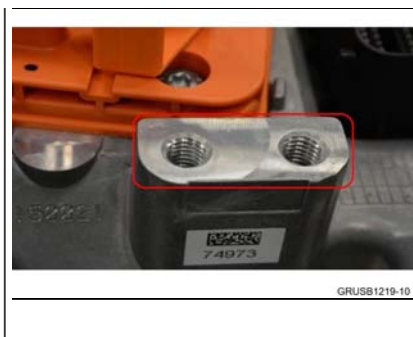
Increased ground cable contact resistance at Electrical Machine Electronics (EME) due to corrosion/oxidation.

- Clean the contact surface of both grounding cables and the ground support point at the EME using 1200 grit emery cloth or equivalent to remove any corrosion or oxidation.

- Reattach both grounding cables. Tighten to 19 Nm.
