COOLANT LEAK FROM LOW TEMPERATURE COOLING CIRCUIT (N63R)

This Service Information bulletin replaces SI B17 06 17 **dated February 2019**.

With the N63R engine

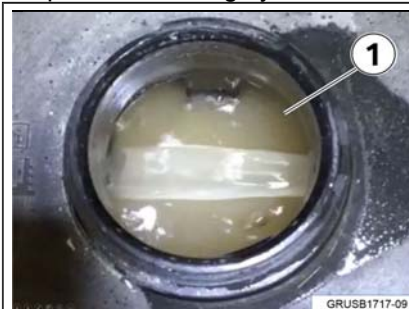
Coolant leaking from the engine compartment. Traces of coolant leaking from the expansion tank of the low temperature cooling system.

Coolant in the low temp cooling circuit may also have an acrid smell and discoloration (1).

Aluminum corrosion in the charge air coolers or the radiator for the low temperature cooling is causing an unfavorable chemical reaction to the coolant.

Replace the radiator and both charge air coolers for the low temperature cooling circuit. Allow all the coolant in the system to drain during repairs (do not clamp off hoses).
