SI B37 02 19
Special Suspension Systems

SERVICE ACTION: CHECKING, IF REQUIRED, REPLACING REAR RIDE HEIGHT SENSOR CONTROL RODS

G05 (X5 Sports Activity Vehicle)	G07 (X7 SAV)		
----------------------------------	--------------	--	--

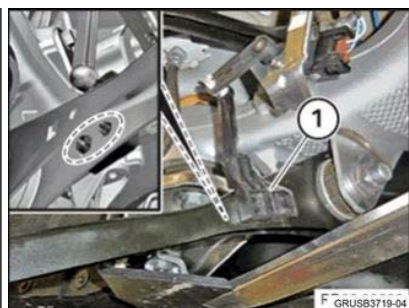
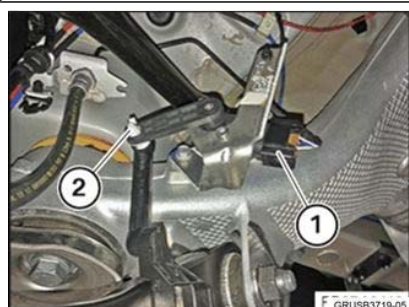
The holders of both control rods for the ride height sensors on the rear axle may have been mounted incorrectly (the locking tabs are not correctly locked).

Manufacturing error.

<p>GRUSB3719-03</p>	<ol style="list-style-type: none"> 1. Inspect the holder of the control rod for both of the ride height sensors on the rear axle. <ul style="list-style-type: none"> • If a clip on a holder is damaged (photos), the ride height sensor must be replaced. Proceed to step 2. • If the clips on the rod holders are not damaged, no further repair is required
	<ol style="list-style-type: none"> 2. Replace the control rod (1) of the ride height sensor on the rear axle. <ul style="list-style-type: none"> • Unclip the control rod holder of the ride height sensor from the trailing arm.

- Detach the clip (2) of the control rod on the ride height sensor.

3. Install the new control rod and clip it in securely.

- Ensure that it locks correctly at the retaining lug
- If a control rod is already loose or is no longer locked correctly, a ride height adjustment must also be performed, the tire pressure monitoring system (TPMS) must be reset and the headlights must be adjusted.
