SI B52 04 19
Seats

SECOND ROW 60/40 DRIVERS SIDE SEAT INTERMITTENTLY WON'T LATCH

| G05 (X5 Sports Activity Vehicle) | G07 (X7 SAV) | | |

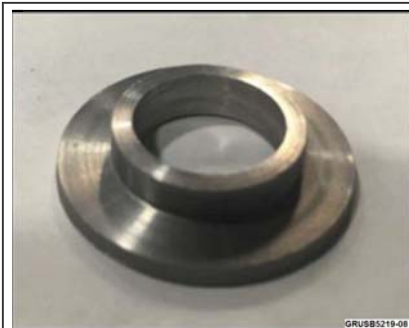
The driver's side (left rear) of the 60/40 split 2nd row seat may intermittently not fully latch into position on one side (inner rail).

Manufacturing tolerances of the seat assembly.

As of March 2019 production, two machined washers (shown) were added to the bottom of the inner seat rail on the driver's side (left rear) of the 60/40 split 2nd row seat.

For vehicles with this specific complaint that were produced prior to March 2019, a comparable correction is to add two 2mm thick flat washers in this location.

- 15mm inner diameter hole for the bolt fitment
- Outside diameter must be at least 30mm

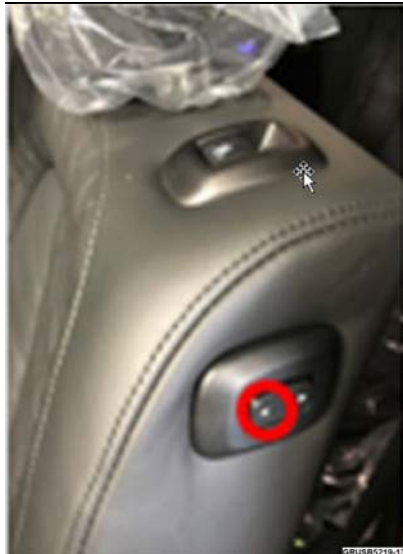
| | <p>8. Check the easy entry function (switch circled).</p> |

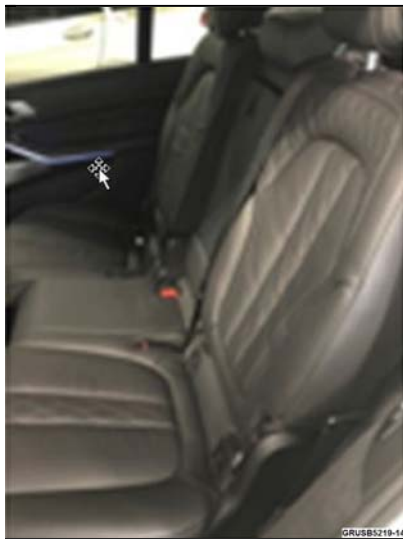
| | <p>9. Relatch the seats and move them fully rearward.</p> |

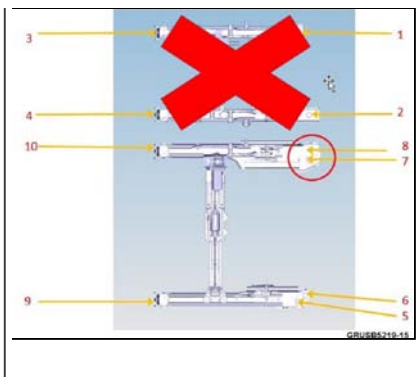
Note: Only install the 2 washers at the specified location

7 / 8 (circled).

- Locations 1 thru 4 pertain to the 40% 2nd row seat which is not affected by this repair.

11. Tighten all fasteners to 42Nm following the torque sequences #5 thru 10
