SI B52 10 19  
Seats

## THIGH SUPPORT UPHOLSTERY DETACHES FROM SEAT

G05 (X5 Sports Activity Vehicle)	G07 (X7 SAV)		
----------------------------------	--------------	--	--

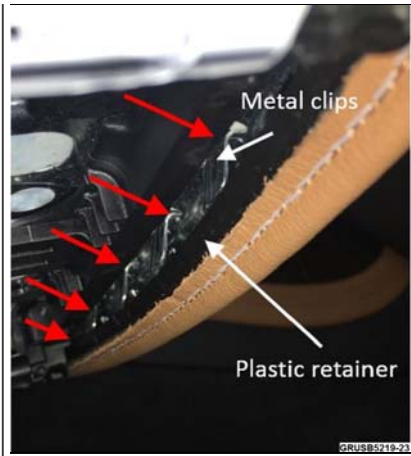
2. **Incorrect:** Retainer and trim are not properly installed (red arrows).

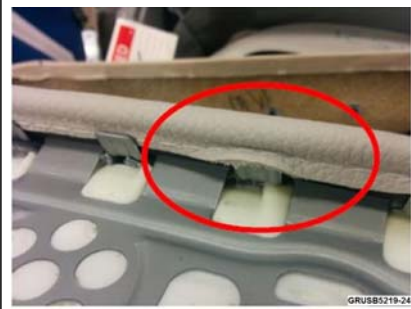
- The edge of the leather seat upholstery is sewn onto a plastic retainer strip
- The retainer strip is supposed to be held in place by the firm contact of the 5 metal clips

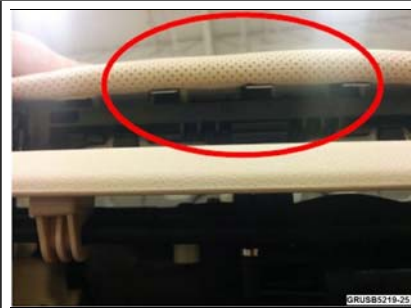
3. **Incorrect:** Retainer and trim not properly installed-
- Left clip too loose against retainer
  - Leather is overlapping the right clip (circled) so that the clip cannot press against the retainer

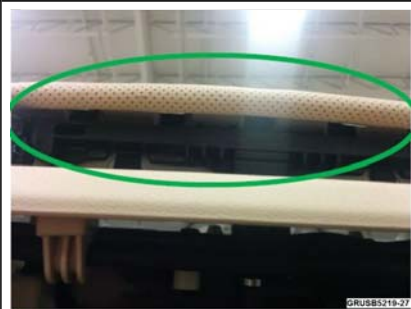
4. **Incorrect:** The metal clips (circled) are not exerting enough force against the retainer strip.
- Slight gaps are present between the clips and the retainer strip

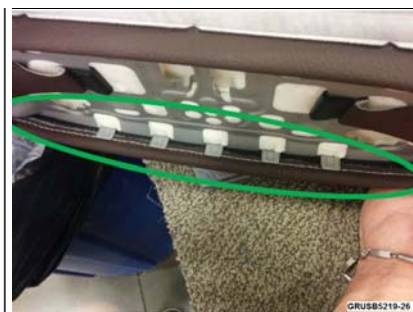
5. **Correct:** Retainer and trim placed correctly inside the metal clips.
- Clips are firmly pressed against the trim
  - No gap exists between the trim and metal clips

Note: Bend the 5 metal clips as necessary.
