SERVICE ACTION: CHECKING THE SIGNAL WIRE AT POWER DISTRIBUTION BOX

This Service Information bulletin replaces SI B61 09 19 **dated June 2019**

G05 (X5 Sports Activity Vehicle)	G07 (X7 SAV)	G12 (7 Series Sedan)	G14 (8 Series Convertible)
G20 (3 Series Sedan)	G29 (Z4 Roadster)

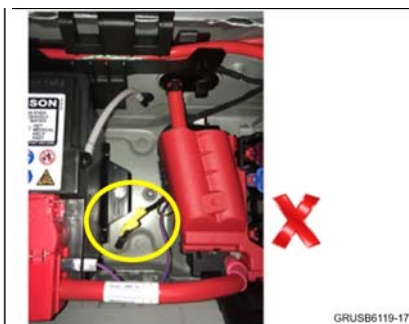
Connector (circled) shown not plugged in.

For G12, G14, G20 and G29:
 Check the signal wire in the luggage compartment under the luggage compartment cover for correct installation.
 • If the signal wire is not plugged in, assemble correctly.

1. Disassemble the storage tray in the luggage compartment under the luggage compartment cover.
 2. Check the signal wire for correct installation.
- If the signal wire is not plugged in, assemble correctly.

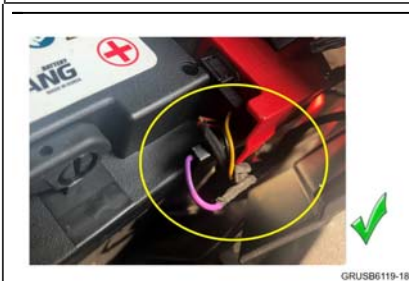
Connector (circled) plugged into the Battery Safety Terminal.

Note: Photo shows a G20. Other models may be slightly different.
