SI B62 07 19  
Instruments

## DIGITAL SPEEDOMETER MISSING FROM THE INSTRUMENT CLUSTER AFTER PROGRAMMING

| G01 (X3 Sports Activity Vehicle) | G02 (X4 Sports Activity Coupe) | |

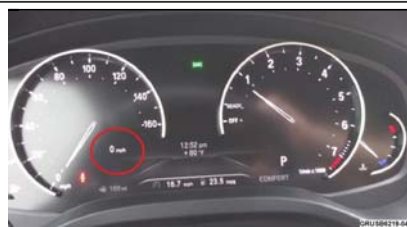
The digital speed display from the left side of the gauges is missing in the Instrument Cluster (KOMBI) after ISTA 4.14.1x programming. There are no I-drive settings for a customer to turn this on/off.

Note: The affected I-Levels are: S15A-18-11-5xx & S15A-19-03-5xx

Software error in the Instrument Cluster basic manufactured by CONTI.

If the I Level is lower than S15A-19-07-530, program/encode the vehicle with ISTA 4.18.2x or higher software.
