Service Information

M63 01 19

DELIVERY STOP: REWORK TAIL LIGHTS

F60 (MINI Countryman)

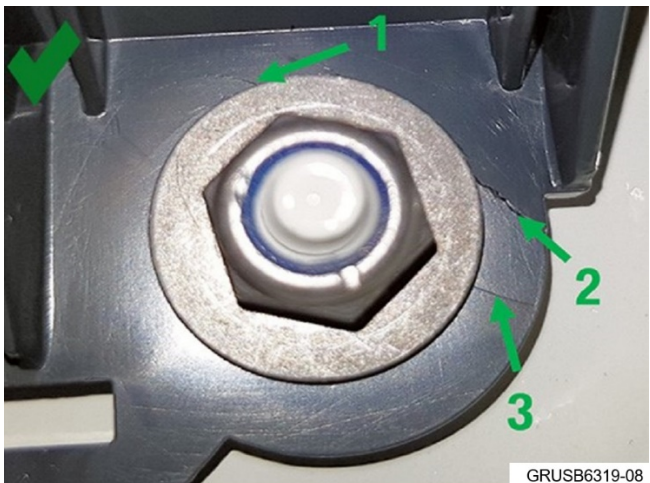
GRUSB6319-08

3. Reference the photos shown to the left, which demonstrate **acceptable** cracking and which require no further correction.

Single cracks are acceptable.

1 – small crack, not circulating, no net of cracks, **OK**

2 – small crack, not circulating, no net of cracks, **OK**

3 – weld line, **OK Attention**: the position of the weld line can vary from model to model

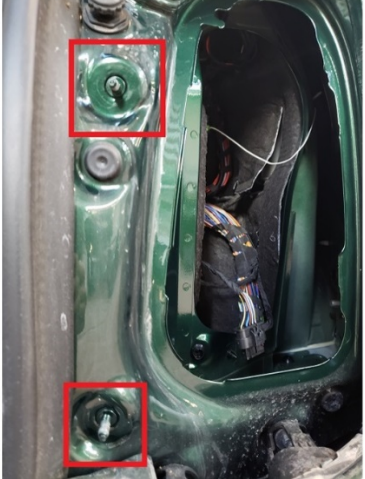
<p>Warning: The tail light mounting nuts are contaminated and can NOT be reused. Reusing a contaminated mounting nut will cause the new tail light to fail.</p>

<p>GRUSB6319-14</p>	<p>8. With the damaged tail light removed from the vehicle, the tail light mounting studs and vehicle body MUST be cleaned to remove residual manufacturing oil.</p> <p>Using an 80% ethanol/20% water mixture on a clean cloth, clean the mounting studs and body area shown to the left.</p> <p>

Warning: 80% Ethanol/ 20% water is the only suitable cleaning solution that is safe for the vehicle body. Do NOT use any alternative cleaning solution.</p> <p>Ethanol can be locally sourced in the form of denatured alcohol.</p> <p>Using any other cleaning solution will cause damage to the vehicle.</p>
<p>9. Once the vehicle body has completely dried, install a new tail light on the affected side(s). The tail light mounting nuts MUST BE REPLACED when replacing a tail light.</p>
