Technical Service Bulletin

87 Faint noise heard in cabin from air conditioning circuit

87 19 93 2044717/9 July 12, 2019. Supersedes Technical Service Bulletin Group 87 number 18-86 dated April 9, 2018 for reasons listed below.

| Model(s) | Year | VIN Range | Vehicle-Specific Equipment |
|---|---|---|---|
| A6, A7 | 2012 - 2015 | All | 2.0L or 3.0L gas engine |

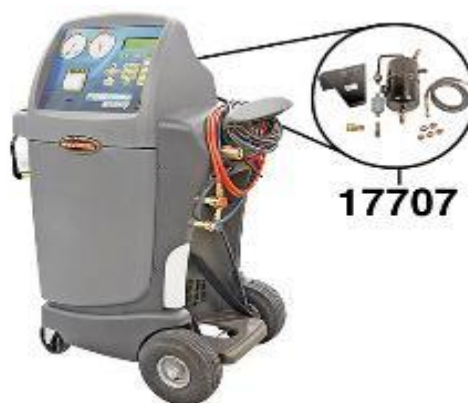
Figure 1. A/C flushing unit.

1. Perform a complete recovery and flush of the air conditioning refrigerant circuit (Figure 1 and Figure 2).

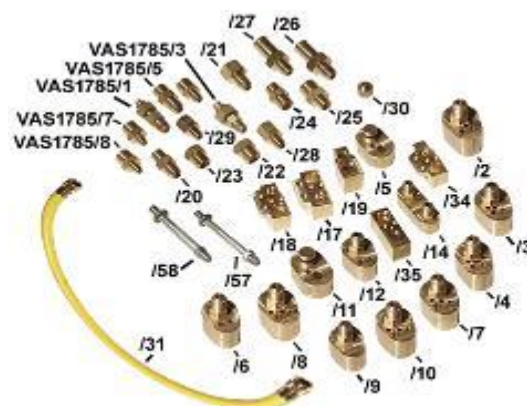
Figure 2. Flushing fitting set.

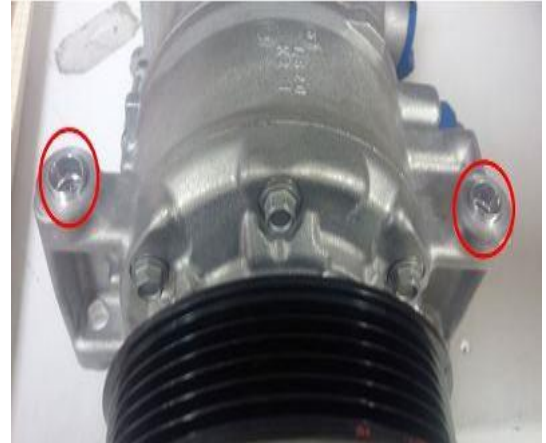
Figure 3. Mounting bolt centering sleeves on the air conditioning compressor housing.

It is imperative that the compressor mounting bolt centering sleeves be reinstalled with the compressor (Figure 3). Failure to reinstall these sleeves will result in compressor failure (as well as possible engine and/or ancillary component damage) in a short period of time. If any sleeves were misplaced during the removal and reinstallation process, new sleeves should be ordered and installed on the compressor housing before reassembly. Compressor or consequential component damage resulting from a failure to install the centering sleeves will not be accepted under warranty.

2. Remove the air conditioning compressor, empty the compressor of the PAG oil completely, then reinstall it to the vehicle. The compressor does not need to be replaced.

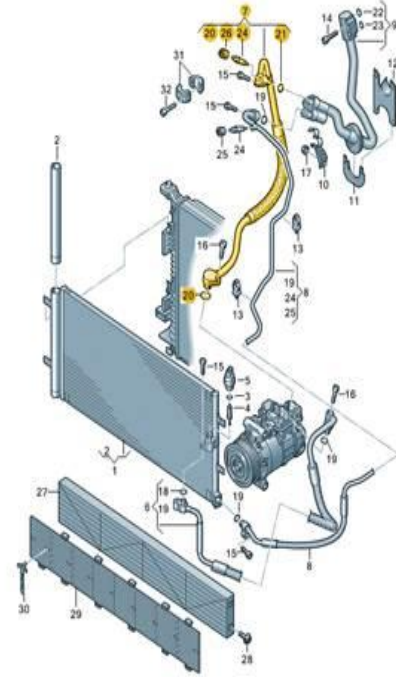
Figure 4. The low side line that needs to be replaced.

3. Replace the low side refrigerant line that connects the air conditioning compressor suction port to the hybrid refrigerant line to the expansion valve (Figure 4). Be certain to use new O-rings at these and all refrigerant circuit joints that are disconnected.

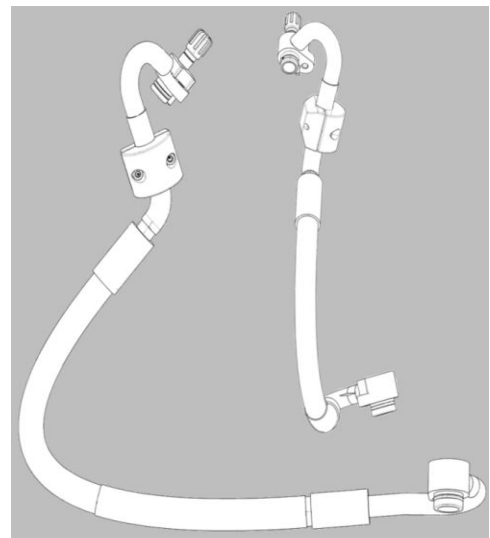
Figure 5. Balance weight position on the low side line.

4. Install the balance weight (part number 4G0513621A) with 2 bolts (part number N 10653601) to the line in the position shown in the illustration (Figure 5).
