# Technical Service Bulletin

## 97 Electrical concerns in the rear trunk area

97 19 64 2043968/4 July 8, 2019. Supersedes Technical Service Bulletin Group 97 number 19-63 dated April 12, 2019 for reasons listed below.

Model(s)	Year	VIN Range	Vehicle-Specific Equipment
A3	2015 - 2016	All	Not Applicable

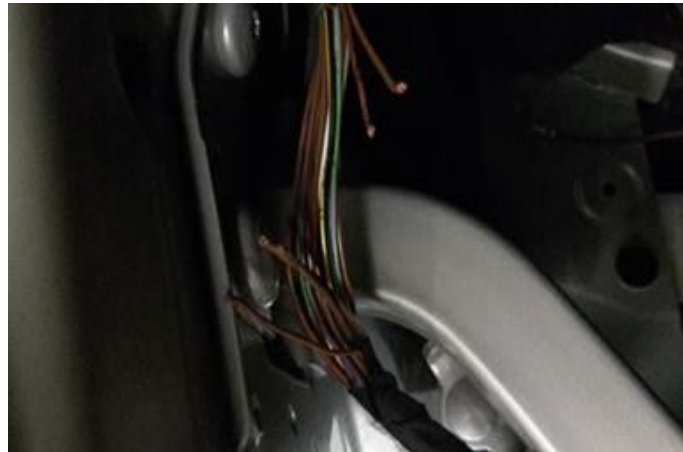
When the rear lid is opened or closed, a wire (or wires) can break in the area of the trunk hinge of the left or right rear lid wiring harness.

*Figure 1. Wire damage at the trunk hinge.*

1. Check the rear lid wiring for damage in the area of the trunk hinge (Figure 1 - Figure 3).  
If the wiring harness is damaged in the area of the trunk hinge, it must be replaced.  
Follow the instructions below.

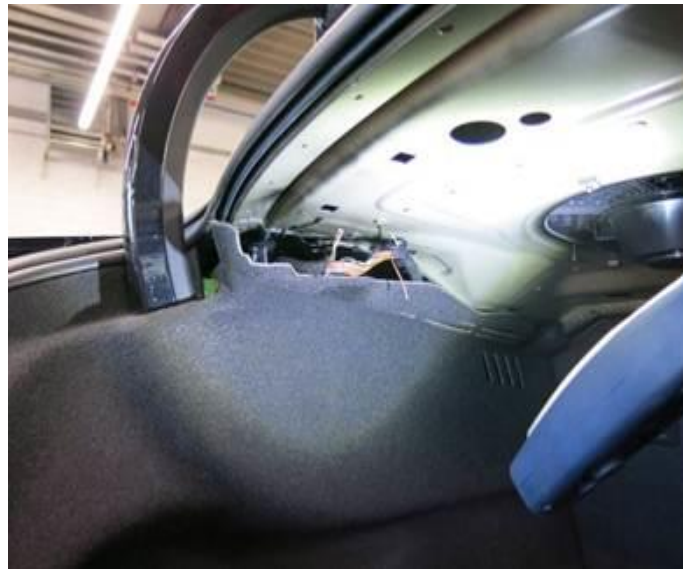
*Figure 2. Wire damage at the trunk hinge.*

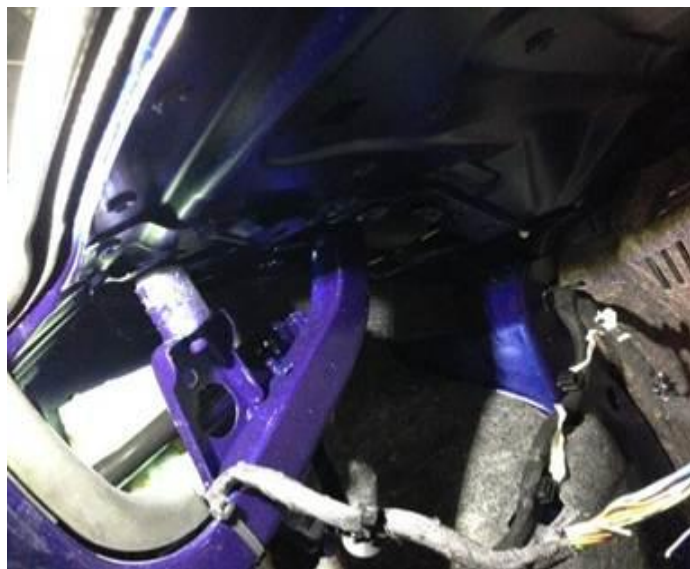
**Figure 3.** Incorrect wire routing at the trunk hinge.

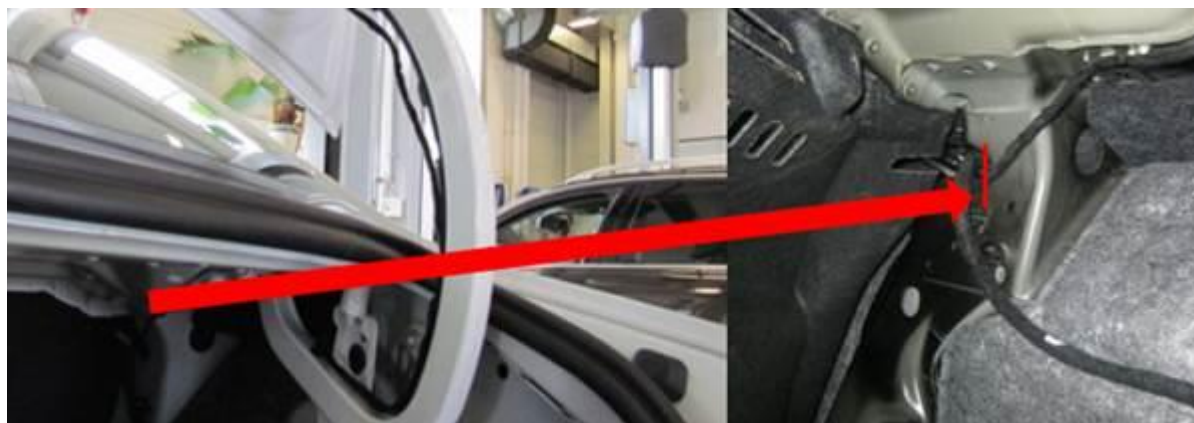
**Figure 5.** Cut cable off on the junction of the main wiring harness (red separation line).

4. Loosen the wiring harness to the reversing camera control module and cut it off on the junction of the main wiring harness (Figure 5). Wrap textile adhesive tape around the cut-off cable.

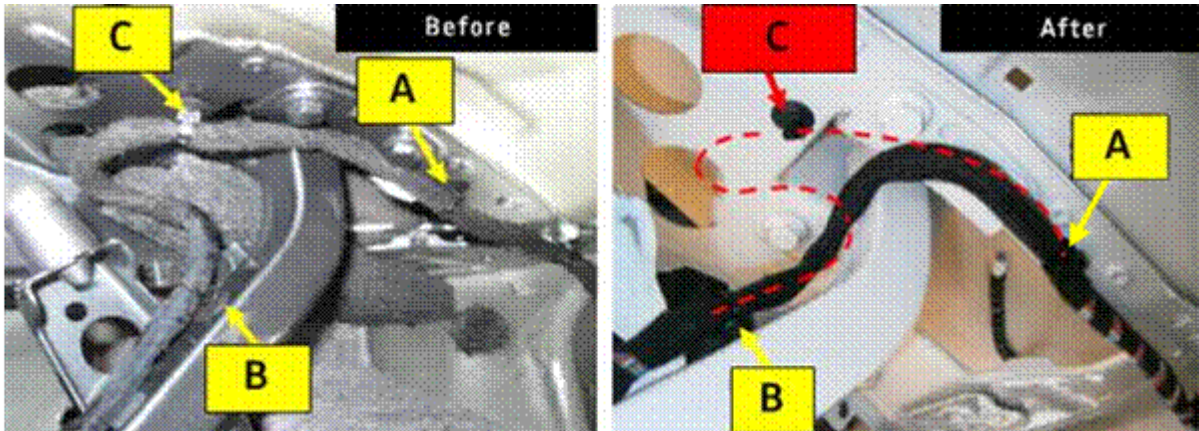
**Figure 7.** Note that clip “C” in the image above is not needed when the service wiring harness is fitted.

6. Fit the service wiring harness. For correct routing, refer to the photographs taken in step 3. Note that one of the clips from the previously-fitted harness is no longer needed (Figure 7).

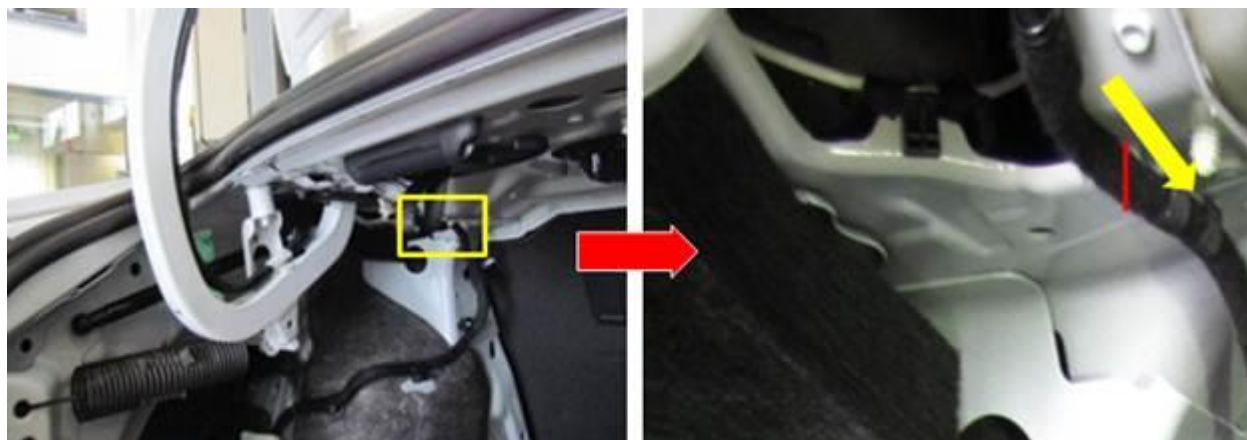
**Figure 13.** Cut the cable at before the last unlevered clip (at red separation line, before clip marked by the yellow arrow).

5. Remove the left rear lid wiring harness and cut the cable off before the last unlevered clip (Figure 13).

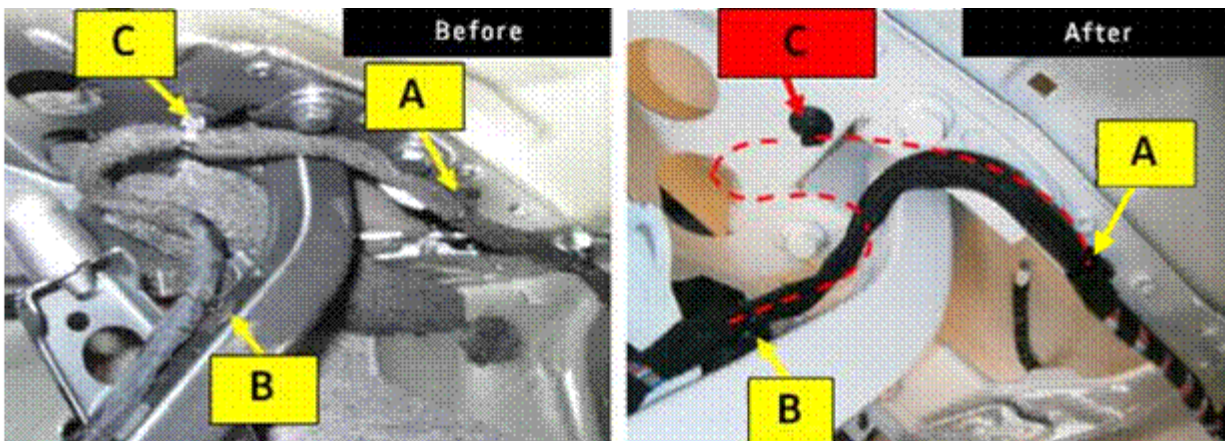
**Figure 20.** Note that clip “C” in the image above is not needed when the service wiring harness is fitted.

Note that one of the clips from the previously-fitted harness is no longer needed (Figure 20).
