Horn Does Not Work

AFFECTED VEHICLES

Year	Model	Trim	VIN Range
2019	Odyssey	ALL	ALL

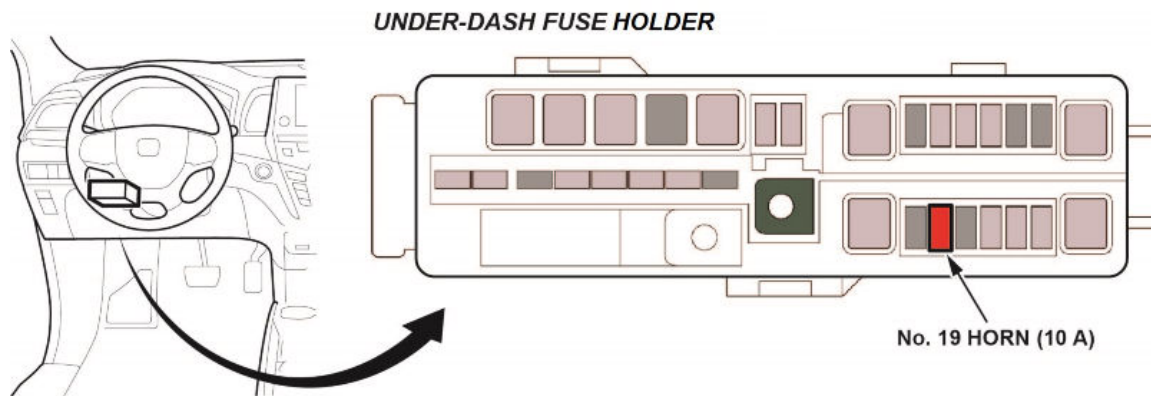
The No. 19 HORN (10 A) fuse is blown or DTC B26AE (horn overload failure) is set.

1. Check the No. 19 HORN (10 A) fuse in the under-dash fuse holder.

Check the No. 19 HORN (10 A) fuse for the horn circuit in the under-dash fuse holder (refer to the Fuse/Relay Box Connection Locations in the Service Information System). Replace the fuse if it is blown. Replace the low and high horns. Check and clear all DTCs.
