July 21, 2019

Version 1

2017-19 CR-V: Display Audio Screen Dims or Goes Dark by Itself

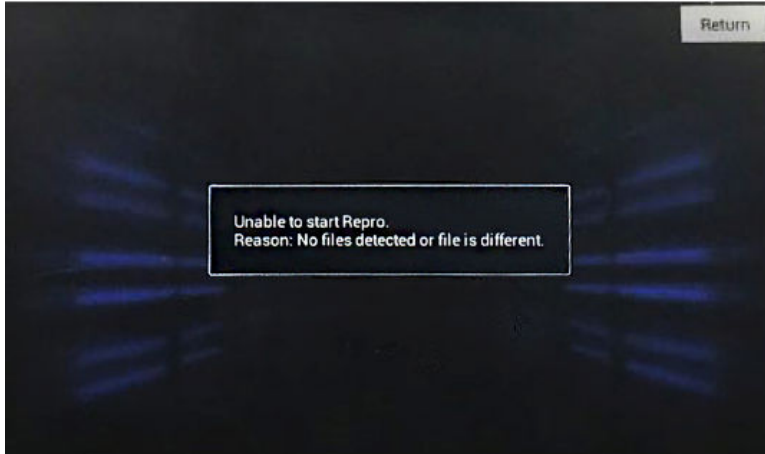
If this message appears, make sure you are using the correct USB.

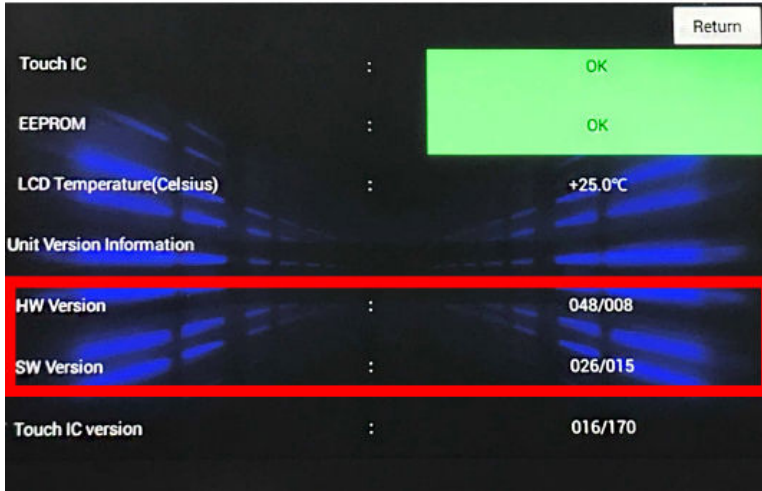
If the versions do not match, make sure the correct VIN was used to download the software as the software is different between 2017 and 2018-19 models.
