Service Bulletin

Bulletin No.: 16-NA-324

Subject: Small Holes Pierced into Sail Panel Area of Folding Top Cover, One/Both Sides

Brand:	Model:	Model Year:		VIN:		Engine:	Transmission:
		from	to	from	to		
Buick	Cascada	2016	2019			All	All
Holden

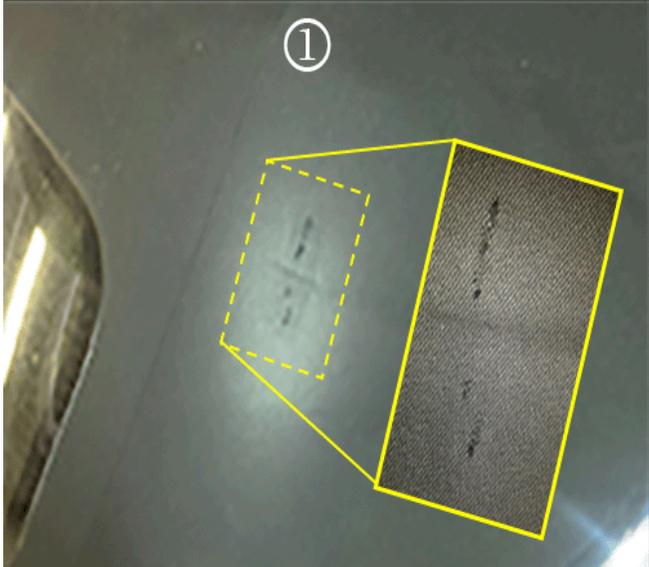
<p>4585782</p>

<p>4585784</p> <p>Some customers may comment on seeing small pierced holes appearing in the sail panel area, on one or both sides of the folding top cover. Examples of right side (1) and left side (2) damage are shown in the graphics above.</p>
<p>Cause</p>	<p>The cause of the condition may be tension straps sewn into the top cover that were too long in length. This allowed the top cover material to fold into, and be pinched by, the kinematic hinge causing the wear/damage.</p>

Replace the folding top cover. Refer to *Folding Top Cover Replacement* in SI.
