Service Bulletin

Bulletin No.: 18-NA-361

Subject: Diagnostic Tip for Fuel System Contamination

Brand:	Model:	Model Year:		VIN:		Engine:	Transmission:
		from	to	from	to		
Chevrolet	Silverado	2017	2018			L5P	
	Silverado 2500/3500	2019	2020				
GMC	Sierra	2017	2018				
	Sierra 2500/3500	2019	2020

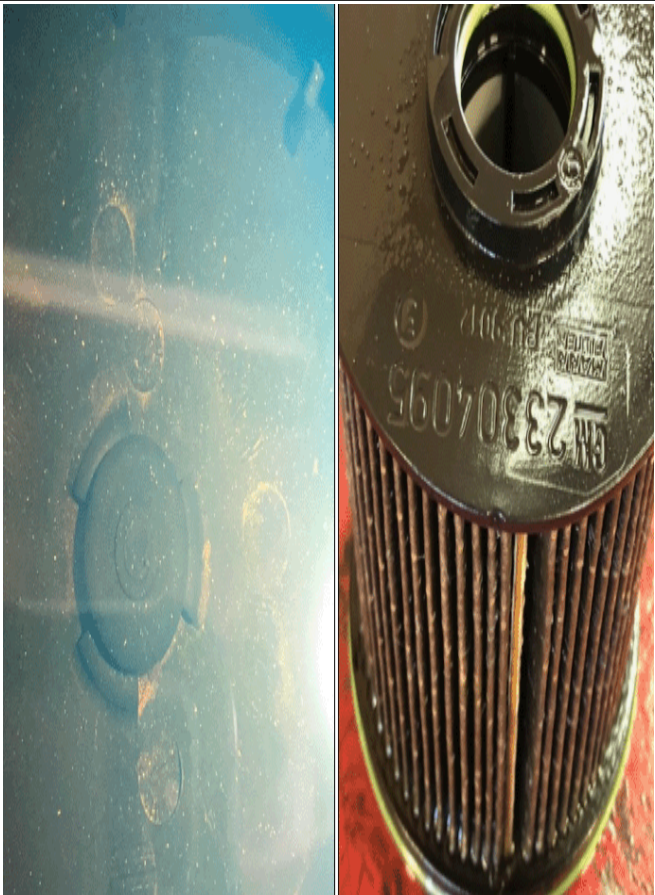
5168457

<p>Some technicians may find metal particles in the fuel system during diagnostics.</p>

Correction	If you encounter such a situation. DO NOT replace the fuel system as described in 16-NA-102. Please perform the following fuel system flushing procedure prior to performing further diagnostics Once the fuel system has been flushed, continue with diagnostics as described in SI.
-------------------	--
