Service Bulletin

Bulletin No.: 19-NA-013

Subject: Ticking or Popping Noise at Roof Rail Assist Handle(s)

Brand:	Model:	Model Year:		VIN:		Engine:	Transmission:
		from	to	from	to		
Chevrolet	Equinox	2018	2019			All	All
GMC	Terrain						
Holden	Equinox

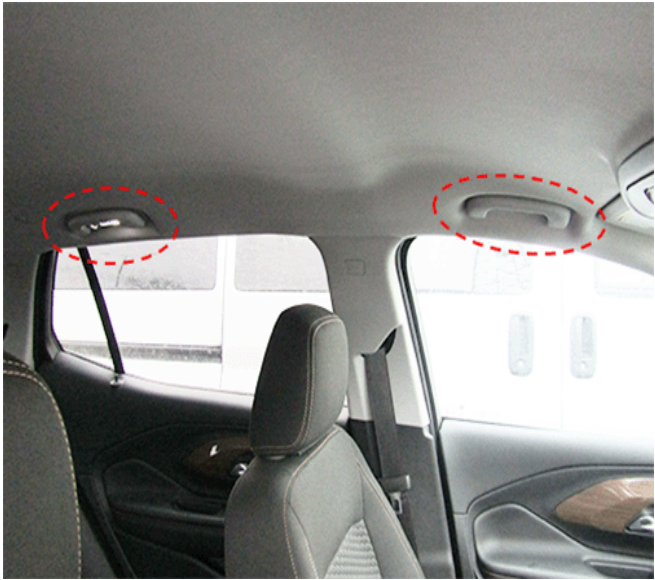
<p style="text-align: right; font-size: small;">5222300</p> <p>Customer may comment on hearing a ticking or popping noise at the area of the roof rail assist handle(s). The noise is usually most noticeable on the driver's side.</p>
Cause	The cause of the condition may be movement between the assist handle mounting bracket and the inner roof rail structure.
Correction	Verify the condition and location(s), then lower the headliner and install a rivet into the assist handle mounting bracket and inner roof rail, at the affected area(s). Follow the steps in the Service Procedure below.
