Service Bulletin

Bulletin No.: 18-NA-063

Subject: Multiple Electrical Issues, Dead Battery, Start/Stop Inoperative, Instrument Cluster and Switch Backlighting Remain Illuminated

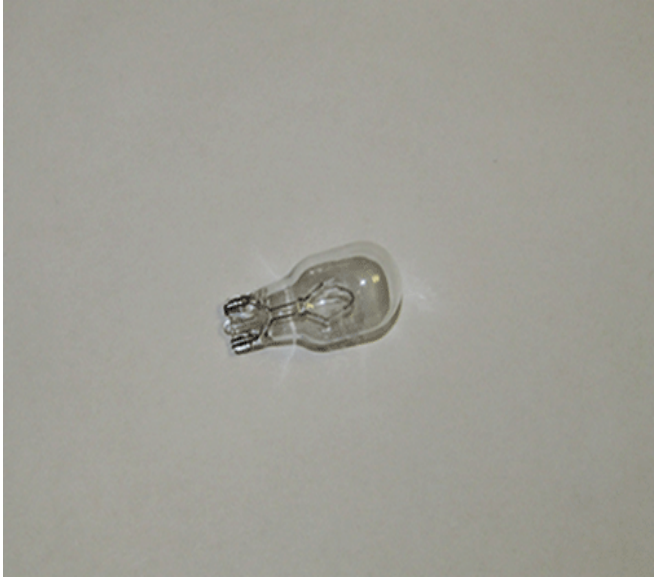
</div> <p style="text-align: right; font-size: small;">4977973</p> <p>The cause of the condition may be that the wrong bulbs may have been installed in the backup lamps. Incandescent bulbs (example shown above) should have been used, but LED's may have been incorrectly installed in their place.</p> <p>Note: The BCM evaluates the Reverse Lamp circuit to determine bulb outages by applying and monitoring a low voltage signal. Because LED lamps have different electrical properties than Incandescent bulbs, the circuit does not operate as expected. The BCM is calibrated for incandescent lamps and may stay awake after key off, if LED's are used. The BCM will continuously monitor the circuit, resulting in the symptoms identified above.</p>

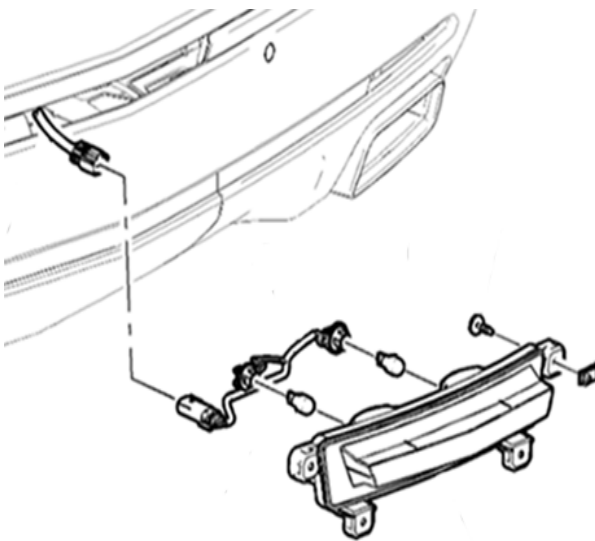
4977982

For Cadillac XT5 Models

1. Locate the backup lamp assembly underneath the rear fascia.
2. Remove the bulb from the lamp assembly by turning it counterclockwise and pulling straight out.
3. Remove the bulb and replace.
4. Reverse Steps 2 and 3 for assembly.

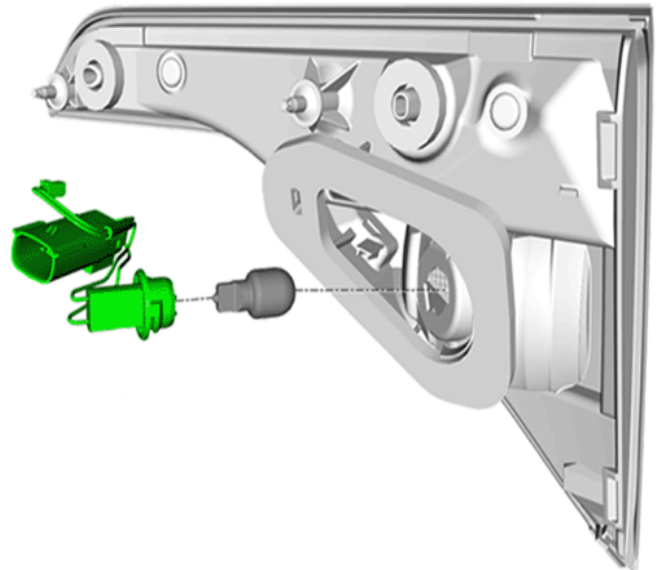
4977986

For GMC Acadia Models

Refer to *Backup Bulb Replacement* in SI.
