Service Bulletin

Bulletin No.: 19-NA-119

Subject: Intermittent No Crank, Malfunction Indicator Lamp (MIL) Illuminated - DTCs P135A, P135B, P16A7 and/or P16AF Set

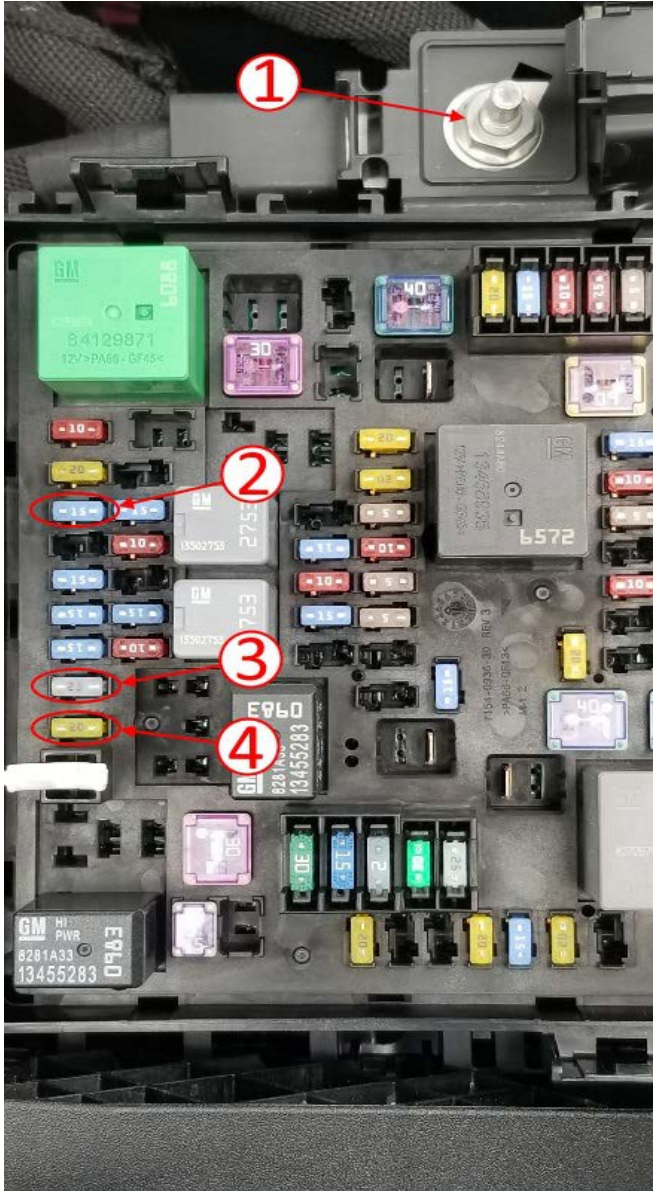
5341449

Involved Region or Country	North America, Middle East, Israel, Russia and South America
Condition	<p>Some customers may comment on one or more of the following conditions:</p> <ul style="list-style-type: none"> • MIL illuminated • Intermittent no crank <p>A technician may find one or more of the following DTCs set:</p> <ul style="list-style-type: none"> • P135A: Ignition Coil Supply Voltage Circuit Bank 1 • P135B: Ignition Coil Supply Voltage Circuit Bank 2 • P16A7: Engine Controls Ignition Relay Feedback Circuit 2 • P16AF: Engine Controls Ignition Relay Feedback Circuit 2 Low Voltage
Cause	This condition may be caused by loose terminal tension located in the underhood fuse block.
Correction	If any of the above conditions are present, the underhood fuse block must be inspected for loose or damaged terminals.

Note: The fuses in the X50A Fuse Block may appear not fully seated as they will be able to be pressed down further into fuse block. This is normal and does not indicate a fuse block failure.

3. Utilizing an alligator clip or equivalent, apply the positive DVOM lead to the positive cable (B+) stud (1).
4. With the vehicle in PARK and the parking brake set, start the vehicle.
 - ⇒ Allow the engine to idle.

5. Apply the negative DVOM lead to the appropriate outboard terminal fuse test port for the following diagnostic trouble codes. Refer to Document ID: 5129085:

- For P135B probe F60 (2)
 - For P16A7 or P16AF; probe F66 (3)
 - For P135A; probe F67 (4)
6. Record the voltage readings:
 - If the voltage is LESS than 200mV, proceed to step 7.

- If the voltage is MORE than 200mV, replace the X50A Fuse Block – Underhood and proceed to step 9. Refer to *Fuse Block Replacement, Underhood Electrical Center or Junction Block Replacement* in SI.

7. Check the terminal for sufficient tension of the corresponding terminal in X50A Fuse Block - Underhood X4 using diagnostic test probe J-35616-35 (VT) or equivalent. Refer to Document ID: 4919719:

- F60 - X50A Fuse Block - Underhood X4 terminal 37
 - F66 - X50A Fuse Block - Underhood X4 terminal 25
 - F67 - X50A Fuse Block - Underhood X4 terminal 23

- Starter Pinion Solenoid Actuator Relay - X50A Fuse Block - Underhood X4 terminal 2
8. Repair and/or replace the terminal as necessary. Refer to *Repairing Connector Terminals (Terminal Repair)* in SI.
