Service Bulletin

Bulletin No.: 19-NA-122

Subject: Rough Running Engine, Malfunction Indicator Lamp (MIL) Illuminated - DTC P0300 Set

Brand:	Model:	Model Year:		VIN Breakpoint:		Engine:	Transmission:
		from	to	from	to		
Chevrolet	Malibu	2016	2017	SOP	HF214702	1.5L (LFV)

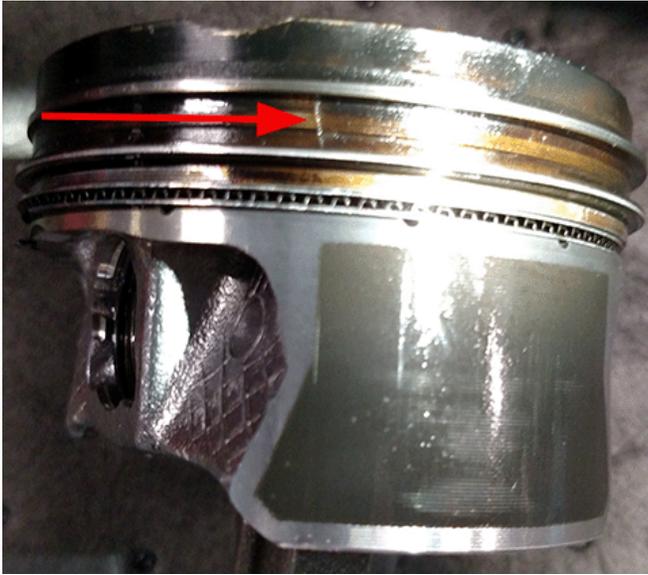
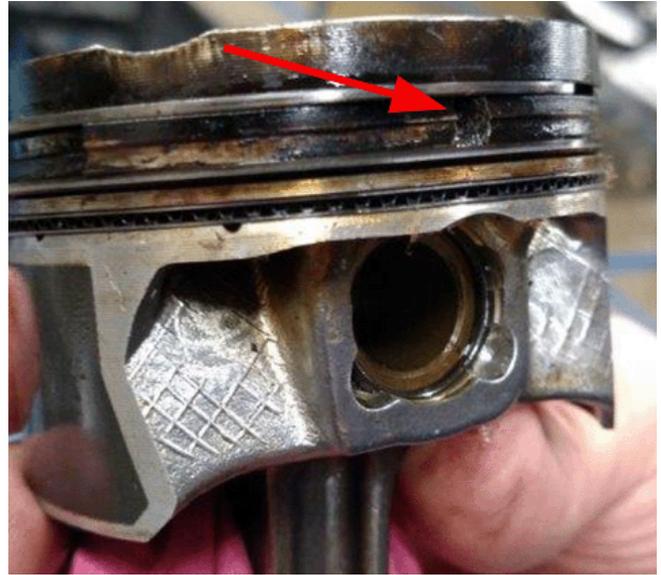
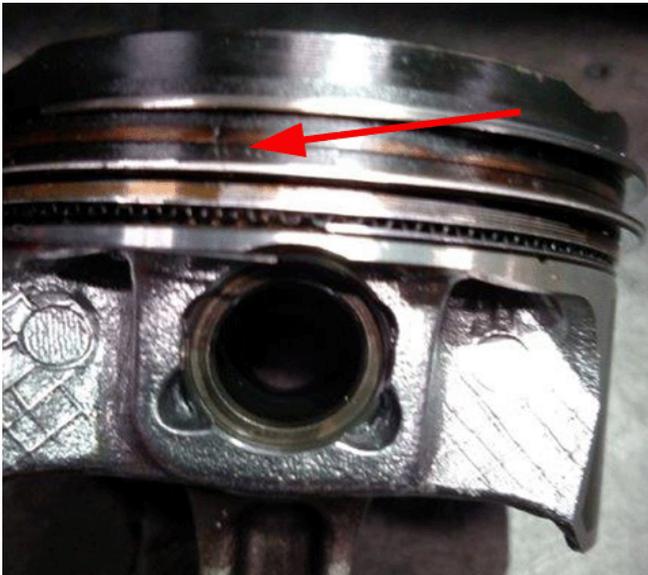
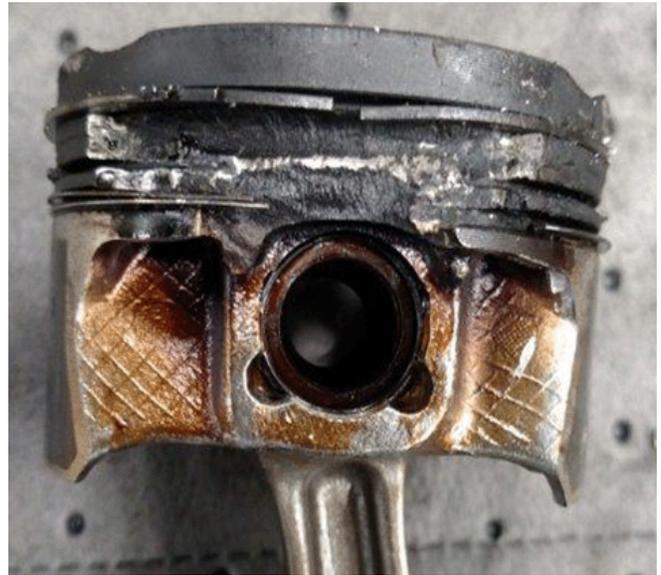
Examples of pistons with varying levels of damage:

1. Perform *Engine Compression Testing* in SI.
2. If low compression is found, perform *Cylinder Leakage Testing* in SI and record the test results to isolate the concern.
 - If excessive leakage to the crankcase is isolated, check piston and cylinder wall condition.
 - If the cylinder wall surface has not been compromised, replace all four piston and rod assemblies.

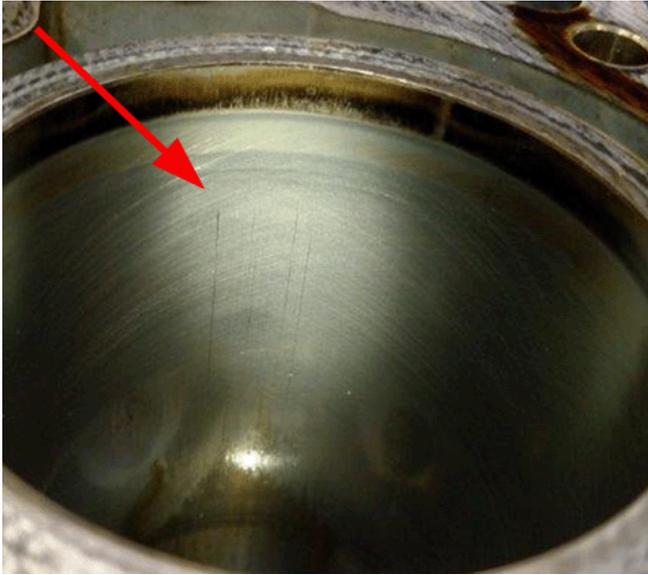
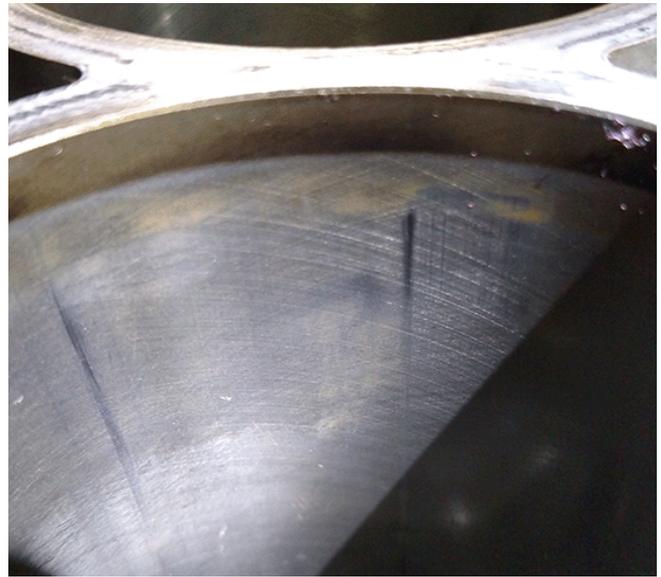
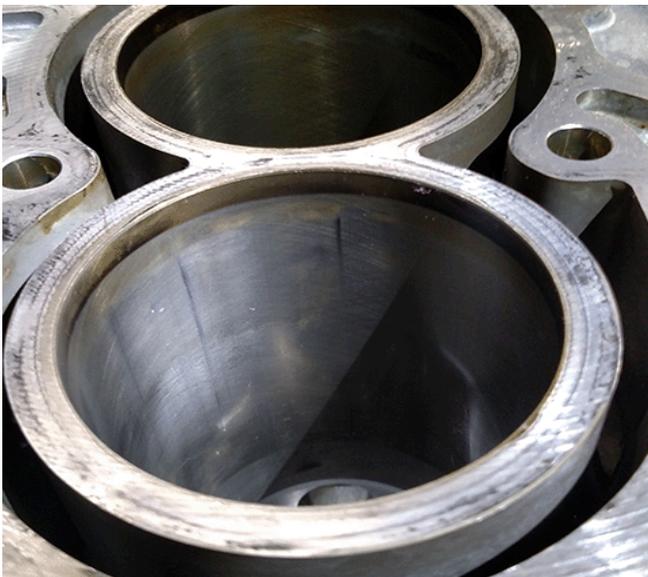
Examples of light vertical marks visible on the cylinder wall:

None of the marks in the cylinder walls could be felt with the fingernail and engine replacement is not recommended.

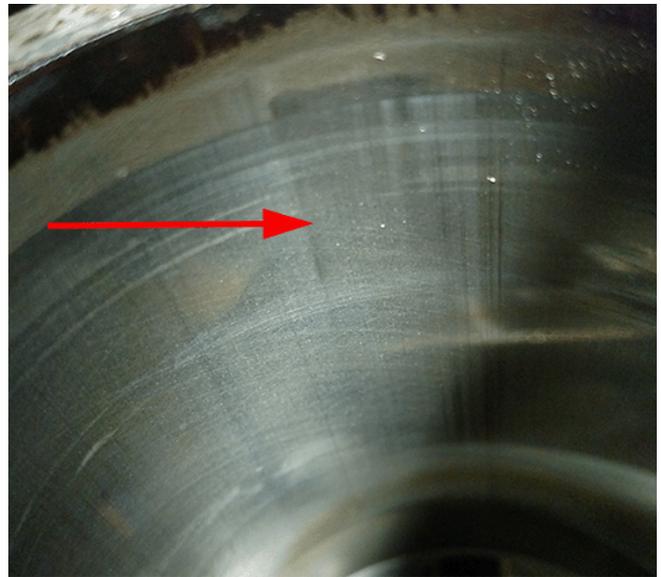
4576914

Example of a damaged cylinder wall:

In this example, the scuffing is wide and has removed the crosshatch from the cylinder wall in the area above the arrow. This would result in oil consumption and requires engine replacement.
