Service Bulletin

Bulletin No.: 19-NA-143

Subject: Loose Fit and/or Rattle Type Noise Heard From the Liftgate Sill Garnish Molding/
Accessory Illuminated Sill Plate

Brand:	Model:	Model Year:		Breakpoint:		Engine:	Transmission:
		from	to	from	to		
Cadillac	XT6	2020	2020

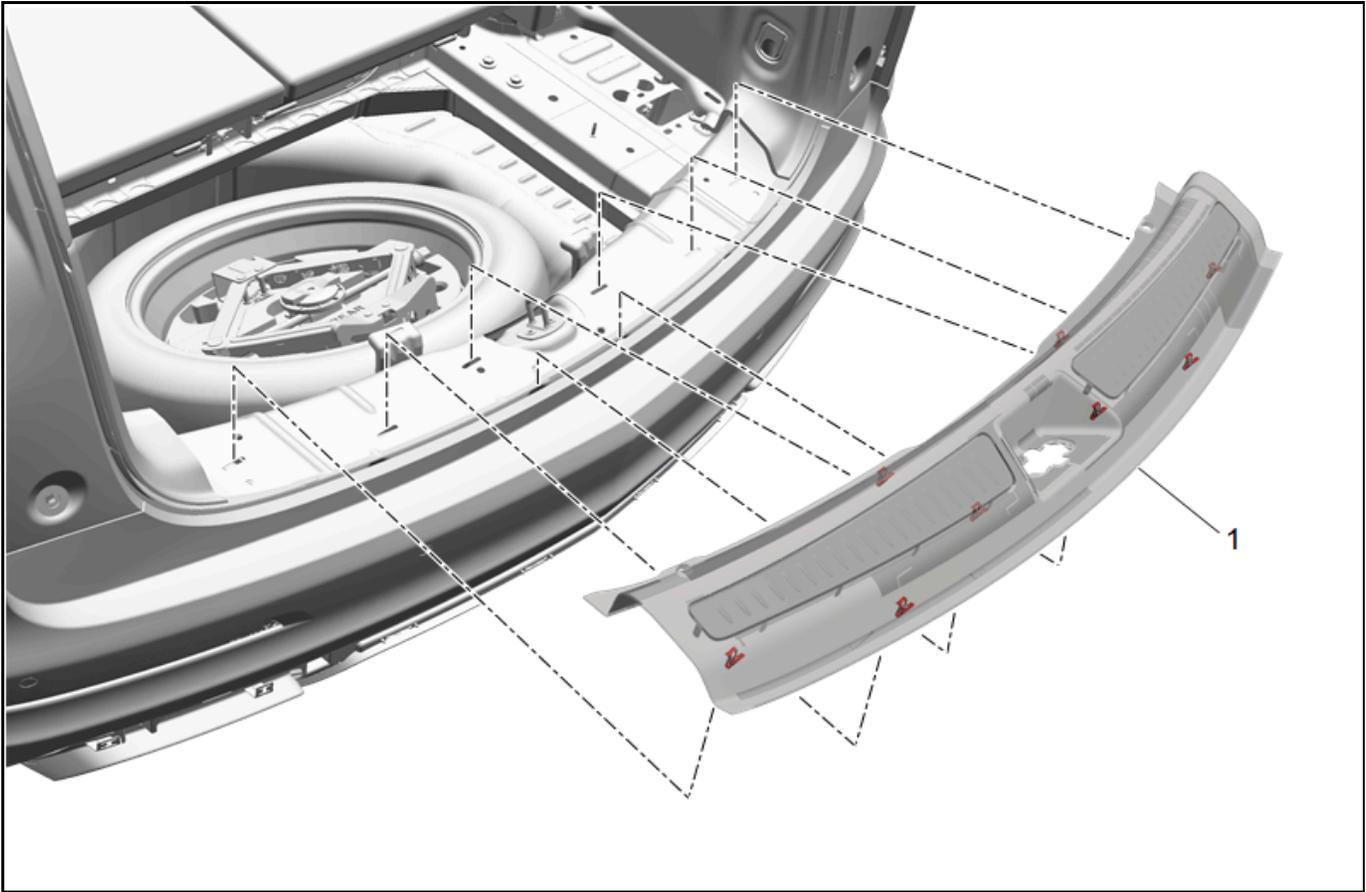
5169891

Involved Region or Country	North America, Mid-East
Additional Options (RPOs)	Equipped with ACCESSORY-ILLUMINATED SILL PLATE - RR COMPT OPENING (RPO 5RU)
Condition	Some customers may comment on a loose fit and/or rattle type noise heard from the liftgate sill garnish molding/accessory illuminated sill plate.
Cause	This condition may be caused by the retainers not providing enough engagement to fasten the liftgate sill garnish molding.
Correction	Replace the retaining clips with the revised service retaining clips following the service procedure below.

5. Install the 8 new retaining clips to the liftgate sill garnish molding.
6. Position the sill plate to the sill of vehicle and engage the clips to the rear sill.

Note: Ensure that the door gasket is seated along the bottom edge.
