# Service Bulletin

Bulletin No.: 09-03-09-001G

**Subject:** Clunking Noise from Rear of Vehicle (Re-torque Leaf Spring Bolts)

**Models:** 2007-2019 Chevrolet Silverado 2500/3500  
2007-2019 GMC Sierra 2500/3500

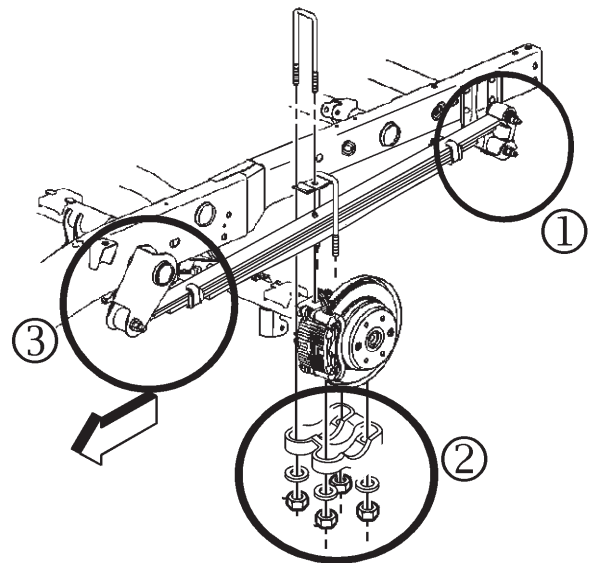
4080776

Some customers may comment about a clunking noise coming from the rear of the vehicle. Upon further investigation, the technician may diagnose the noise coming from the rear suspension leaf spring area.

2. Loosen the shackle joint to the frame, front eye joint to the frame, rear eye to shackle joint and the anchor plate U-bolts.
3. Re-torque the shackle joint to the frame and to the rear eye (1). Refer to SI for torque specifications.

4. Re-torque the anchor plate U-bolts (2). Refer to SI for torque specifications.
5. Re-torque the front rear spring mounting nut (3). Refer to SI for torque specifications.
6. Repeat steps 2 through 5 for the right side leaf spring.
7. Re-test the vehicle for the same clunking noise. If the issue remains, follow the regular repair procedure.
